Addendum #2

Limited Asbestos Inspection Report

La Center Community Center Kitchen

LIMITED ASBESTOS INSPECTION
La Center Community Center Kitchen
1000 E 4th Street
La Center, Clark County, Washington 98629

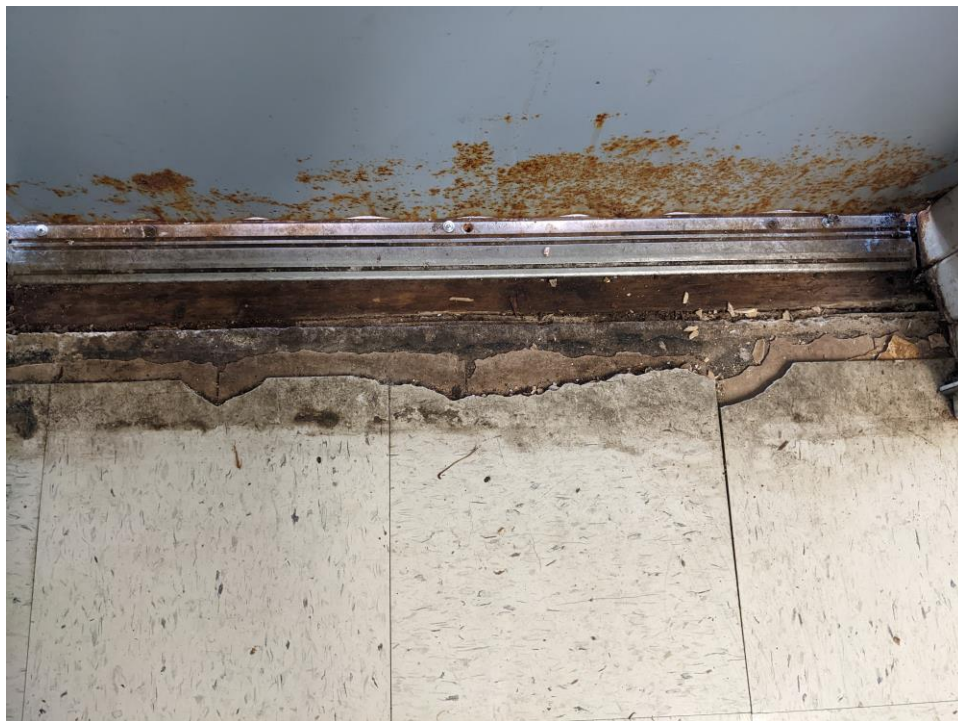
- HA-3: 8"x8" tan vinyl floor tile (2% Chrysotile) and black mastic (4% Chrysotile)
- HA-6: Black sink undercoat (3% Chrysotile)

Photo 4 HA-3: 8"x8" tan vinyl floor tile (2# Chrysotile) and black mastic (4% Chrysotile).

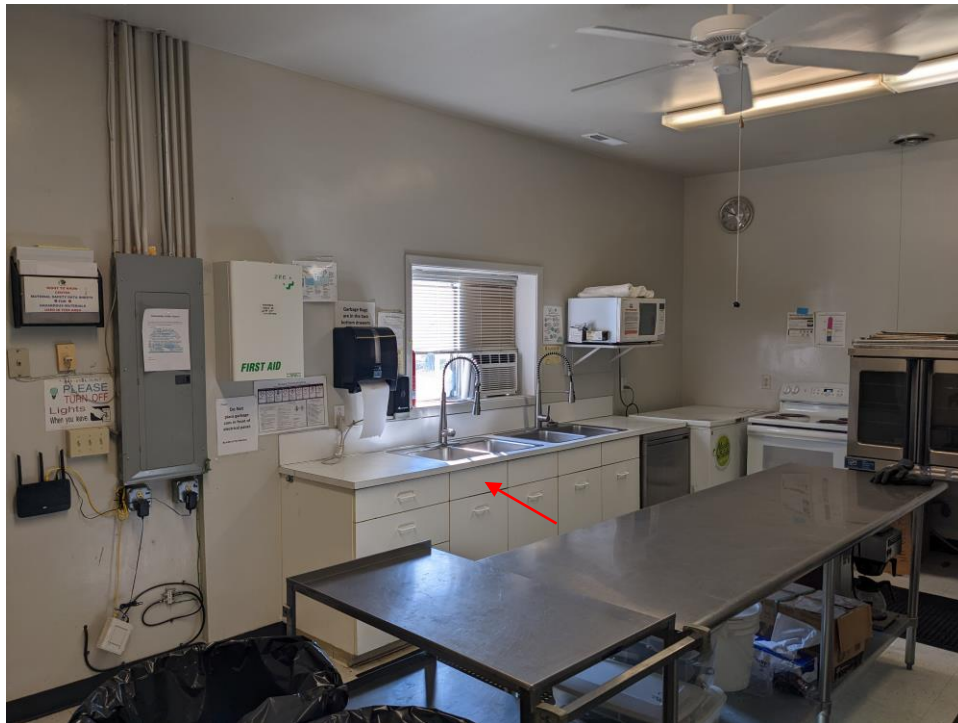
Photo 5 General view of the project area with HA-6: Black sink undercoat (3% Chrysotile).
