**Engineering Geologic Report  
Miller Residence  
East of 410 W E Avenue  
La Center, Washington**

**CGT Project Number G2005397**

December 9, 2020

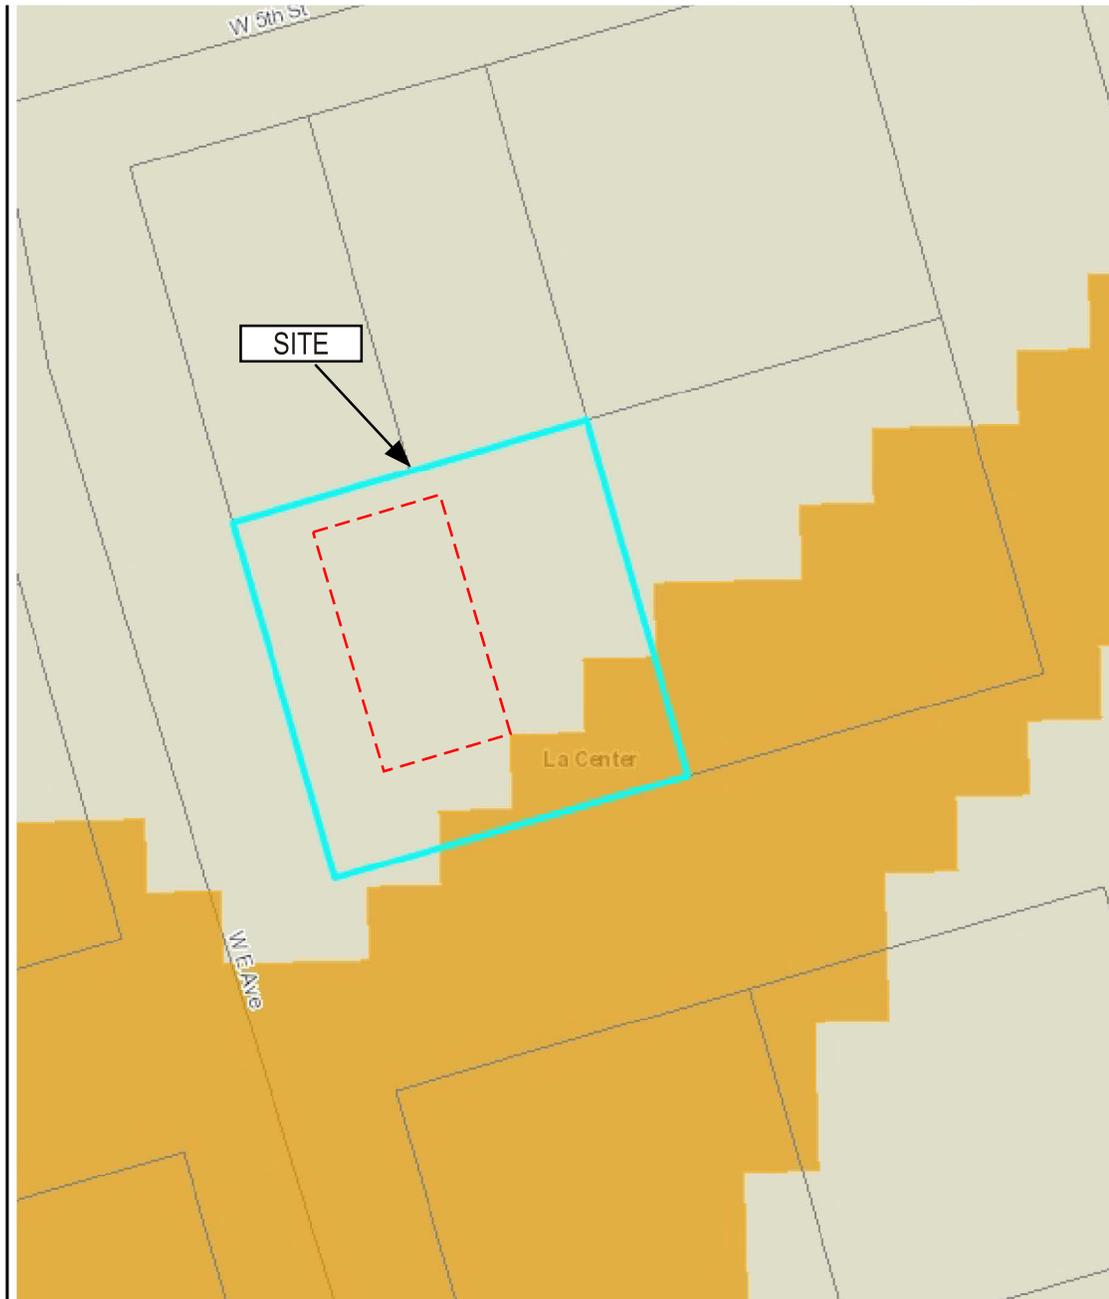
The Clark County Property Information Center<sup>6</sup> shows a small portion of the southeast portion of the site within an Area of Potential Instability (landslide hazard area). The site and landslide hazard area are shown on the attached Figure 4. The landslide hazard zone was assigned based on topography (slope gradient). As shown on Figure 4, the area of proposed development is not located within this zone. In addition, as described in Section 5.1 below, the maximum gradient observed in the southeast portion of the site was about 5H:1V, and no signs of instability or past landsliding were noted.

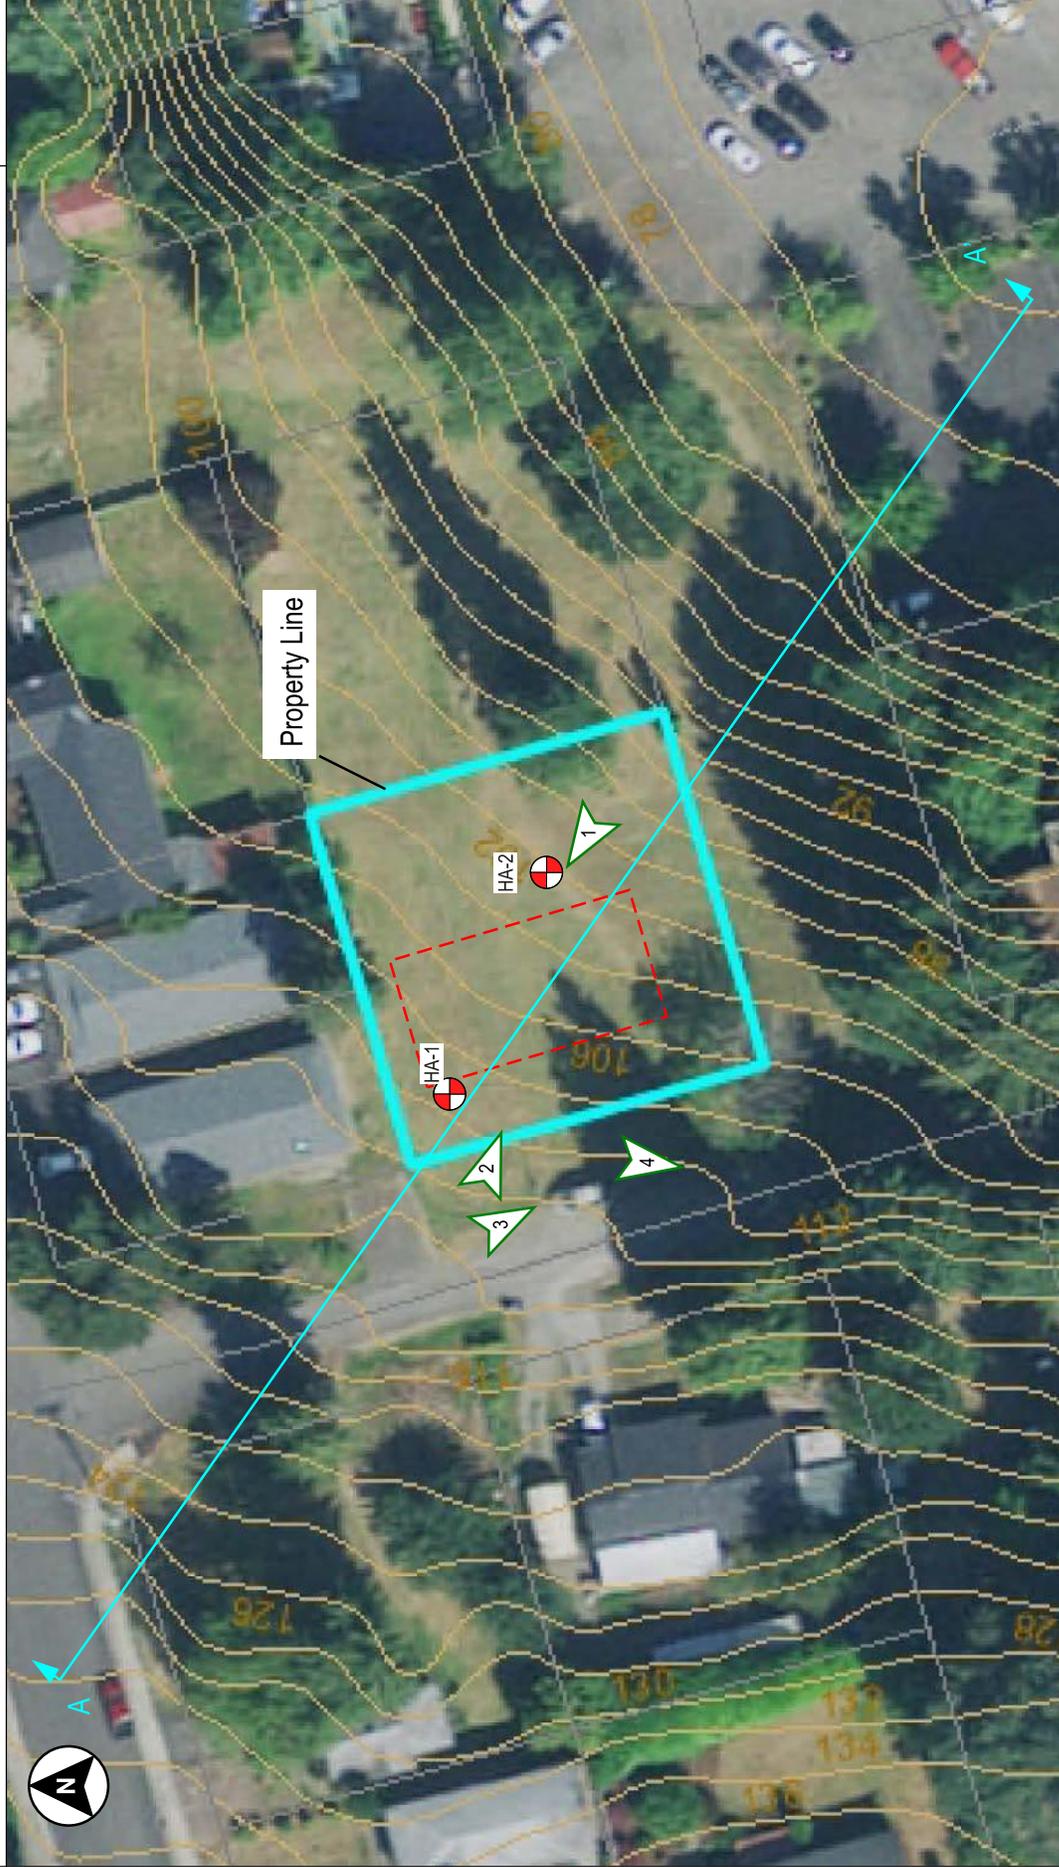
**FIGURE 5**  
**Site Plan**

The approximate 0.23-acre site was bordered by West E Avenue to the west, developed residential properties to the north and south, and a vacant lot to the east. The site was vegetated with grasses and scattered trees. The site was not occupied by any structures or previous development at the time of our site visit.

The site descended to the southeast below West E Avenue at gradients ranging from about 8H:1V near the street to about 5H:1V near the southeast corner of the property. Topography of the site is shown on the Site Plan (Figure 5) and Site Topographic Profile (Figure 7).

No indicators of recent or ongoing slope instability were observed on the site during the reconnaissance.

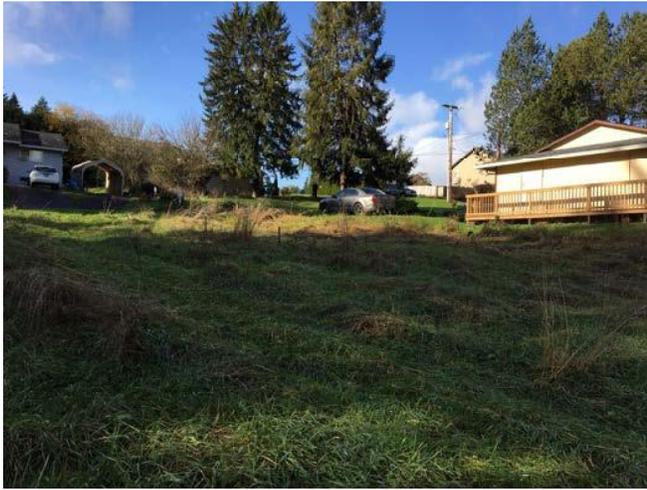
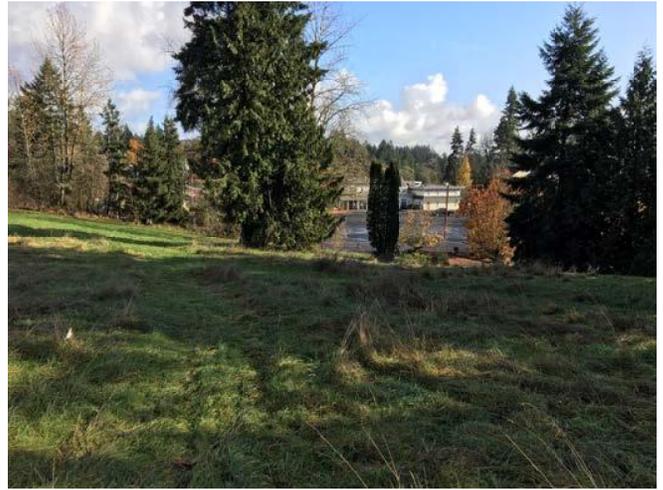
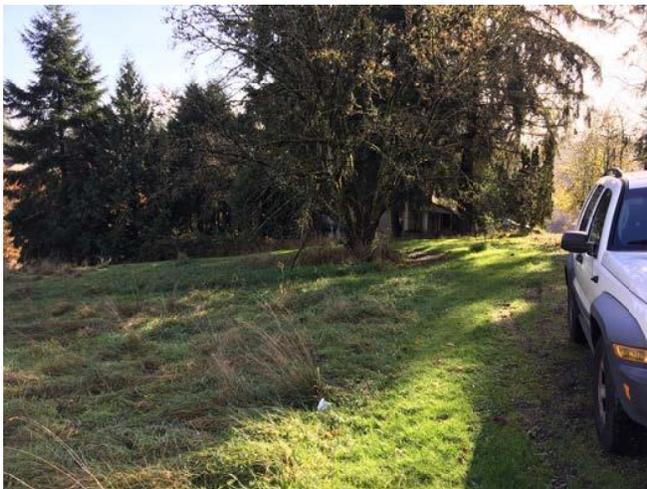
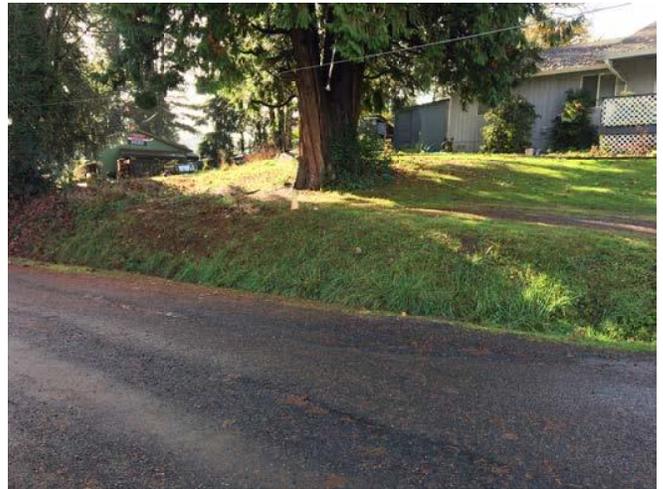
The proposed site layout and conditions are shown on the attached Site Plan (Figure 5) and Site Photographs (Figure 6).
