**Engineering Geologic Report
Riverside Estates Subdivision
Ridgeline Park
34512 NW Pacific Highway
La Center, Washington**

CGT Project Number G2005322

July 22, 2020

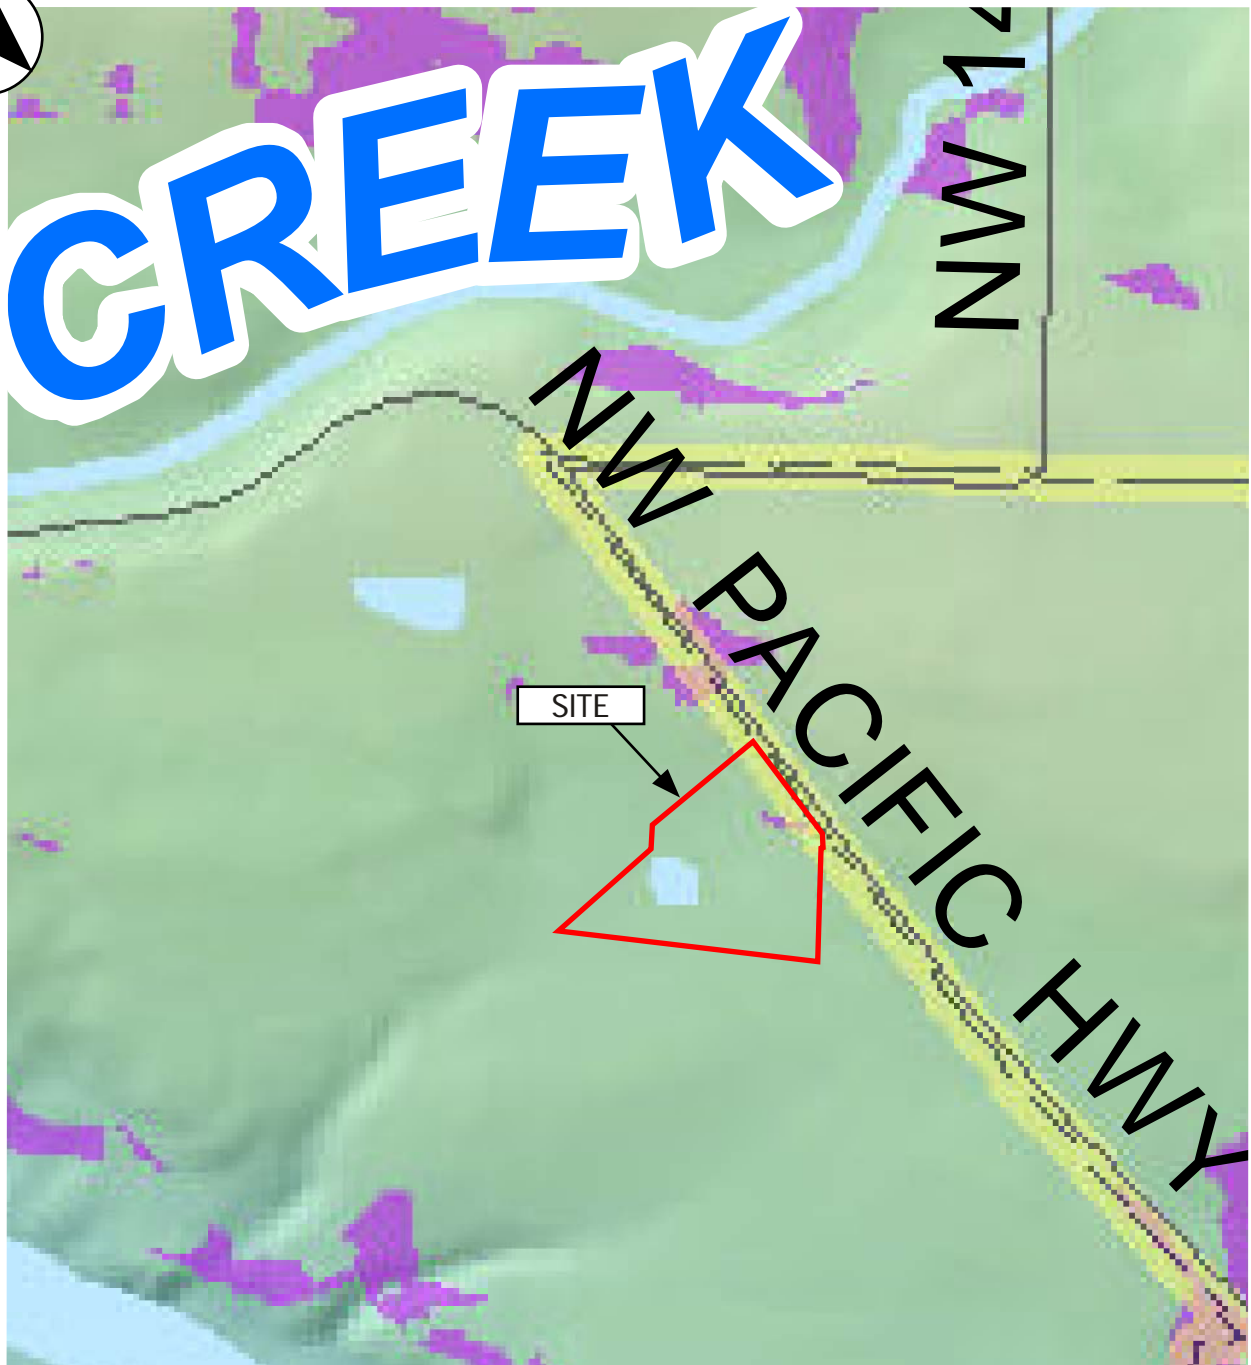
The Clark Regional Emergency Services Agency (CRESA)²¹ shows a small portion of the northeast portion of the site within a landslide hazard area (Figure 7). Another landslide hazard area is mapped northwest of the site alongside NW Pacific Highway. This map is based on topography, and indicates areas with slope gradients in excess of 15 percent.

The Clark Regional Emergency Services Agency (CRESA)²⁸ shows a small portion of the northeast portion of the site within a landslide hazard area. Another landslide hazard area is mapped northwest of the site alongside NW Pacific Highway. We did not observe signs of previous or ongoing instability during our reconnaissance. As described in Section 1.1, the proposed development will include the placement of up to about 7 feet of structural fill in the area of the proposed roadway and ADA path to reach finished grades. New fill slopes will have finished gradients up to 2 horizontal to 1 vertical (2H:1V). We conclude the proposed development will have no significant impact on the potential for large-scale slope instability.

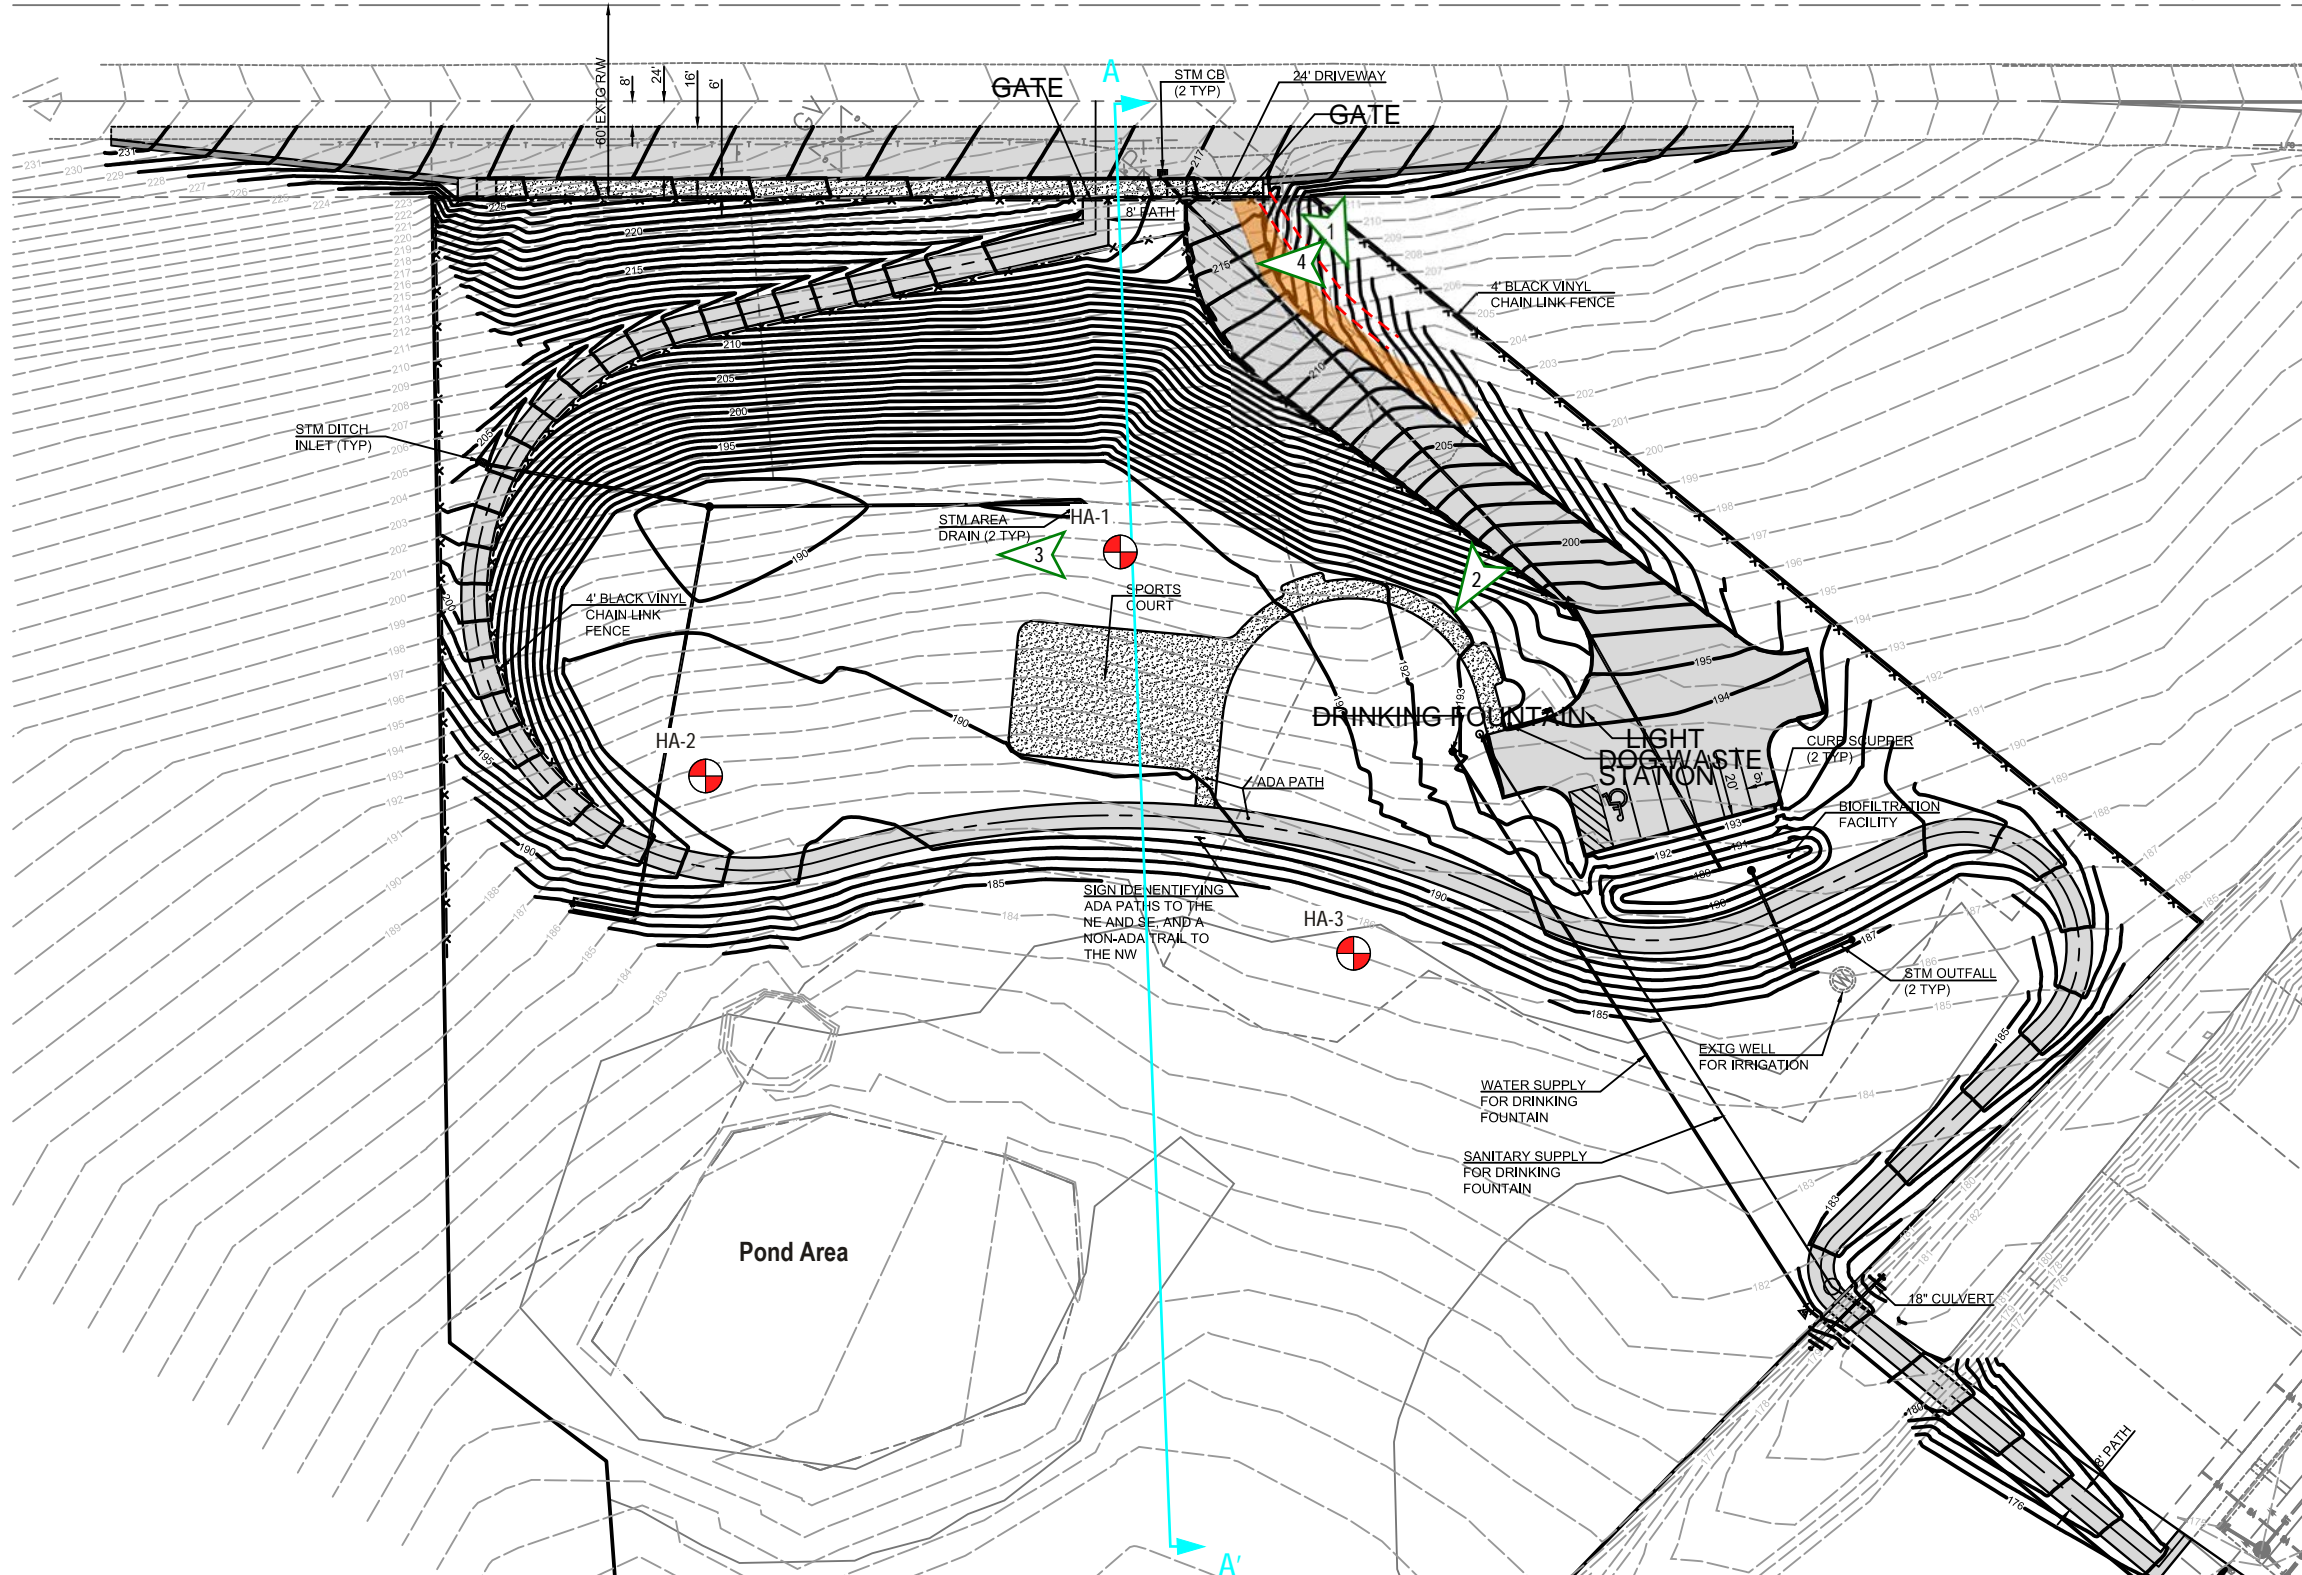
The proposed site layout and site conditions during our reconnaissance are shown on the attached Site Plan (Figure 8) and Site Photographs (Figure 9). The existing topography shown on the Site Plan is consistent with that observed during the reconnaissance.

Our subsurface investigation consisted of three hand auger borings (HA-1 through HA-3) completed on July 16, 2020. The approximate exploration locations are shown on the Site Plan, attached as Figure 8. In summary, the borings were advanced to depths ranging from about 5 to 5½ feet bgs. Details regarding the subsurface investigation, logs of the explorations, and results of laboratory testing are presented in Appendix A. Subsurface conditions encountered during our investigation are summarized below.

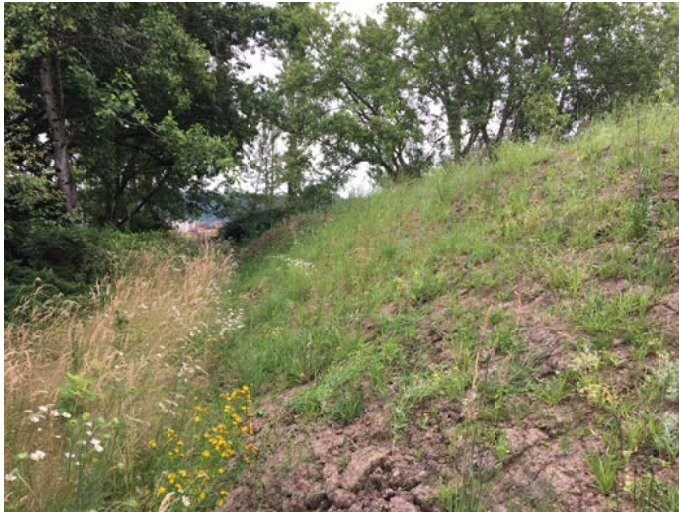
Photograph 1

No indicators of recent or ongoing slope instability were observed on the site during the reconnaissance.
