Holley Park Subdivision La Center, Washington Critical Areas Assessment

Date: March 14, 2019

Prepared By: Stacey Reed, PWS, Senior Wetland Scientist
Taya K. MacLean, PWS, Senior Biologist

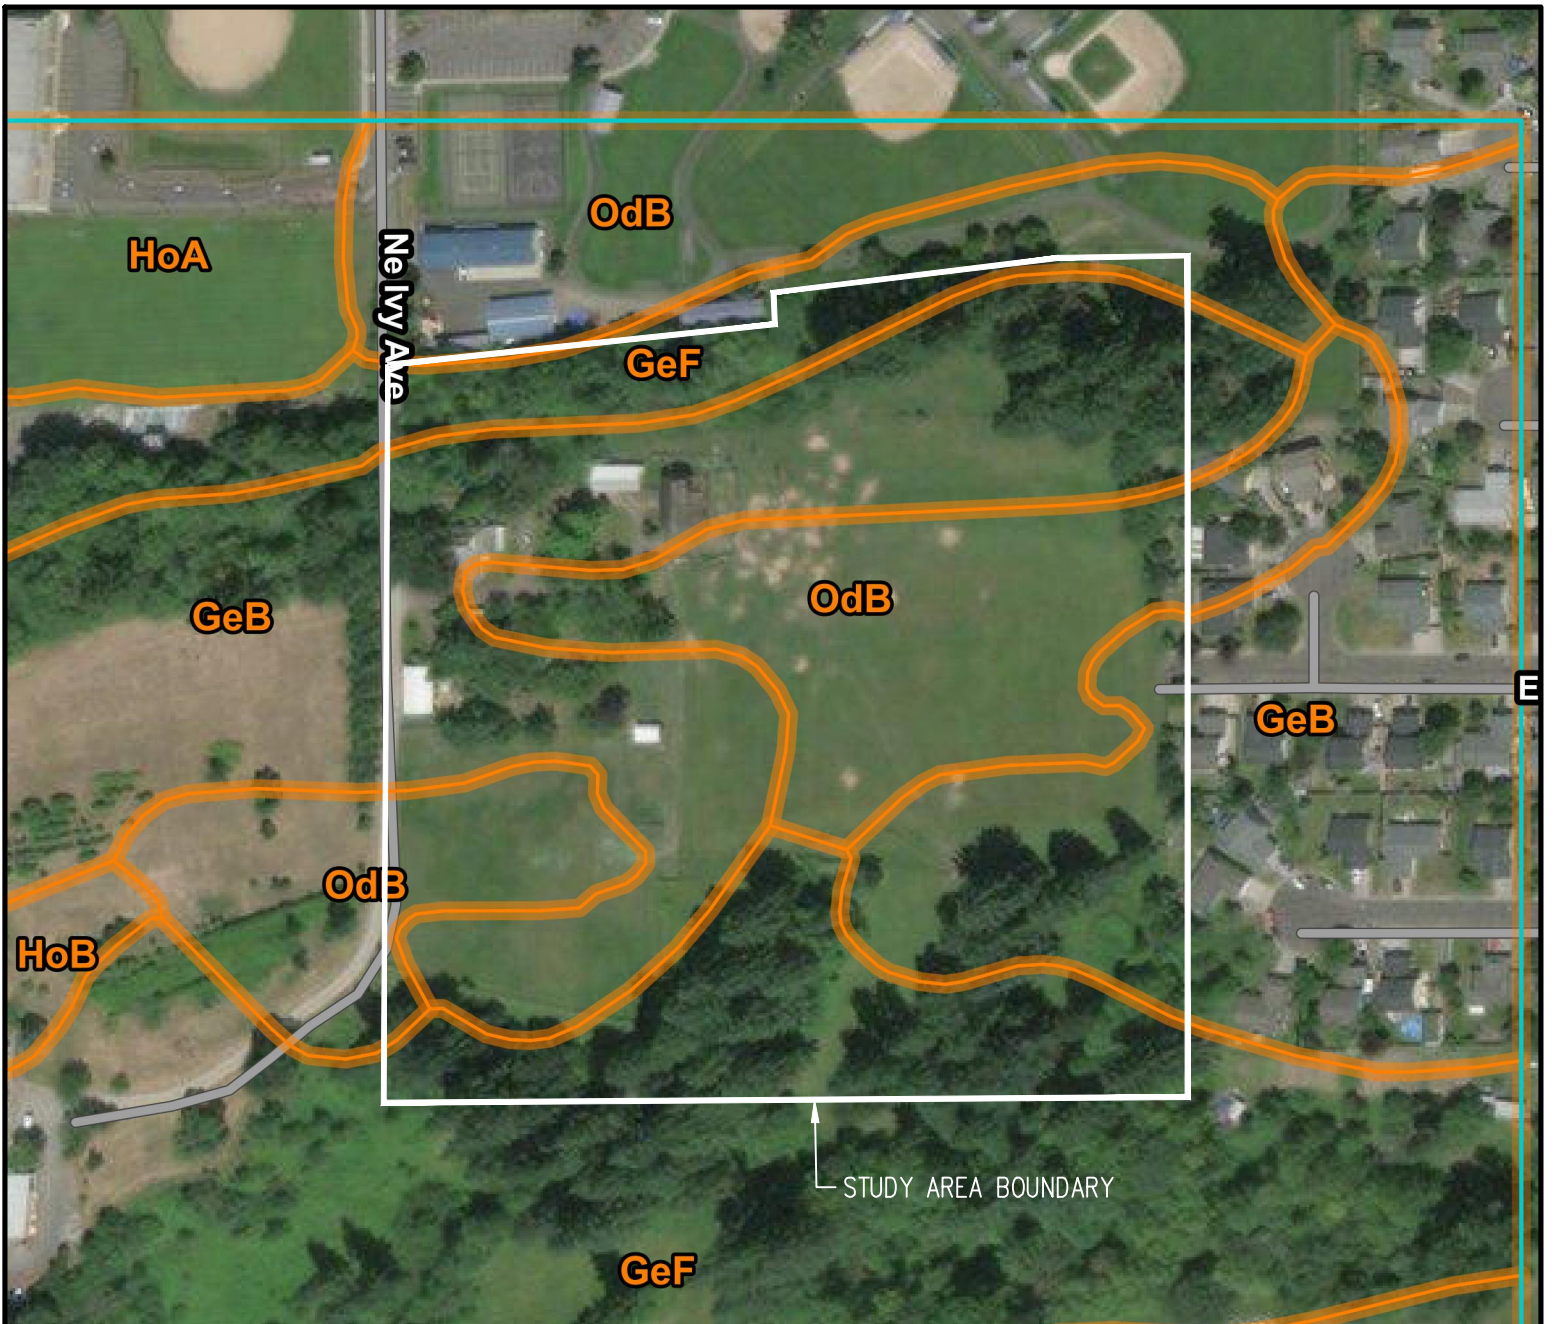
NRCS WEB SOIL SURVEY FOR
CLARK COUNTY

According to the Natural Resources Conservation Service (NRCS) Soil Survey Map for Clark County (Figure 3), the following soils are mapped within the study area (Figure 3 in Appendix A):

- Gee silt loam (0% to 8% slopes, Unit GeB; non-hydric)
- Gee silt loam (30%-60% slopes, Unit GeF; non-hydric)
- Odne silt loam (0% to 5% slopes, Unit OdB; hydric)

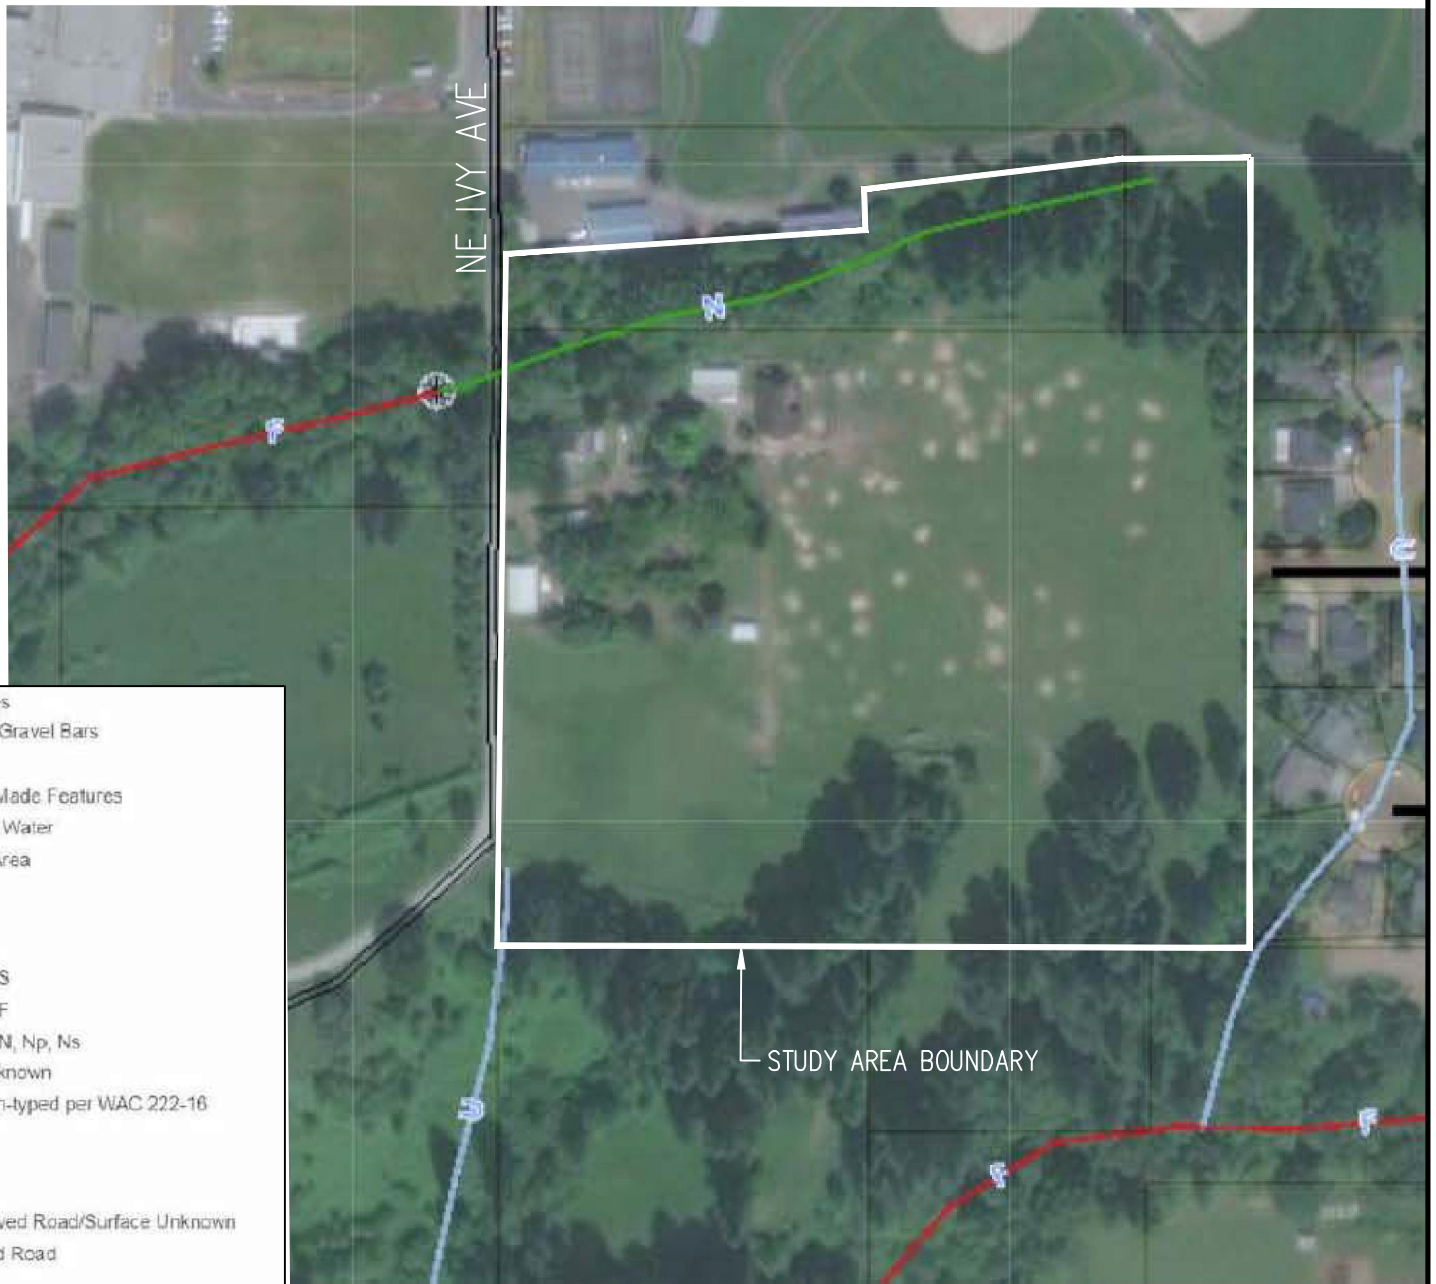
DNR WATERS MAP		FIGURE 6
HOLLEY PARK SUBDIVISION CRITICAL AREAS ASSESSMENT		
AKS ENGINEERING & FORESTRY, LLC 12965 SW HERMAN RD, STE 100 TUALATIN, OR 97062 P: 503.563.6151 F: 503.563.6152 aks-eng.com		DRWN: SKT CHKD: SAR AKS JOB: 6962

According to the DNR online mapping tool, a Type N stream is mapped along the northern portion of the site. AKS identified this stream as Water 1, a Type Ns stream (Figure 6, Appendix A). Two "unknown" streams are mapped by DNR, including one immediately off-site to the east and one in the southeastern portion of the study area (Figure 6, Appendix A). AKS identified these features as Water 2 and 3, Type Ns streams.

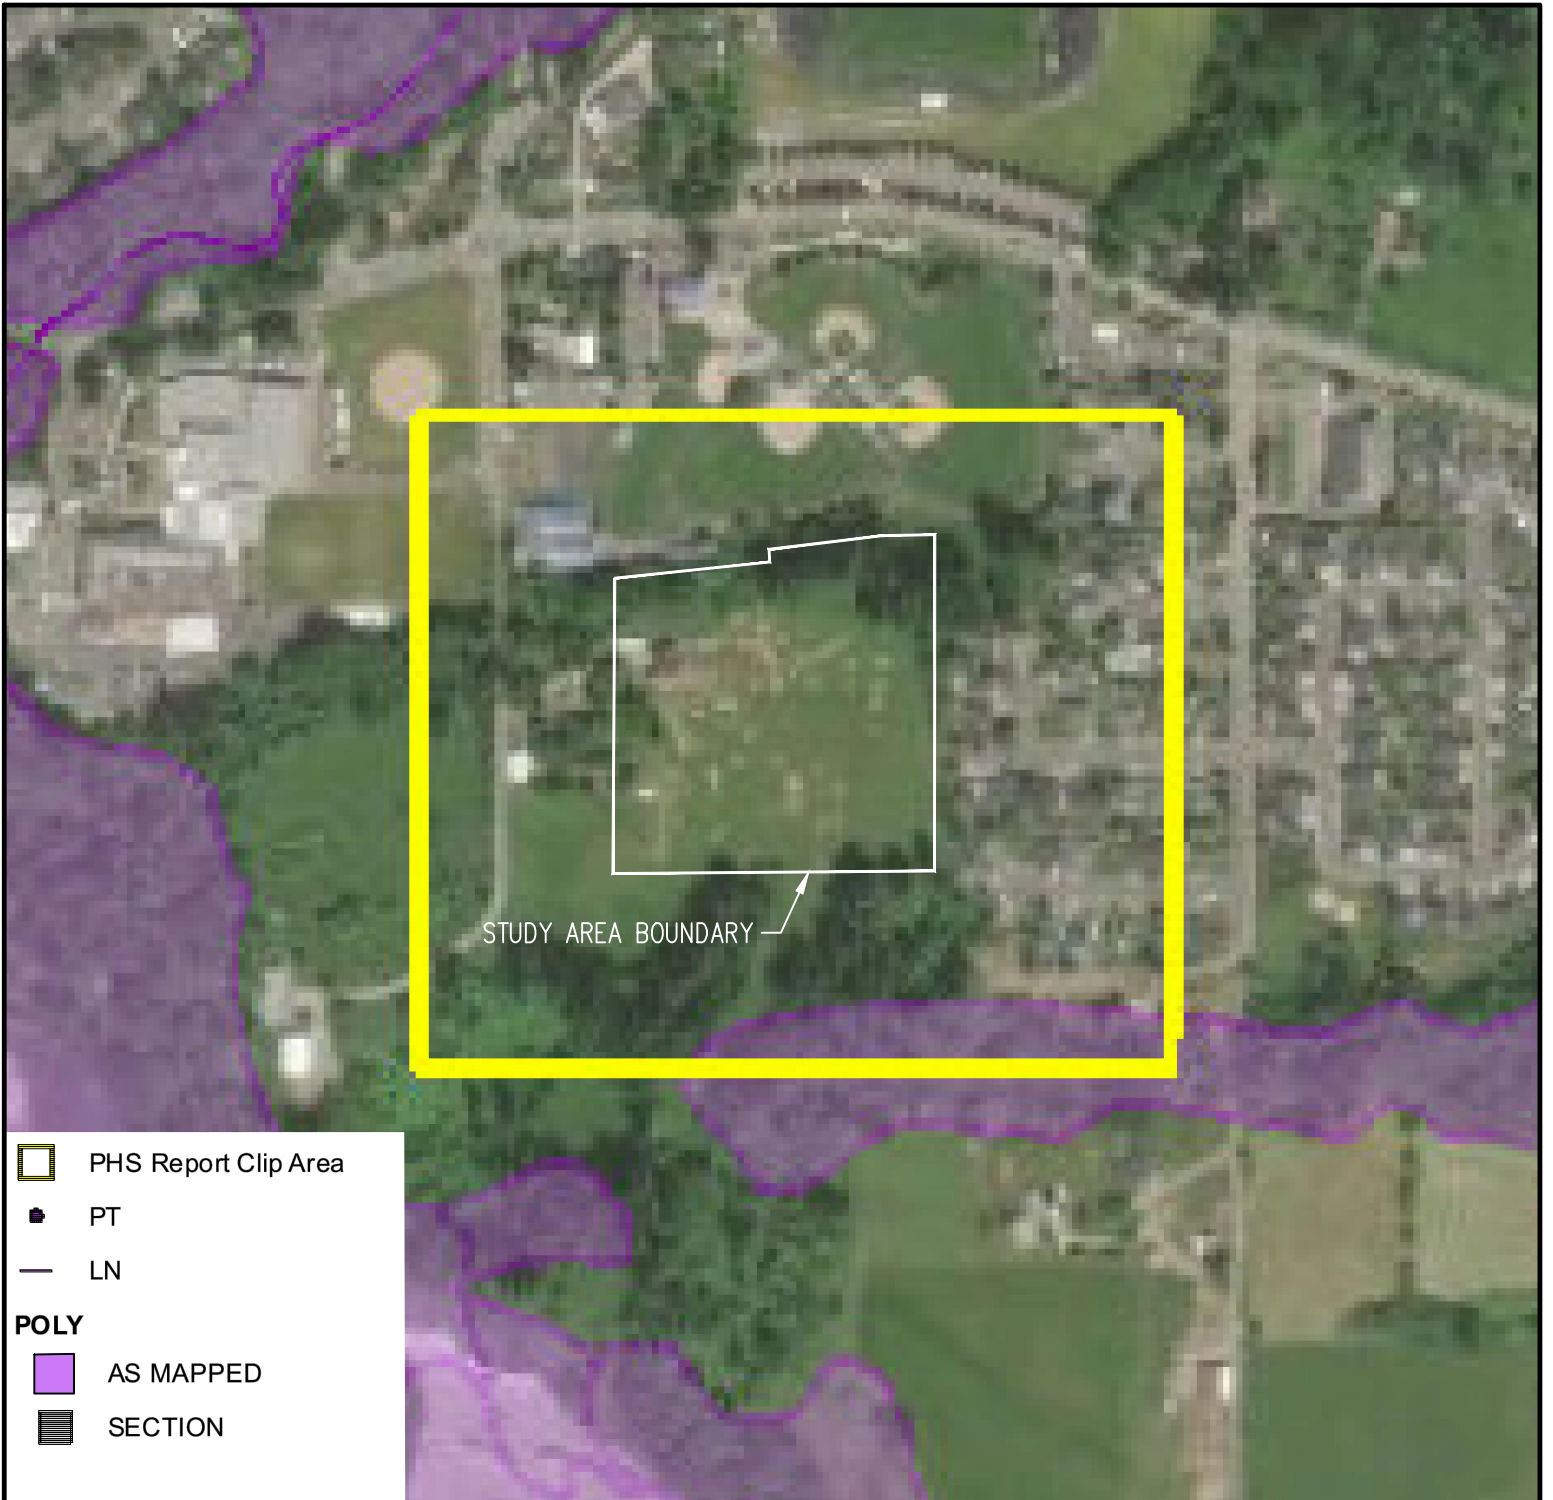
WDFW PRIORITY HABITAT AND SPECIES MAP HOLLEY PARK SUBDIVISION CRITICAL AREAS ASSESSMENT		FIGURE 8
AKS ENGINEERING & FORESTRY, LLC 12965 SW HERMAN RD, STE 100 TUALATIN, OR 97062 P: 503.563.6151 F: 503.563.6152 aks-eng.com		DRWN: SKT CHKD: SAR AKS JOB: 6962

According to WDFW's PHS mapping, Oregon white oak woodland priority habitat is mapped within 300 feet of the study area, but priority oak habitat is not mapped on the project site (Figure 8 of Appendix A). No other priority habitat species are mapped on the site. According to DNR's SalmonScape mapping,

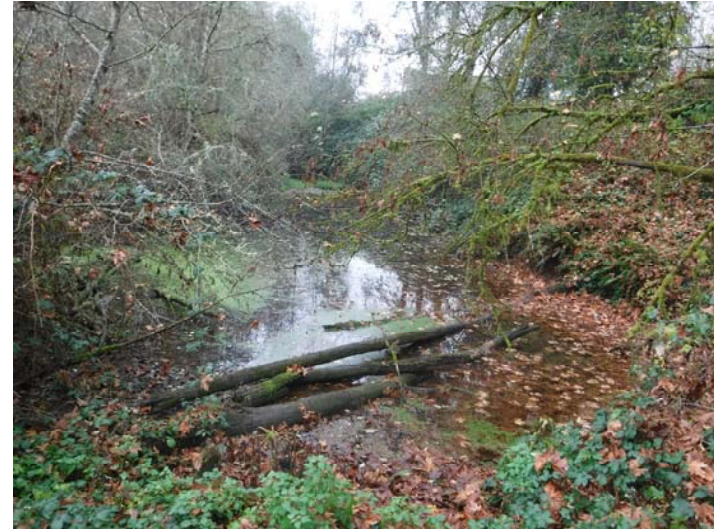
Photo B. View facing east of Water 1 from NE Ivy Avenue.

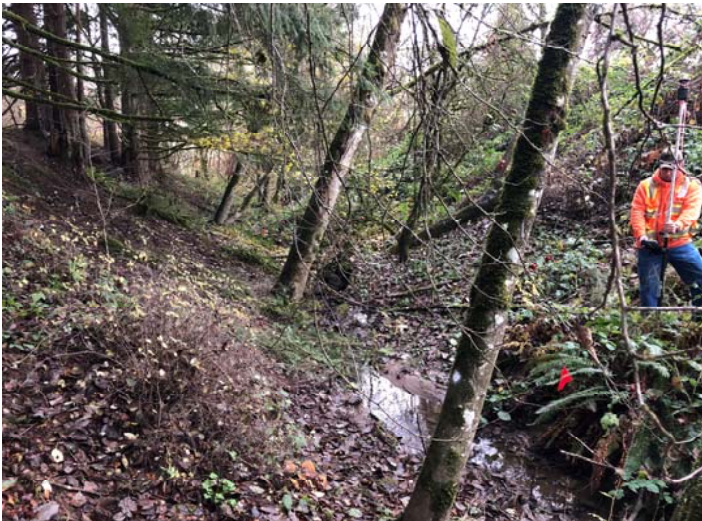
Photo G. View facing east of Water 1. Water flows west. Photo taken by AKS survey crew on 12/02/18.

Water 1 is an intermittent, non-fishbearing (DNR Water Type Ns) stream which flows westerly along the northern boundary. Water 1 extends off-site to the west via an 18-inch diameter culvert under NE Ivy Avenue, where it appears to have a direct hydrologic connection to wetlands adjacent to the East Fork Lewis River. Water 1 originates immediately off-site to the northeast.

Within the study area, the upper reach of the channel bed averages approximately 4-feet wide with 2-foot tall banks. Approximately 4-inches of continuous flow was present in the entire on-site channel reach during the November 2018 site visit. The downstream end contained scour at the culvert inlet under NE Ivy Avenue. The channel is generally unvegetated with scattered giant horsetail (*Equisetum telmateia*; FACW), western lady fern (*Athyrium cyclosorum*; FAC), and Himalayan blackberry growing along the banks. Dominant channel bed substrate consisted of silt loam with scattered gravels and cobbles with some large wood debris.

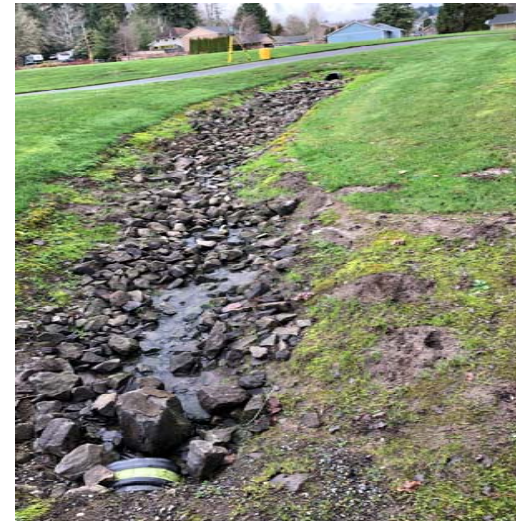
Photo H. View facing northeast of rip-rap lined swale off-site where Water 1 originates. Photo taken by AKS survey crew on 12/02/2018.

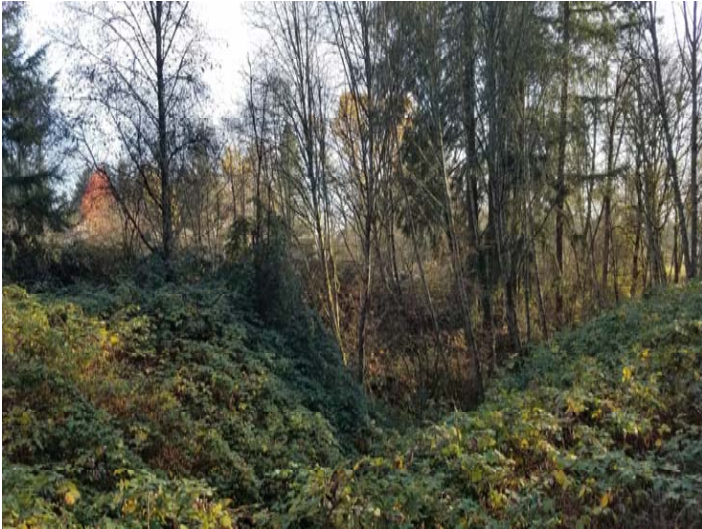
Photo M. View facing southeast of Water 3 corridor. Photo taken by AKS survey crew on 11/20/18.

Water 3 is an intermittent, non-fishbearing (DNR Water Type Ns) stream which originates on-site at the bottom of a ravine in the southeastern portion of the study area. Water 3 extends off-site to the south and appears to have a direct hydrologic connection to wetlands adjacent to the East Fork Lewis River. The channel bed is approximately 4-feet wide with 1 foot tall channel banks. Approximately 0.25-inch deep of continuous flow was observed within Water 3 during the November 2018 site visit. The channel is generally unvegetated with western lady fern and Himalayan blackberry growing along the banks.

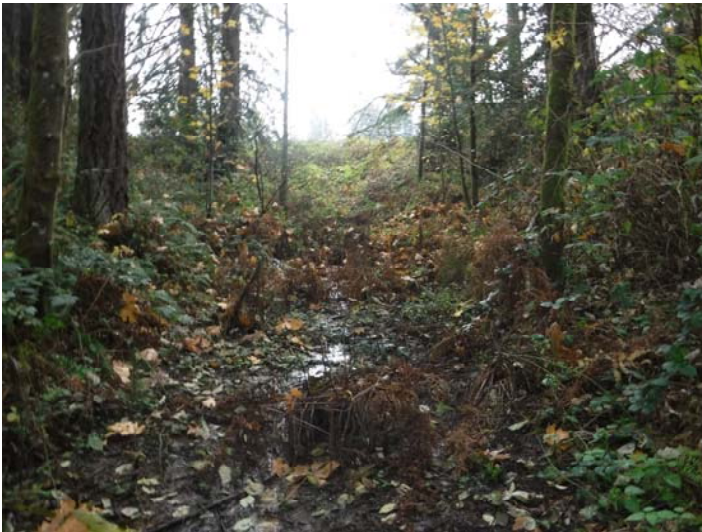
Photo O. View facing south of Water 2. No wetlands found above the OHWM

Water 2 is an intermittent, non-fishbearing (DNR Water Type Ns) stream which is mapped in the south-central portion of the study area. Water 2 extends off-site to the south and appears to have a direct hydrologic connection to wetlands adjacent to the East Fork Lewis River. Within the study area, the channel bed averages approximately 5-8-feet wide and had approximately 2-inches of continuous flow during the November 2018 site visit. The channel bed was unvegetated with scattered giant horsetail, western lady fern, and stinging nettle (*Urtica dioica*; FAC) growing along the banks and below the OHWM.

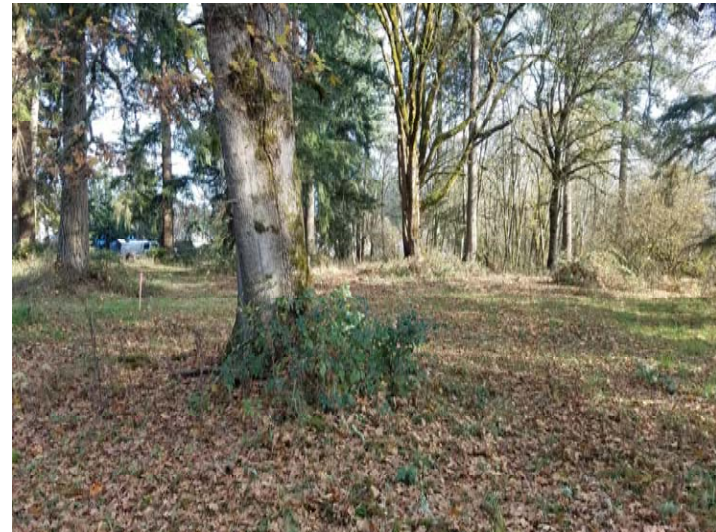
Photo P. View east of forested area with Oregon white oaks near Water 3. Photo taken by AKS survey crew on 11/20/18.

AKS biologist Taya MacLean met on-site with WDFW biologists David Howe and Julie Grobelny, on February 21, 2019 to verify priority individual oaks on the site. AKS observed six Oregon white oaks with diameters at breast height (DBH) varying from 10 inches to 30 inches throughout the study area that meet WDFW's definition of a priority individual oak tree. The locations of the surveyed priority oaks and associated driplines are shown on attached Figure 9, Appendix A.
