Chinookan, LLC
Geotechnical Engineering Evaluation

Vineyard Vista Subdivision
Off NE North Fork Ave
La Center, Washington, 98629

True North Project No. 22-0389-1
December 1, 2023

Subject: Geotechnical Engineering Evaluation

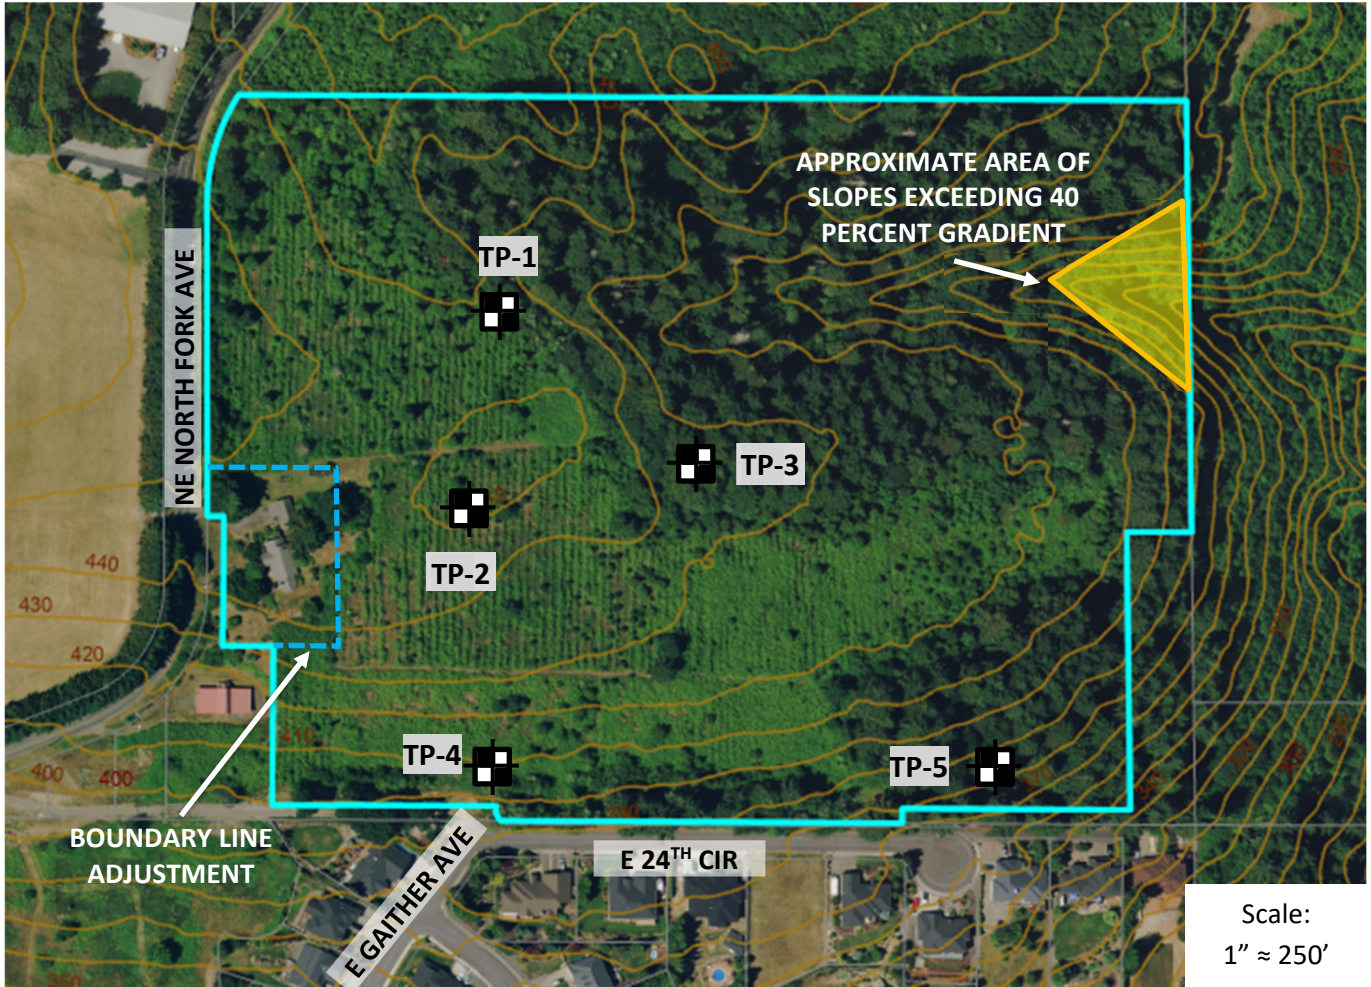
<p>TRUE NORTH ◀ GEOTECHNICAL ▶</p>	<p>Chinookan, LLC Vineyard Vista Subdivision La Center, WA</p>	<p>Project # 22-0389-1</p>
<p>219 West 4th Street Vancouver, WA 98660 360-984-6584</p>	<p>December 2023</p>	<p>Figure 2 –Site Plan</p>

Approximate Exploratory Test Pit Locations, September 28-29, 2022.

True North's current understanding of the proposed development is based on a review of Preliminary Grading and Stormwater plans for the project, prepared by The Wolfe Group, LLC, dated November, 2023. We understand that the proposed project consists of the subdivision of the existing lots into 84 new lots. The new lots will range in size from approximately 6000 to 10,000 square-feet, and will each accommodate one single-family home. The existing home and shop on the property will remain and has been property line adjusted into a new lot located at the southwest of the proposed development (see site plan). We understand that several new public roadways are planned to provide access to the lots from NE North Fork Avenue. In general, we understand that utilities are planned below the new roadways. The site with respect to existing nearby features is shown in the attached Vicinity Map, Figure 1. The location of our explorations with respect to existing site conditions and boundaries is shown on the attached Figure 2, Site and Exploration Plan.

The portions of the site where slope gradients exceed 40 percent should be considered geologically hazardous areas for steep slopes, in accordance with La Center Municipal Code (LCMC) 18.300. This encompasses a small portion of the northeastern corner of the site, where the plateau descends into the gully leading to Brezee Creek. As such, activities at the top of the slope should be subject to setbacks and restrictions, which are outlined in the Recommendations section of this report. See Figure 2 – Site Plan for more information.

The limits of the steep slope hazard area, as well as approximate setback limits are shown in Figure 2. Actual slope limits and associated setbacks should be determined after completion of a site-specific topographic survey. We have included a typical slope setback figure for guidance as Figure 5 of this report.

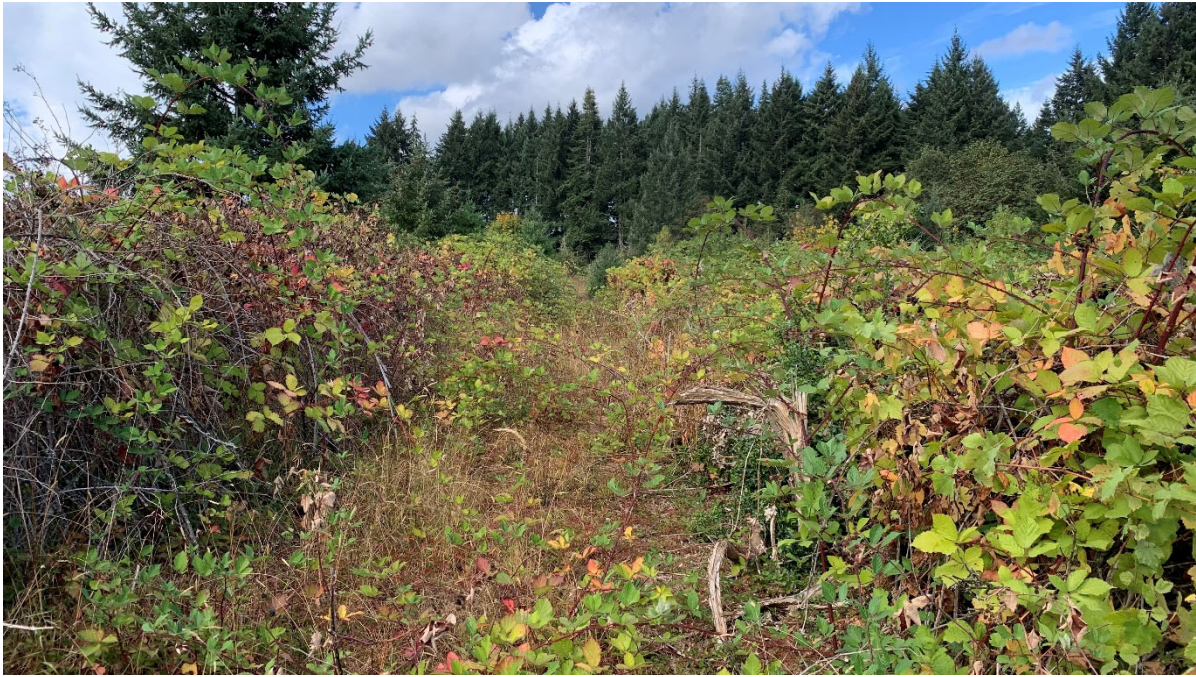
Photo 1. Looking northeast upslope from behind the existing barn towards the gully.

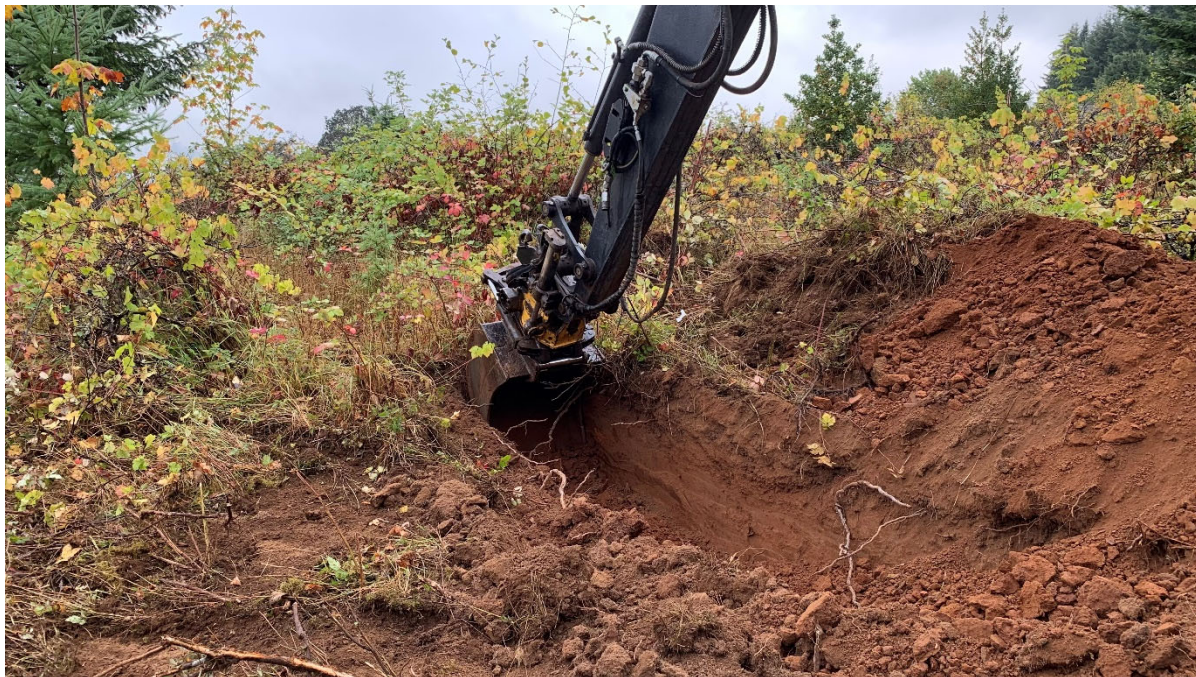
Photo 2. Excavating Test Pit 2.

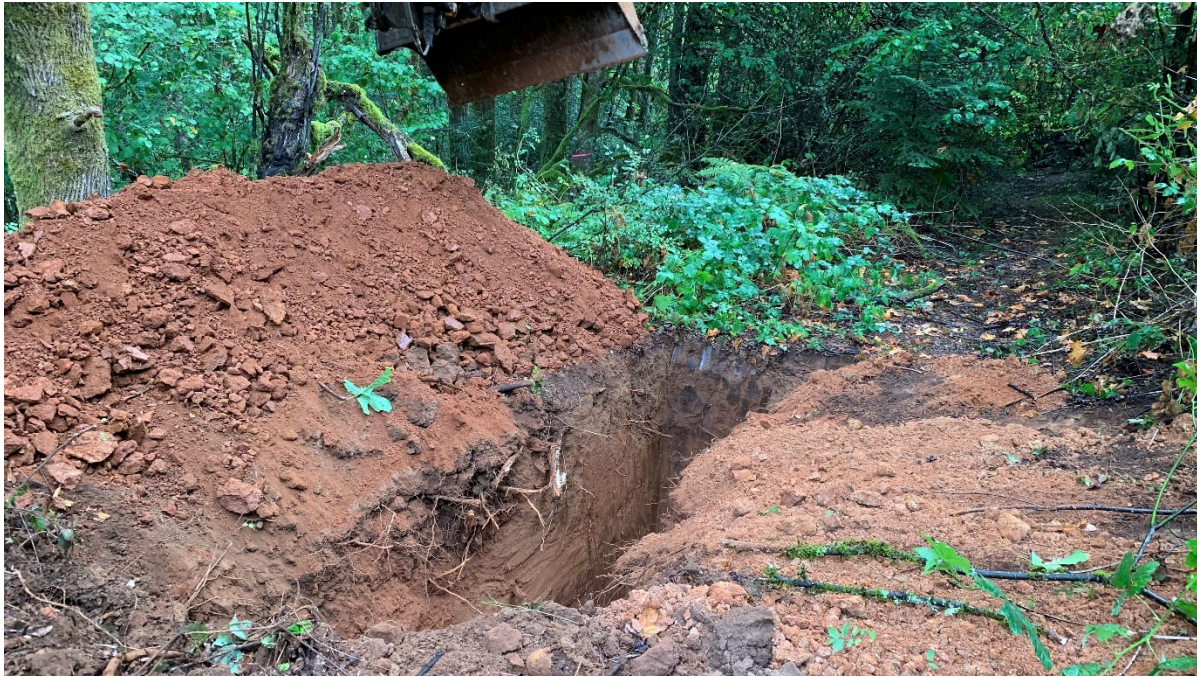
Photo 3. Excavation of Test Pit 3, just southwest of the gully.

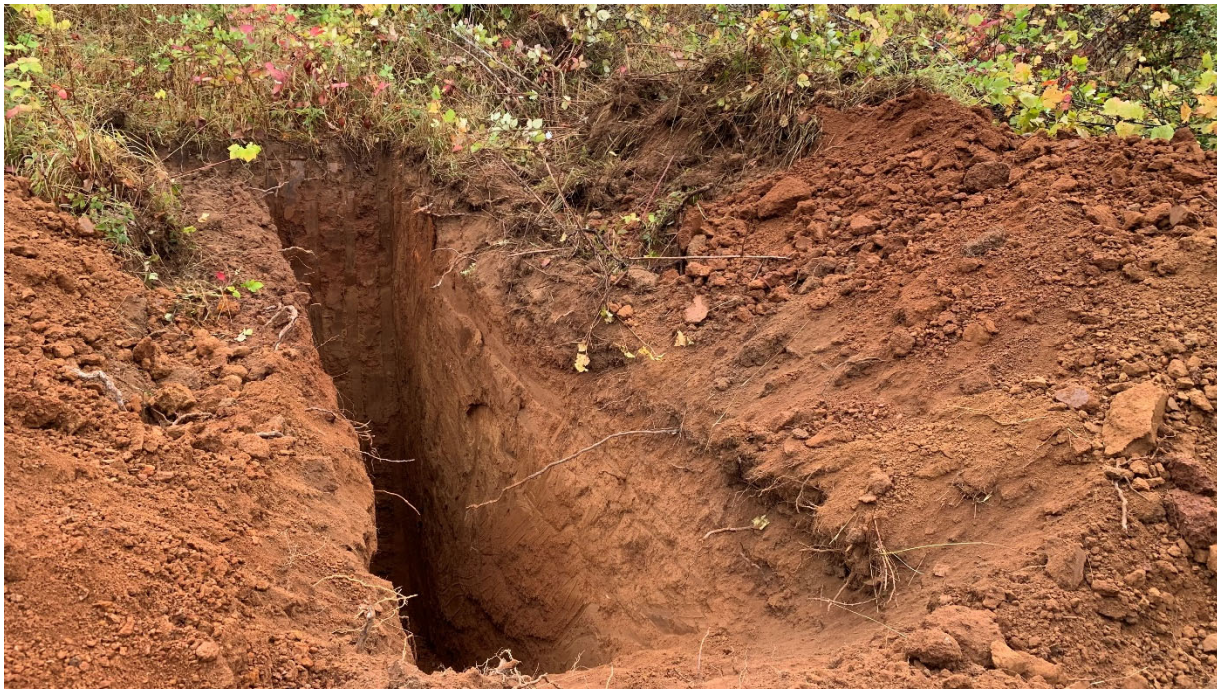
Photo 4. Test Pit 1.
