Critical Areas Report and Stream Buffer
Mitigation Plan
for
Larsen Drive Subdivision
XXXX Larsen Drive
La Center, Washington

Project 332.02

Prepared by:
Loowit Consulting Group, LLC
312 Gray Road
Castle Rock, WA 98611
360.431.5118
Thaderly42@gmail.com

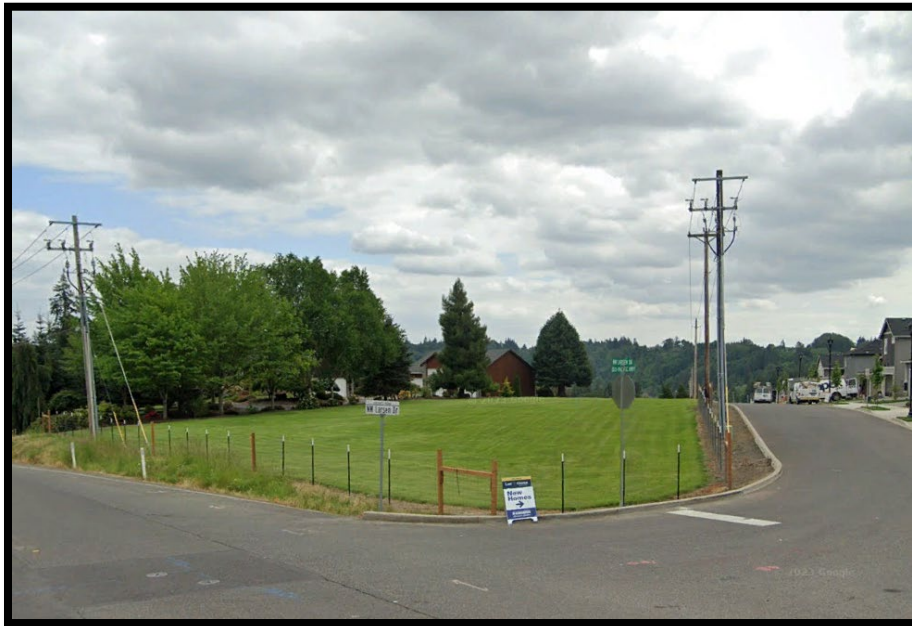
Photograph 1: Intersection of NW Pacific Hwy (left) and Larsen Drive (right). This is the northern portion of the Subject Site with the single-family residence visible in the middle of the photo. Photo is looking southeast. (Photo source: Google Maps)

The Subject Site is located south of NW Pacific Highway and east of Larsen Drive. The northern approximate one-third of the site is occupied by a single-family residence and associated outbuildings, and is surrounded by maintained landscaping (Photograph 1). The Subject Site, proposed for development, is the southern two-thirds of the subject site, east of Larsen Drive

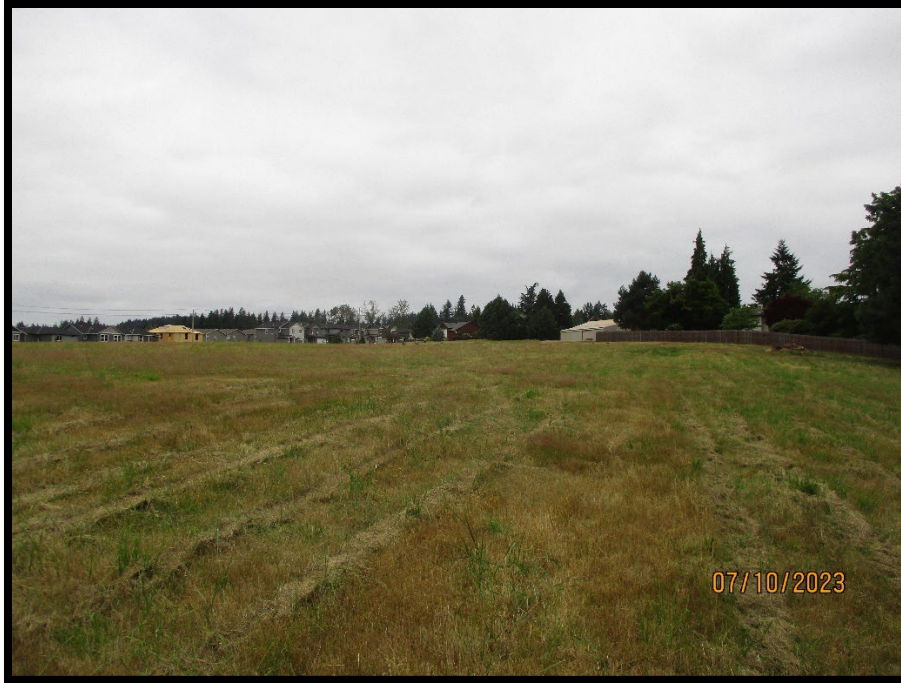
Photograph 2: Looking northwest across the Subject Site towards Larsen Drive (in front of the houses in distance to left of photo) and the single-family residence (center of photo) in the northern third of the Subject Site. The Subject Site extends nearly to the single-family residence in the middle distance, and includes the tan barn (middle right of photo).

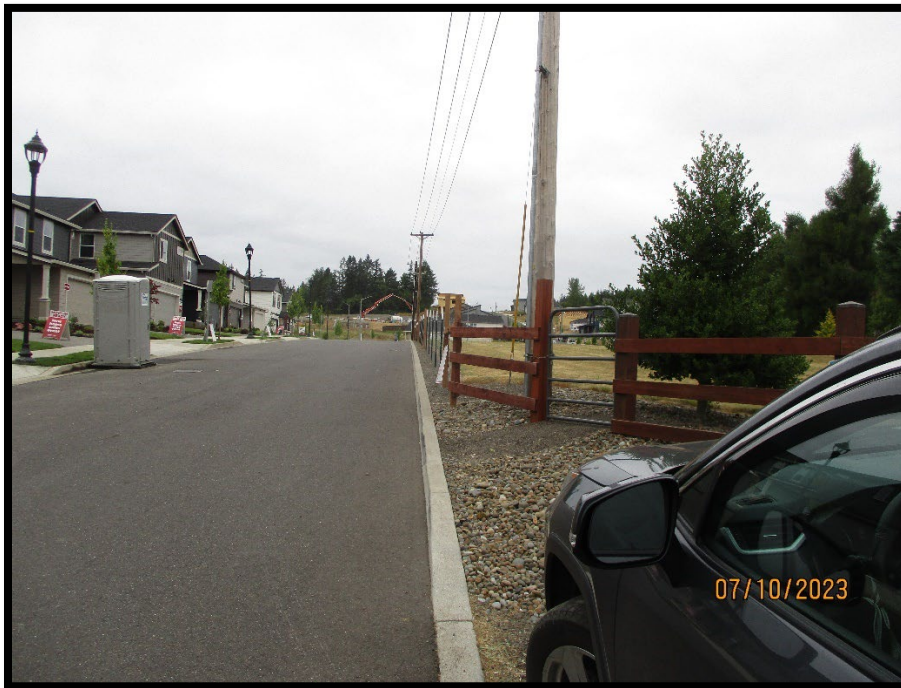
Photograph 3: Looking north along Larsen Drive from near the northwest corner of the Subject Site. Subject Site behind, and to the right, of the photographer.

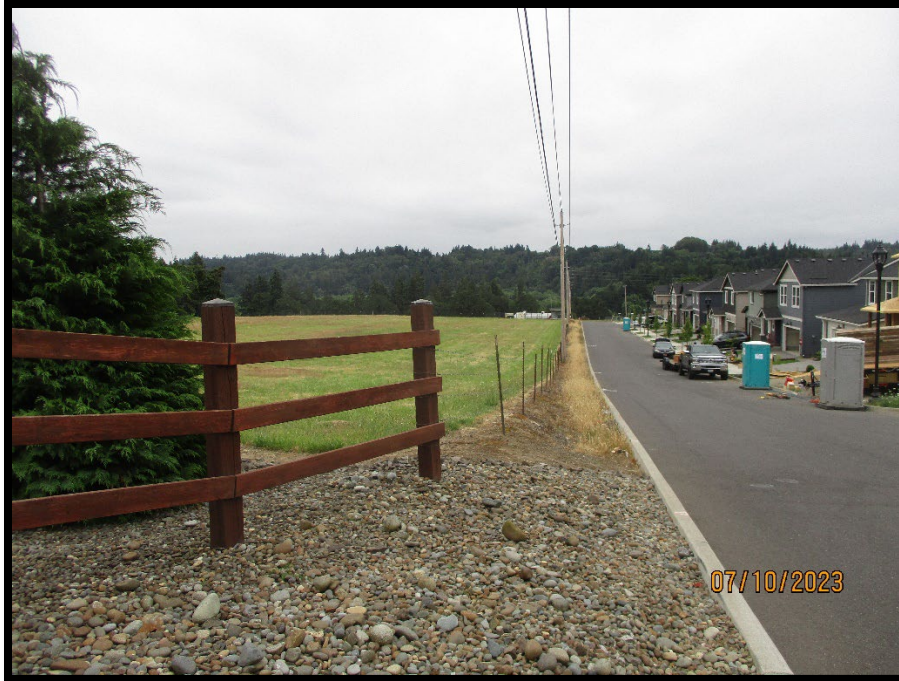
Photograph 4: Looking south along Larsen Drive from near the northwest corner of the Subject Site. Subject Site on the left. The roadside drainage ditch is trending away from the viewer in the middle of the photo (left of Larsen Drive), and the sewer pump station on the neighboring property to the south is visible in the distance (also to the left of Larsen Drive).

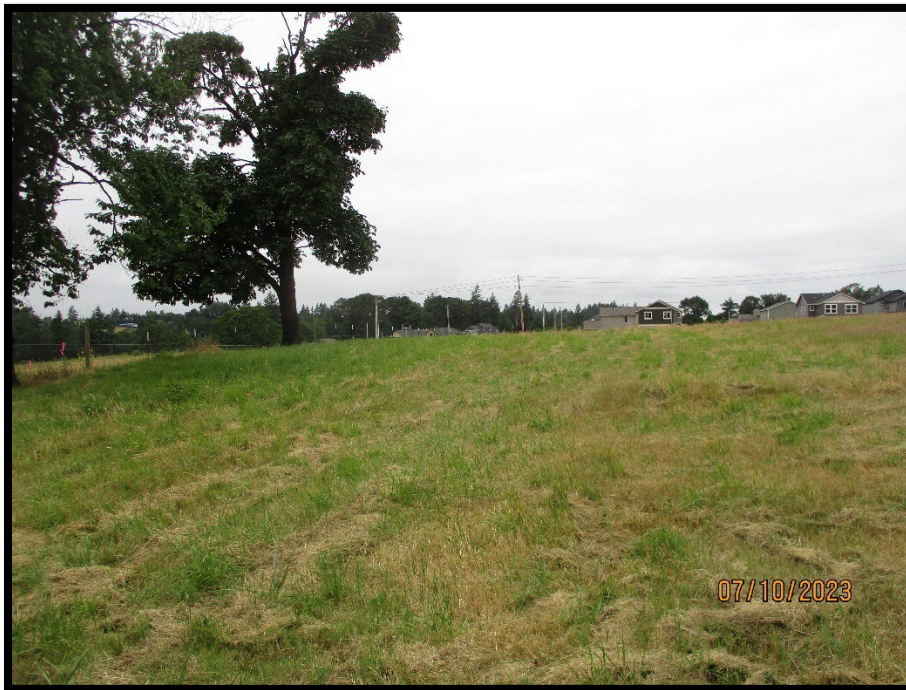
Photograph 5: Looking west along the southern boundary. Photo taken near the southeast corner of the Subject Site.

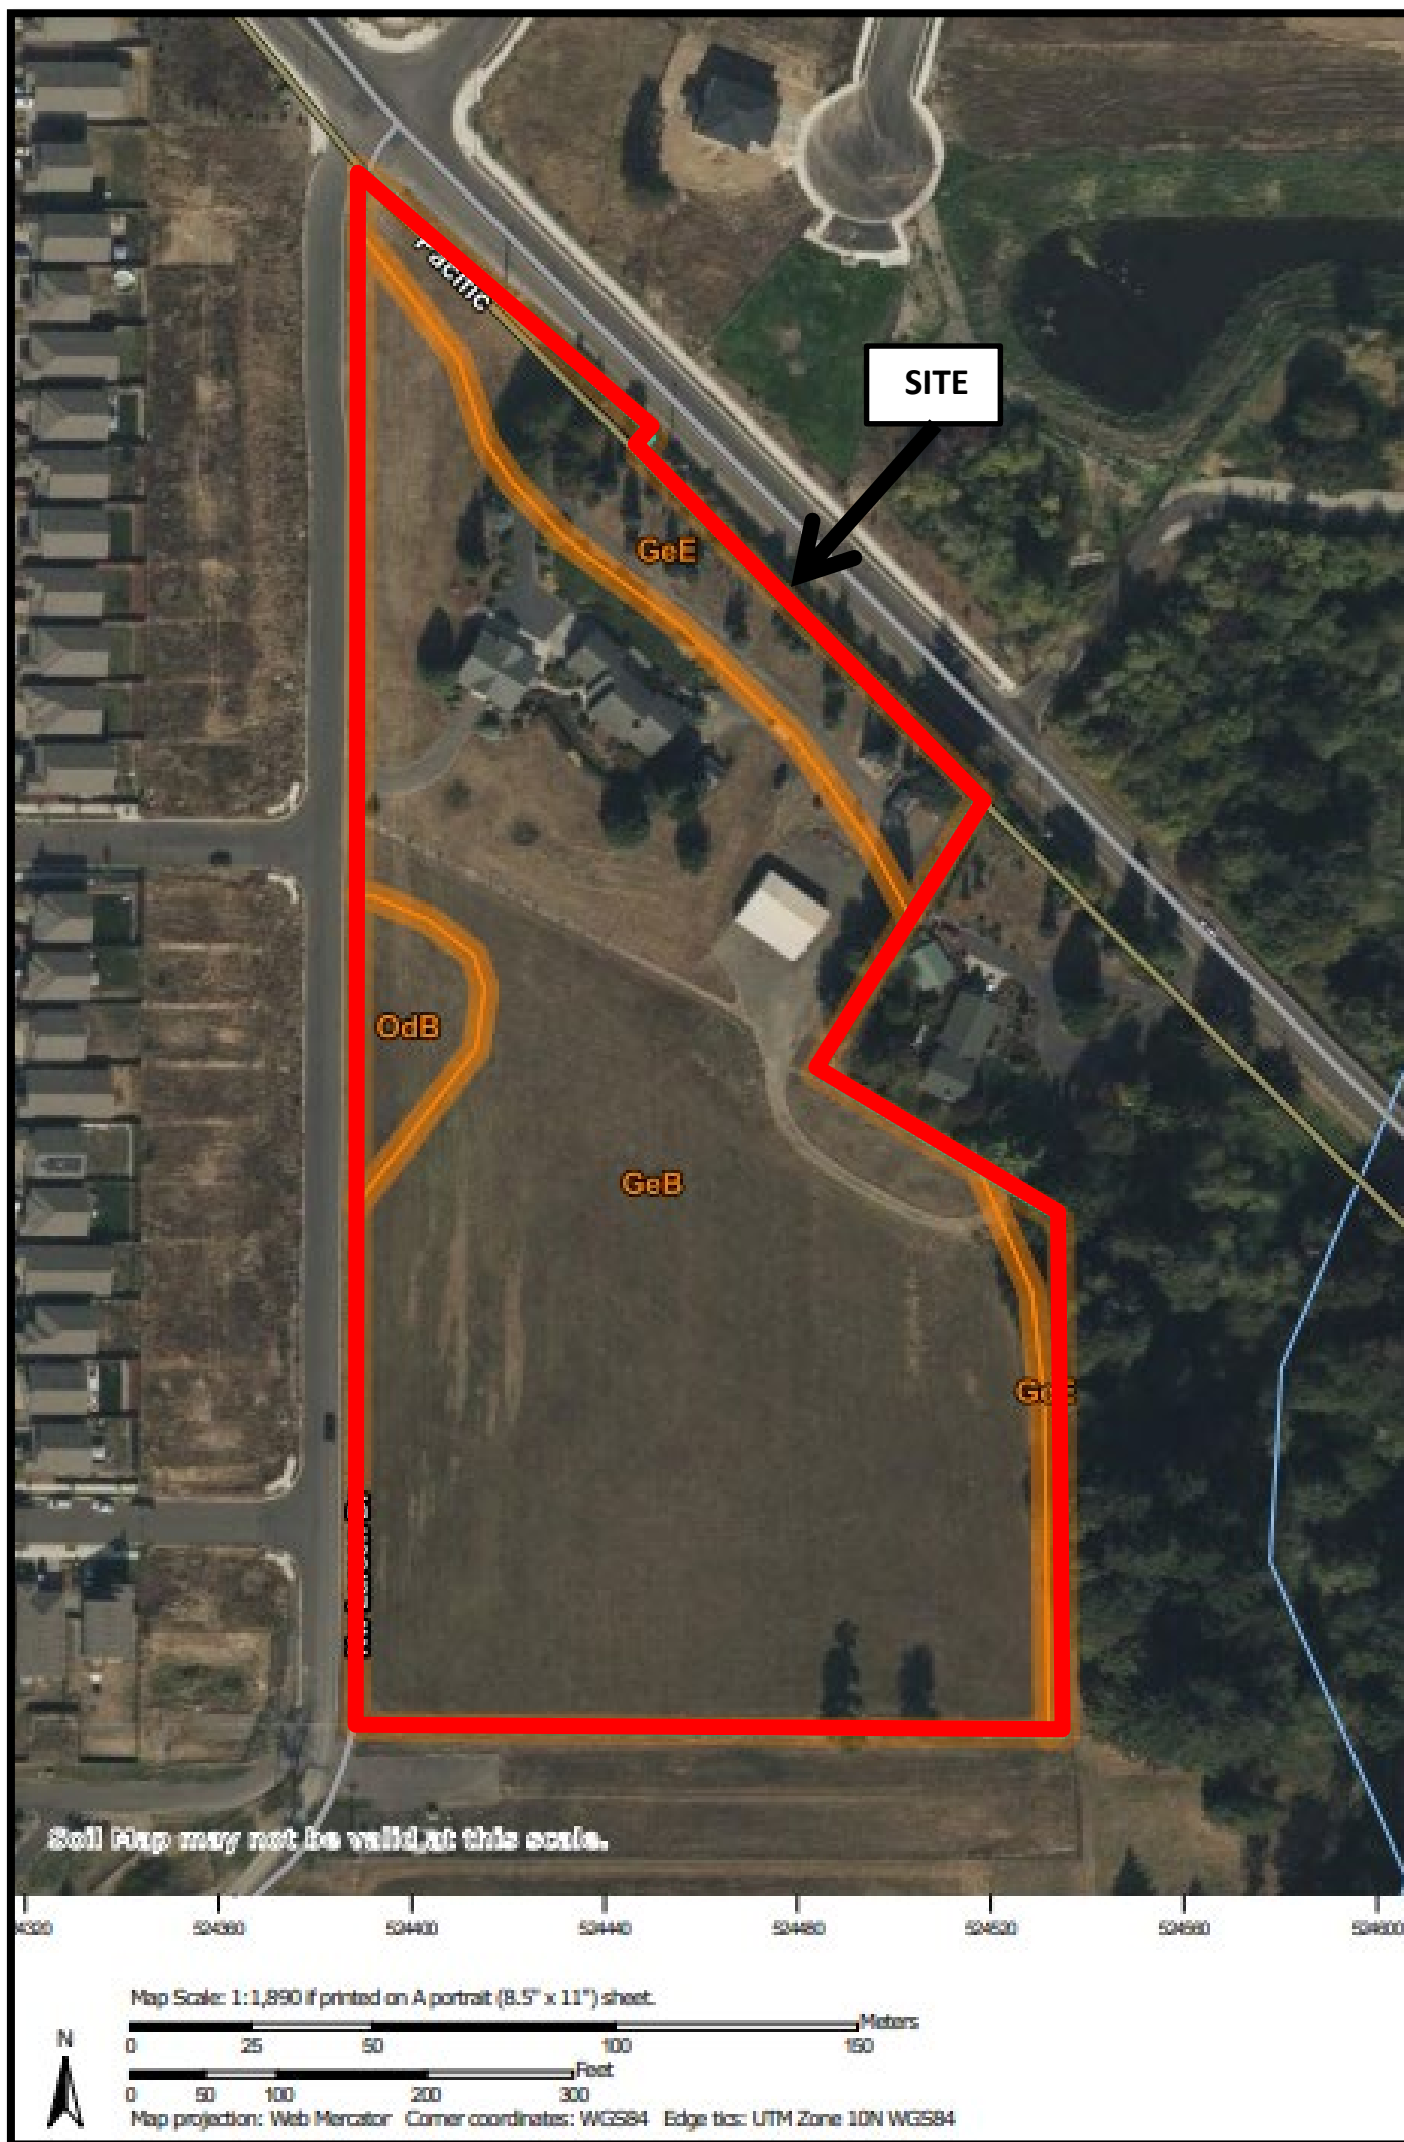
Figure 4
Soils Map
Larsen Drive Subdivision

Map Unit Symbol	Map Unit Name	Acres in AOI	Percent of AOI
GeB	Gee silt loam, 0 to 8 percent slopes	7.1	84.7%
GeE	Gee silt loam, 20 to 30 percent slopes	1.0	12.2%
OdB	Odne silt loam, 0 to 5 percent slopes	0.3	3.1%
Totals for Area of Interest		8.4	100.0%

According to the US Department of Agriculture Natural Resources Conservation Service (NRCS) Web Soil Survey for Clark County, there are three types of soil on the Subject Site and within the Subject Site: two Gee Series silt clay loams, and Odne silt loam. The majority of the Subject Site is overlain by the Gee silt loam series, the soils in this series are differentiated by the steepness of the slope they reside upon. They are all alluvial and are commonly found on ridges, slopes, and terraces in the local area. Gee silt loam (GeB) comprises the majority of the soils on the Subject Site, with the western edge of a larger deposit of Gee silt loam (GeE) along the eastern property boundary where the ground begins to drop off toward the creek. The only other soil in the Subject Site is a lobe of Odne silt loam that extends onto the northern portion of the Subject Site from the west. It is a hydric soil, alluvial derived, and commonly associated with drainageways and terraces in the local area. Table 4 summarizes the soils on Subject Site and Figure 4 represents the NRCS soil mapping on the site.
