CRITICAL AREAS REPORT

October 14, 2019

Faust Permitting *La Center, Washington*

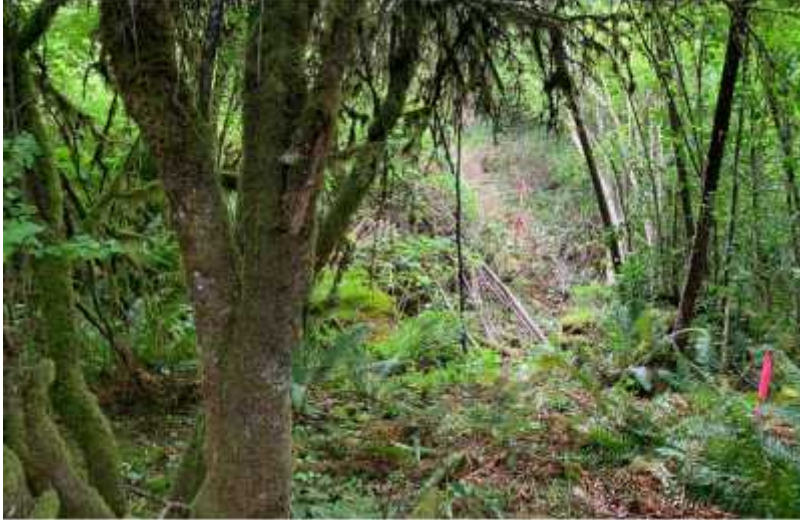
Photo 1 was taken along the eastern property boundary facing north. The property boundary is indicated by the pink flagging tape. This photo was taken to illustrate the prevalence of upland vegetation onsite, namely western swordfern (*Polystichum munitum*) and Douglas-fir (*Pseudotsuga menziesii*).

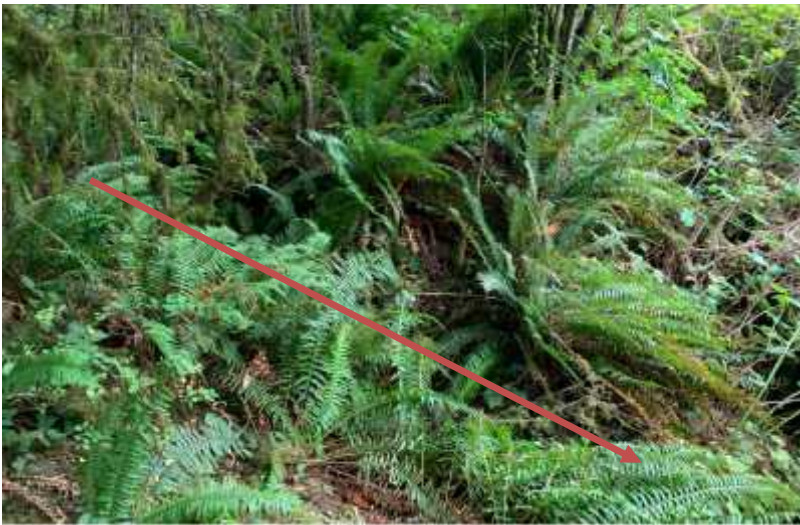
Photo 2 was taken in the central portion of the study area facing north and depicts the channel of Stream 1. The red arrow denotes the Stream 1 with flow direction.

Stream 1 does not meet either of the above criteria (A or B). The stream channel is approximately 6- to 12-inches wide with steep, sloped sides consisting of soil with leaf litter and vegetation consisting primarily of sword ferns and other upland shrubs (Photoplate 1). There was not suitable substrate for fish spawning or rearing within the stream channel. This stream channel does not serve as a migratory path as its headwater is a small depression wetland located just offsite to the west. Given Stream 1 does not meet either of the above criteria, it is ELS’ opinion that the stream is a seasonal, non-fish bearing stream (Type Ns). Chuck Stambaugh-Bowey from WDFW approved this stream type designation on September 5, 2019.

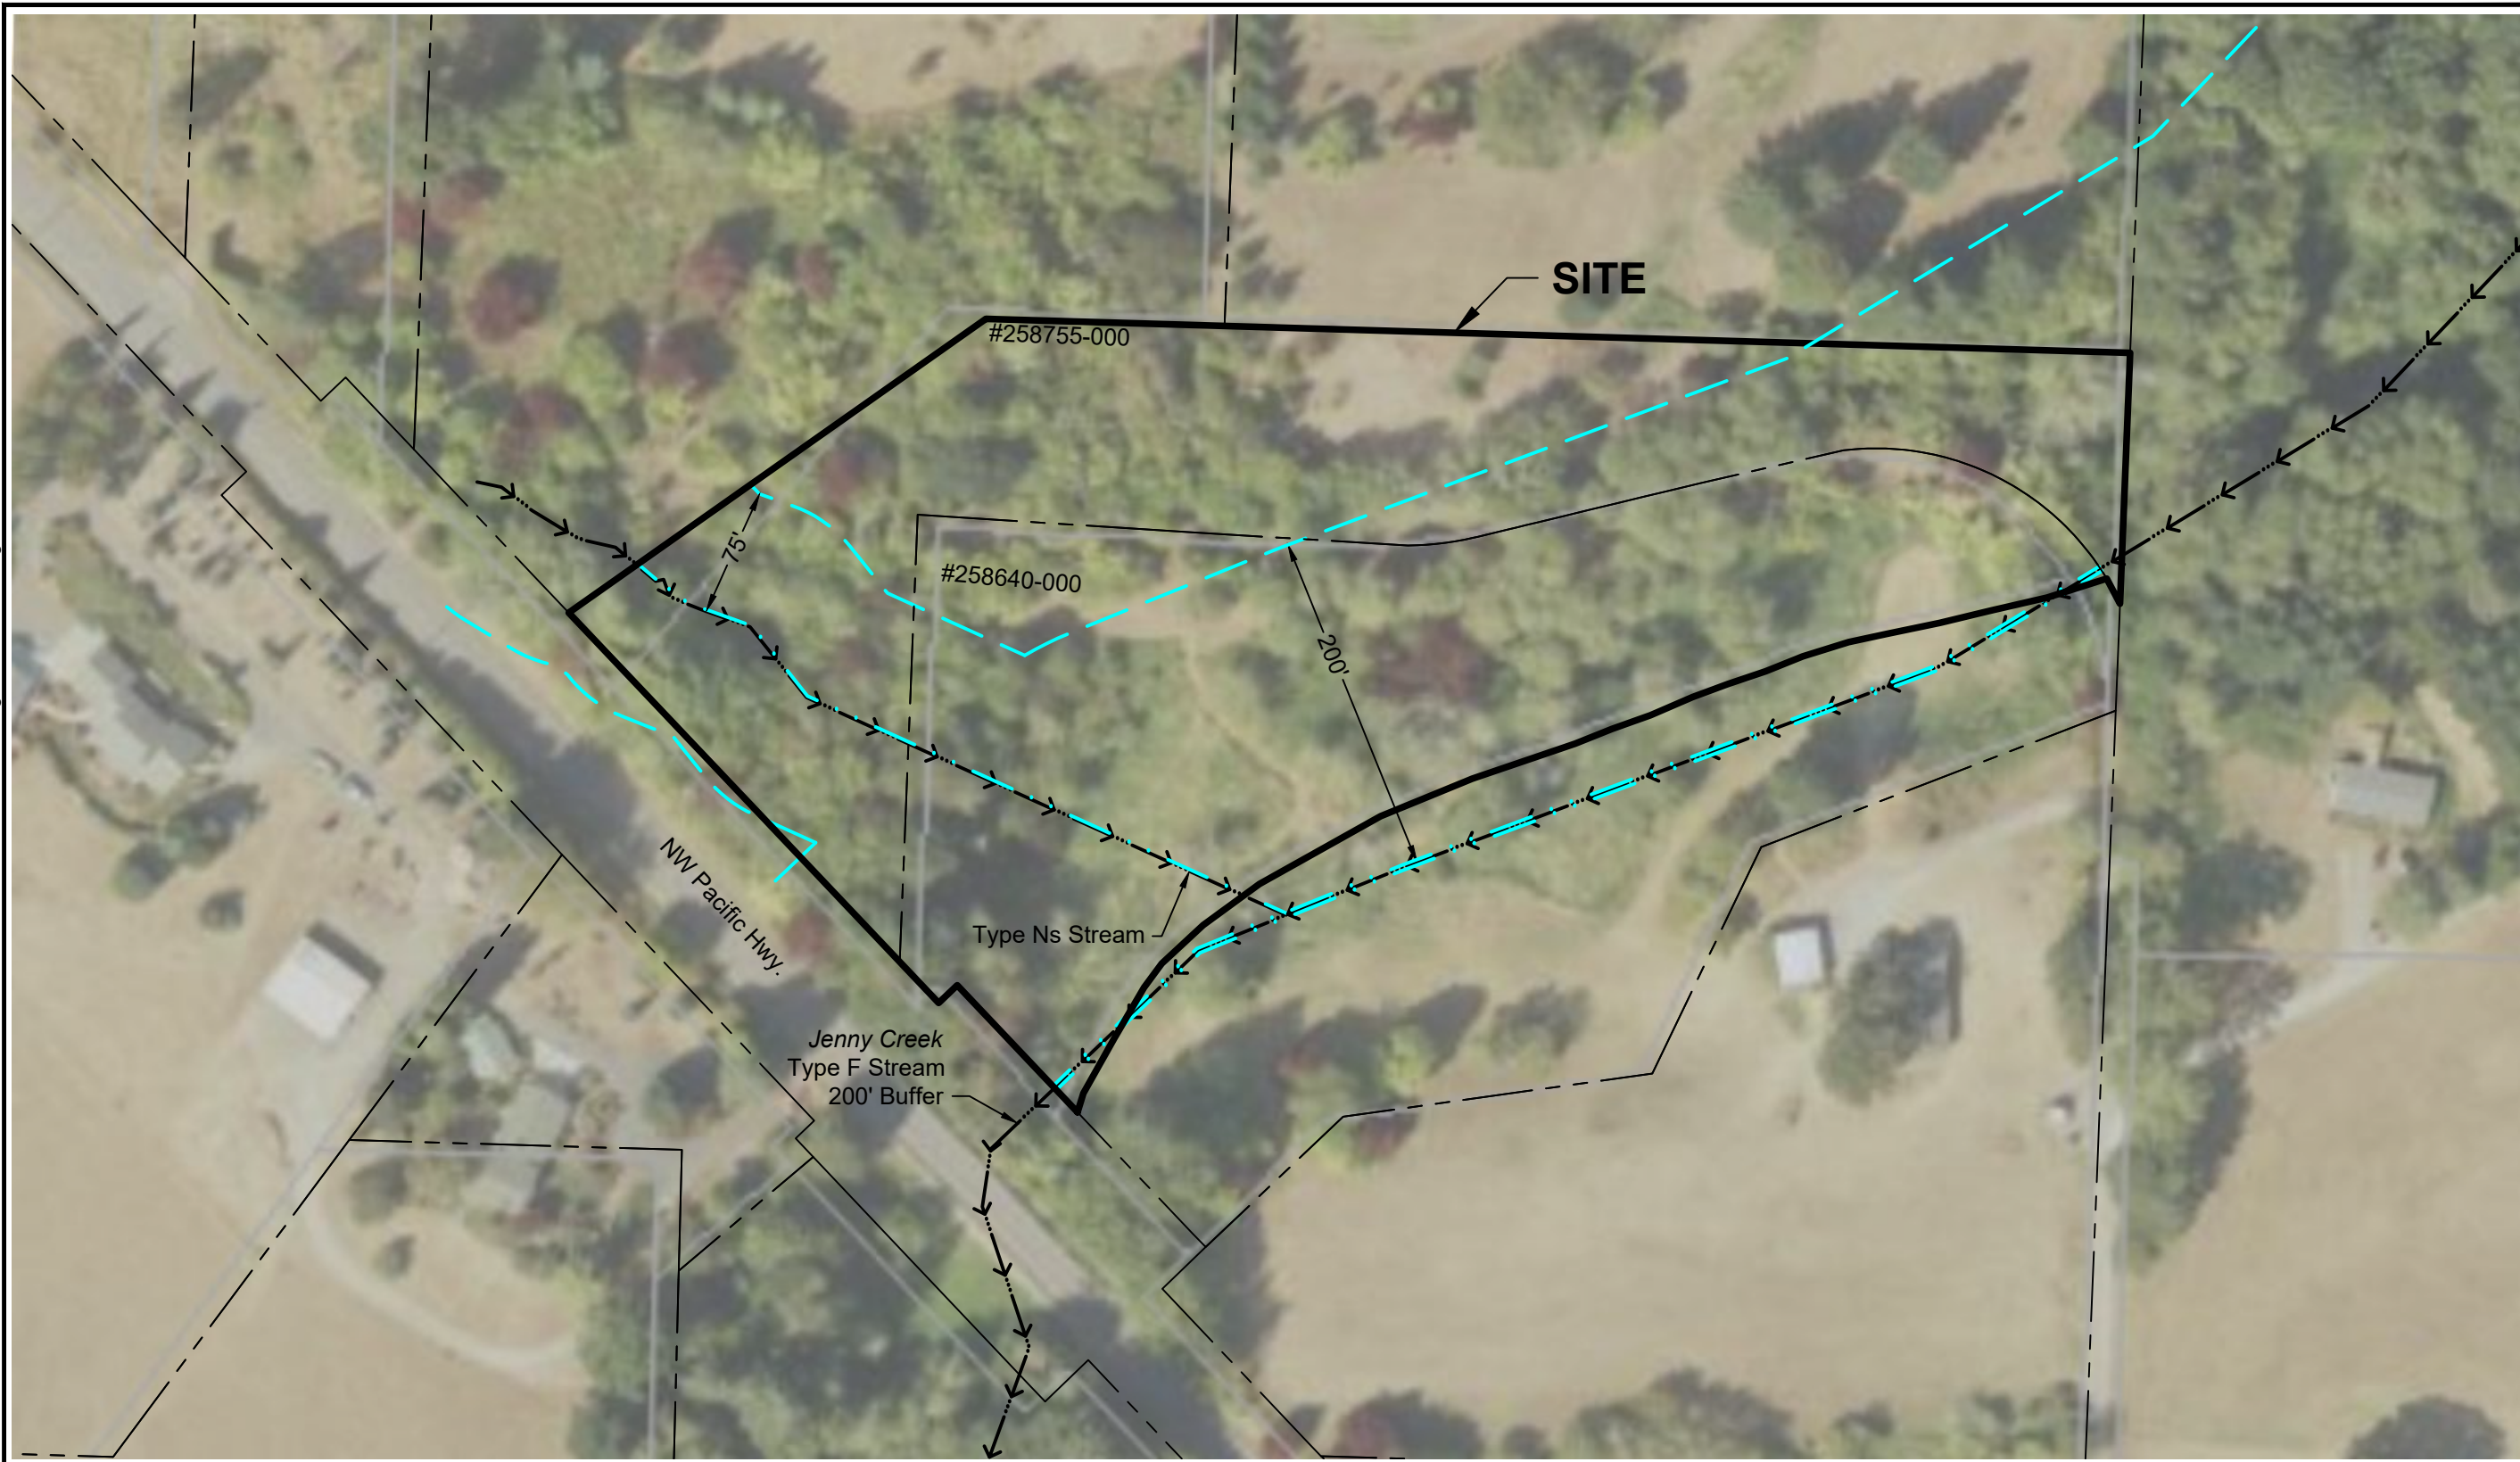
EXISTING CONDITIONS SITE MAP

1. Parcels from Clark County GIS Department (June 2018).
2. Streams were mapped by an ELS Biologist using a hand-held GPS unit with submeter accuracy and aerial imagery from DNR, Google™.

ELS conducted a site visit on July 16, 2019 to collect vegetation and hydrology data, and to make a determination about the presence or absence of critical areas on and offsite. Given the prevalence of upland vegetation and lack of hydrology onsite, ELS determined no test plots were necessary. The study area consisted primarily of Douglas-fir and western swordfern, both of which are indicative of upland environments (Photoplate 1). ELS identified two streams onsite, including an unnamed stream (Stream 1) and a portion of Jenny Creek (Sheet 2).

In addition to the wetland delineation, the OHWM of Jenny Creek and the unnamed stream were determined using standard methodology as described in the Washington State Department of Ecology (Ecology) manual: Determining the Ordinary High Water Mark on Streams in Washington State (Olson and Stockdale 2010). The main indicators used to determine the OHWMs were scour along the stream edges and exposed roots, as well as changes in topography. In this case, the OHWM of Jenny Creek and Stream 1 were determined to be synonymous with their top of banks. The channel of Stream 1 is only 6- to 12-inches wide, therefore a single OHWM line was used to depict the OHWM of the stream, given the stream channel is narrower than the line depicted in Figures 2 and 3. Stream centerline locations and OHWMs were mapped using a handheld GPS unit with sub-meter accuracy (Sheets 2 and 3).

Jenny Creek is a fish-bearing (Type F) stream located primarily offsite to the south, with portions intersecting the southeast and southwest corners of the study area. During the site visit, the stream channel was approximately 1 to 2 feet wide with minimal flow. In this case, the channel width was synonymous with the OHWM. Jenny Creek flows southwest along the southern study area boundary before intersecting a culvert on Northwest Pacific Highway. After intersecting the culvert, the stream flows south for approximately 2,000 feet before connecting with the East Fork Lewis River. According to *LCMC Table 18.300.090(2)(f)*, a Type F stream has a designated buffer width of 200 feet (LCMC 2019) (Sheet 2).

synonymous with the OHWM. Stream 1 flows east through the central portion of the study area before draining into Jenny Creek. According to *LCMC Table 18.300.090(2)(f)*, a Type Ns stream has a designated buffer width of 75 feet (LCMC, 2019) (Sheet 2). Table 1 summarizes the critical areas onsite.
