# PRELIMINARY TECHNICAL INFORMATION REPORT

### Larsen Drive Subdivision

La Center, Washington

### Larsen Drive Subdivision Preliminary Drainage Report

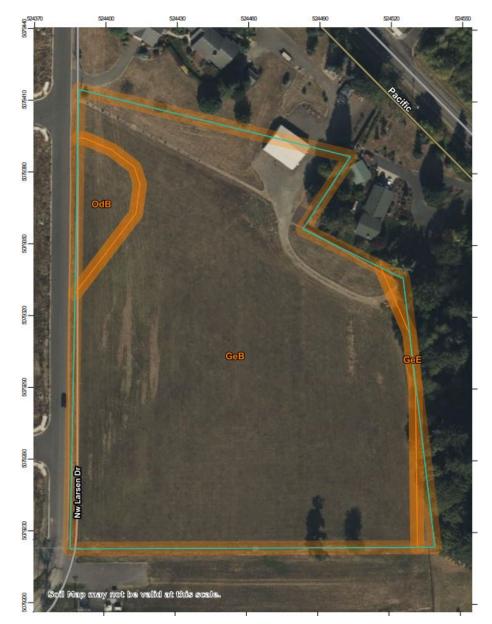
### (b). Soils Map

GeB (Gee silt loam, 0-8% slopes):	93.8% of site
GeE (Gee silt loam, 20-30% slopes):	1.5% of site
OdB (Odne silt loam, 0-5%% slopes):	4.6% of site

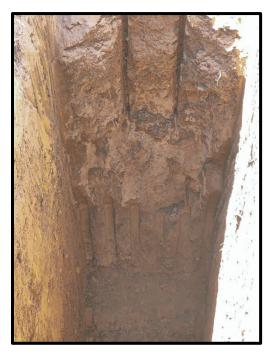
Typical Soil Mottling, Test Pit, TP-1

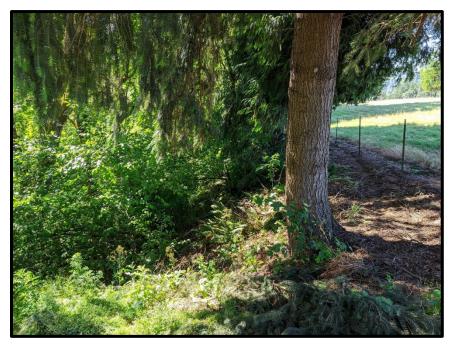
East Slope, Facing South

To observe geomorphic conditions, Columbia West conducted visual and physical reconnaissance of the drainage ravine slopes located along the eastern property boundary. As previously described, test pit explorations conducted near the slopes indicated the presence of stiff to very stiff clay underlain by dense sedimentary conglomerate. No landslide debris was observed within subsurface soils explored near the slopes.

Review of topographic mapping indicates that vertical slope heights for the eastern drainage ravine slopes (east facing), as measured from toe to top-of-slope break, vary from approximately 40 to 50 feet. Slope grades generally range from 25 to 65 percent with localized steeper areas. Slopes currently support dense vegetation consisting of deciduous and conifer trees, blackberry vines, grasses, and shrubs. Slopes are generally planar with no observed evidence of instability. There was no observed direct evidence of large-scale, mass slope movements or historic landslides.

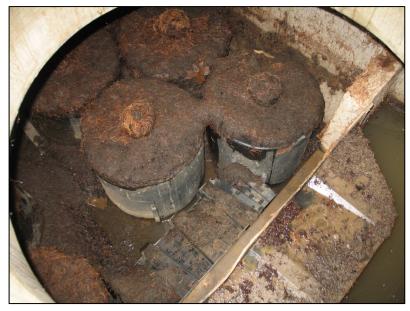
Media Cartridge Filter Vault with Accumulated Sediment

- The most common tool for cleaning media cartridge filters is a truck with a tank and vacuum hose (e.g.Vactor® truck) to remove sediment and debris from the vault.
- Media cartridge filters are enclosed spaces where harmful chemicals and vapors can accumulate. Therefore, the inspection and maintenance of these facilities should be conducted by an individual trained and certified to work in hazardous confined spaces.
- Cartridges require replacement when the individual cartridges no longer meet the specifications for pollutant removal.
