# PRELIMINARY TECHNICAL INFORMATION REPORT

## Lockwood Meadows Subdivision

La Center, Washington

**GEOTECHNICAL SITE INVESTIGATION  
LOCKWOOD MEADOWS SUBDIVISION  
LA CENTER, WASHINGTON**

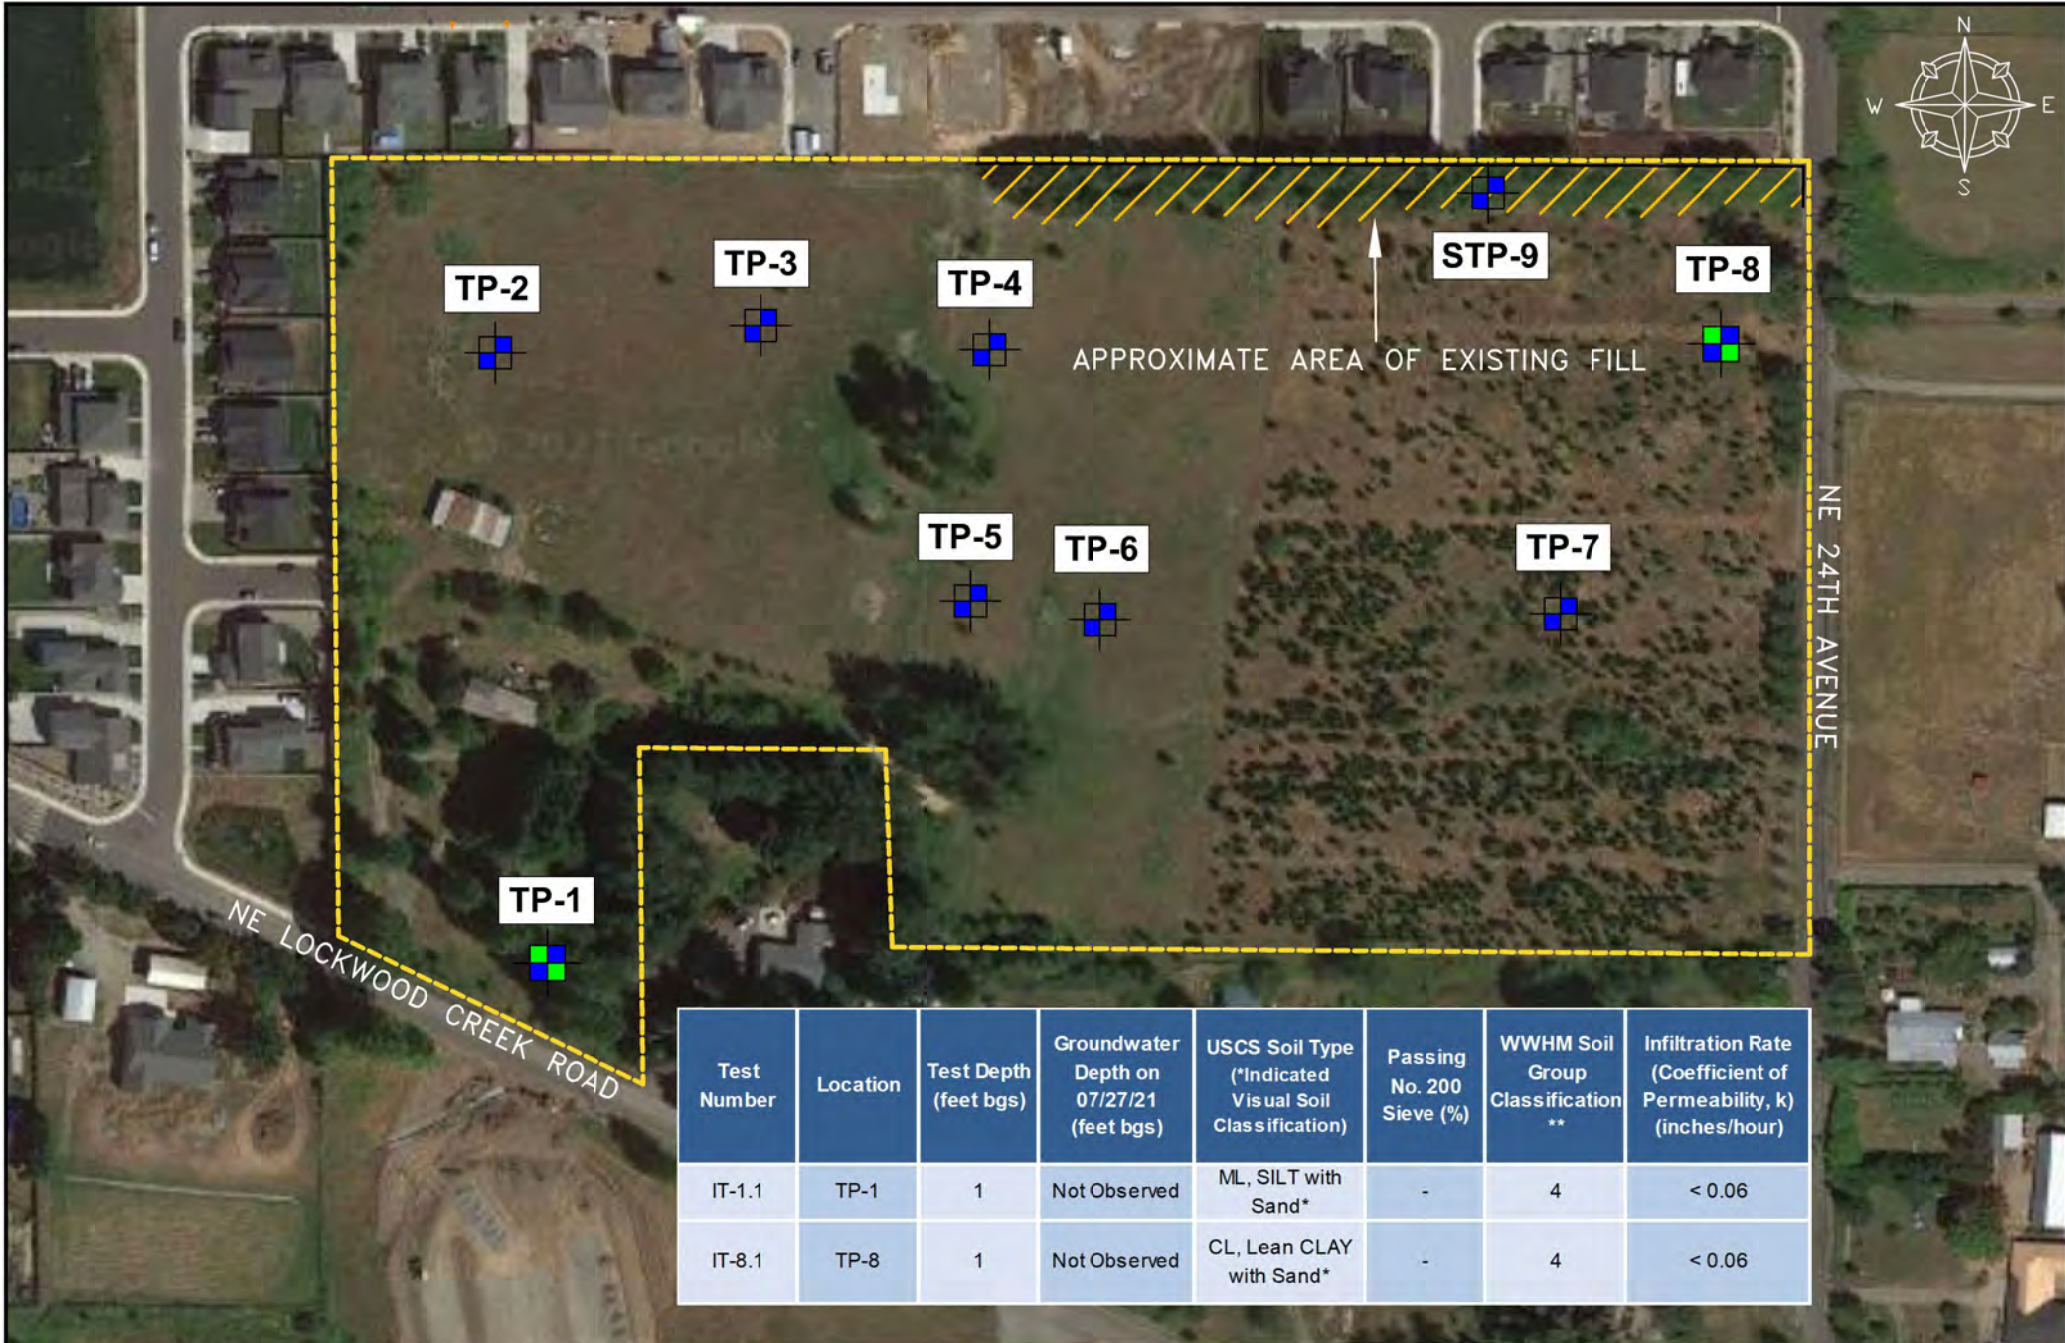
Test Number	Location	Test Depth (feet bgs)	Groundwater Depth on 07/27/21 (feet bgs)	USCS Soil Type (*Indicated Visual Soil Classification)	Passing No. 200 Sieve (%)	WWHM Soil Group Classification **	Infiltration Rate (Coefficient of Permeability, k) (inches/hour)
IT-1.1	TP-1	1	Not Observed	ML, SILT with Sand*	-	4	< 0.06
IT-8.1	TP-8	1	Not Observed	CL, Lean CLAY with Sand*	-	4	< 0.06

--- SITE BOUNDARY   
 LOCATION OF TEST PIT   
 LOCATION OF INFILTRATION TEST

A geotechnical field investigation consisting of visual reconnaissance, nine test pits (TP-1 through TP-8 and STP-1) and two infiltration tests (IT-1 and IT-2) was conducted at the site on July 27, 2021. The test pits were explored with a track-mounted excavator. Subsurface soil profiles were logged in accordance with Unified Soil Classification System (USCS) specifications. Disturbed soil samples were collected from relevant soil horizons and submitted for laboratory analysis. Analytical laboratory test results are presented in Appendix A. Exploration locations are indicated on Figure 2. Subsurface exploration logs are presented in Appendix B. Soil descriptions and classification information are provided in Appendix C. A photo log is presented in Appendix D.

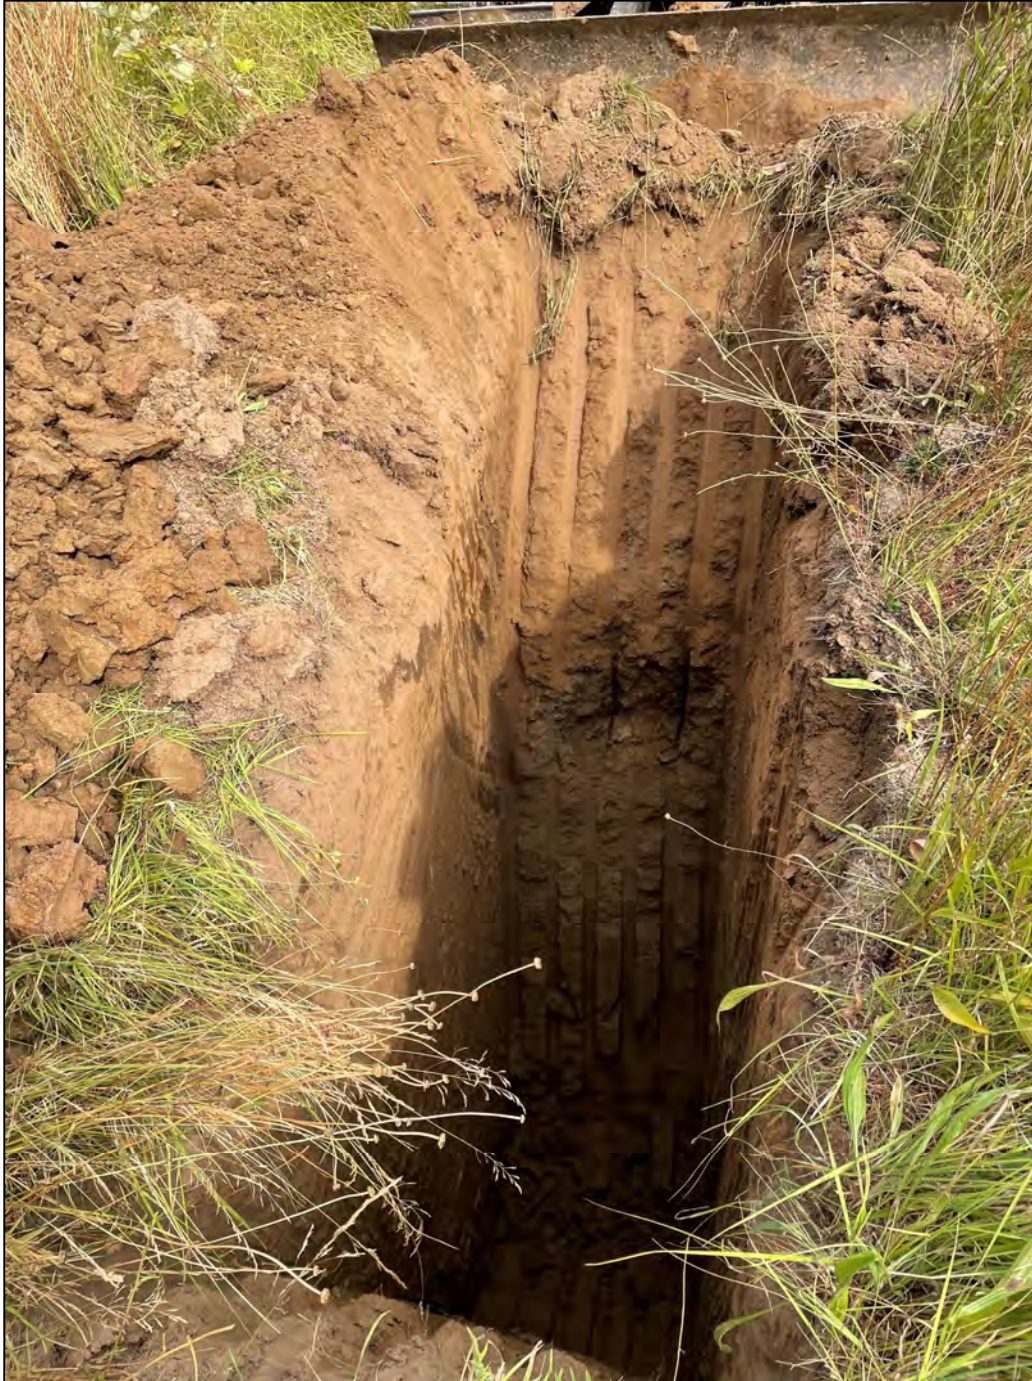
Typical Soil Profile, TP-5

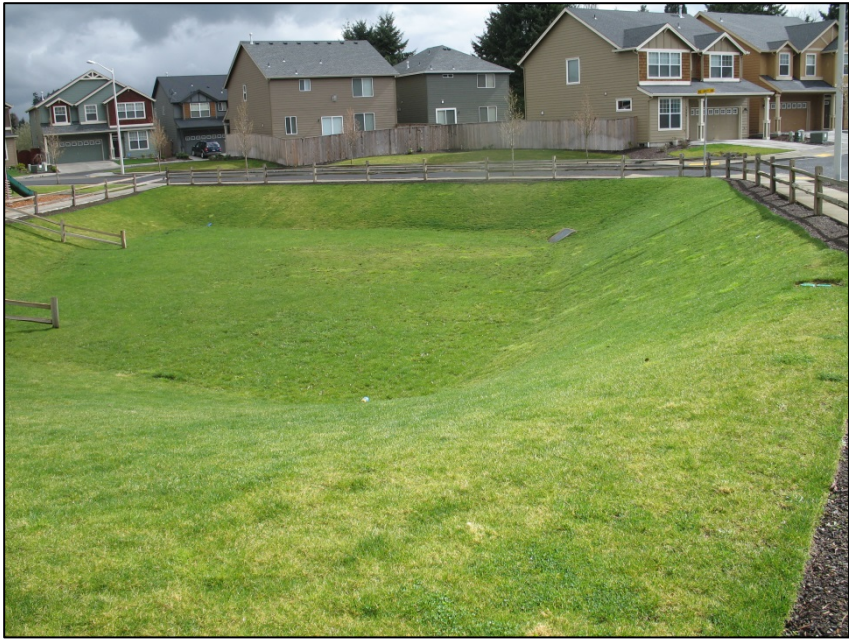
**Example of a Manicured Detention Pond**

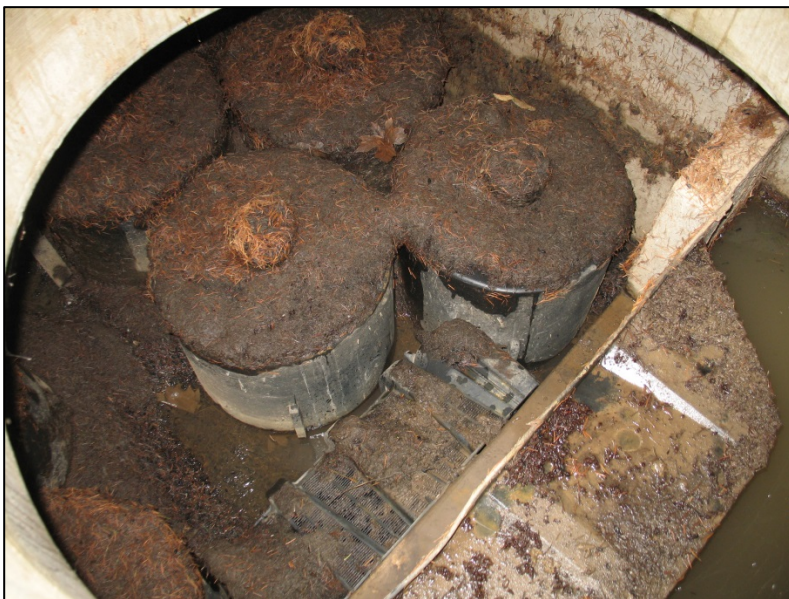
**Media Cartridge Filter Vault with Accumulated Sediment**
