BANK USE PLAN

July 23, 2020

*Neighborhood Park Project
La Center, Washington*

CRITICAL AREAS REPORT

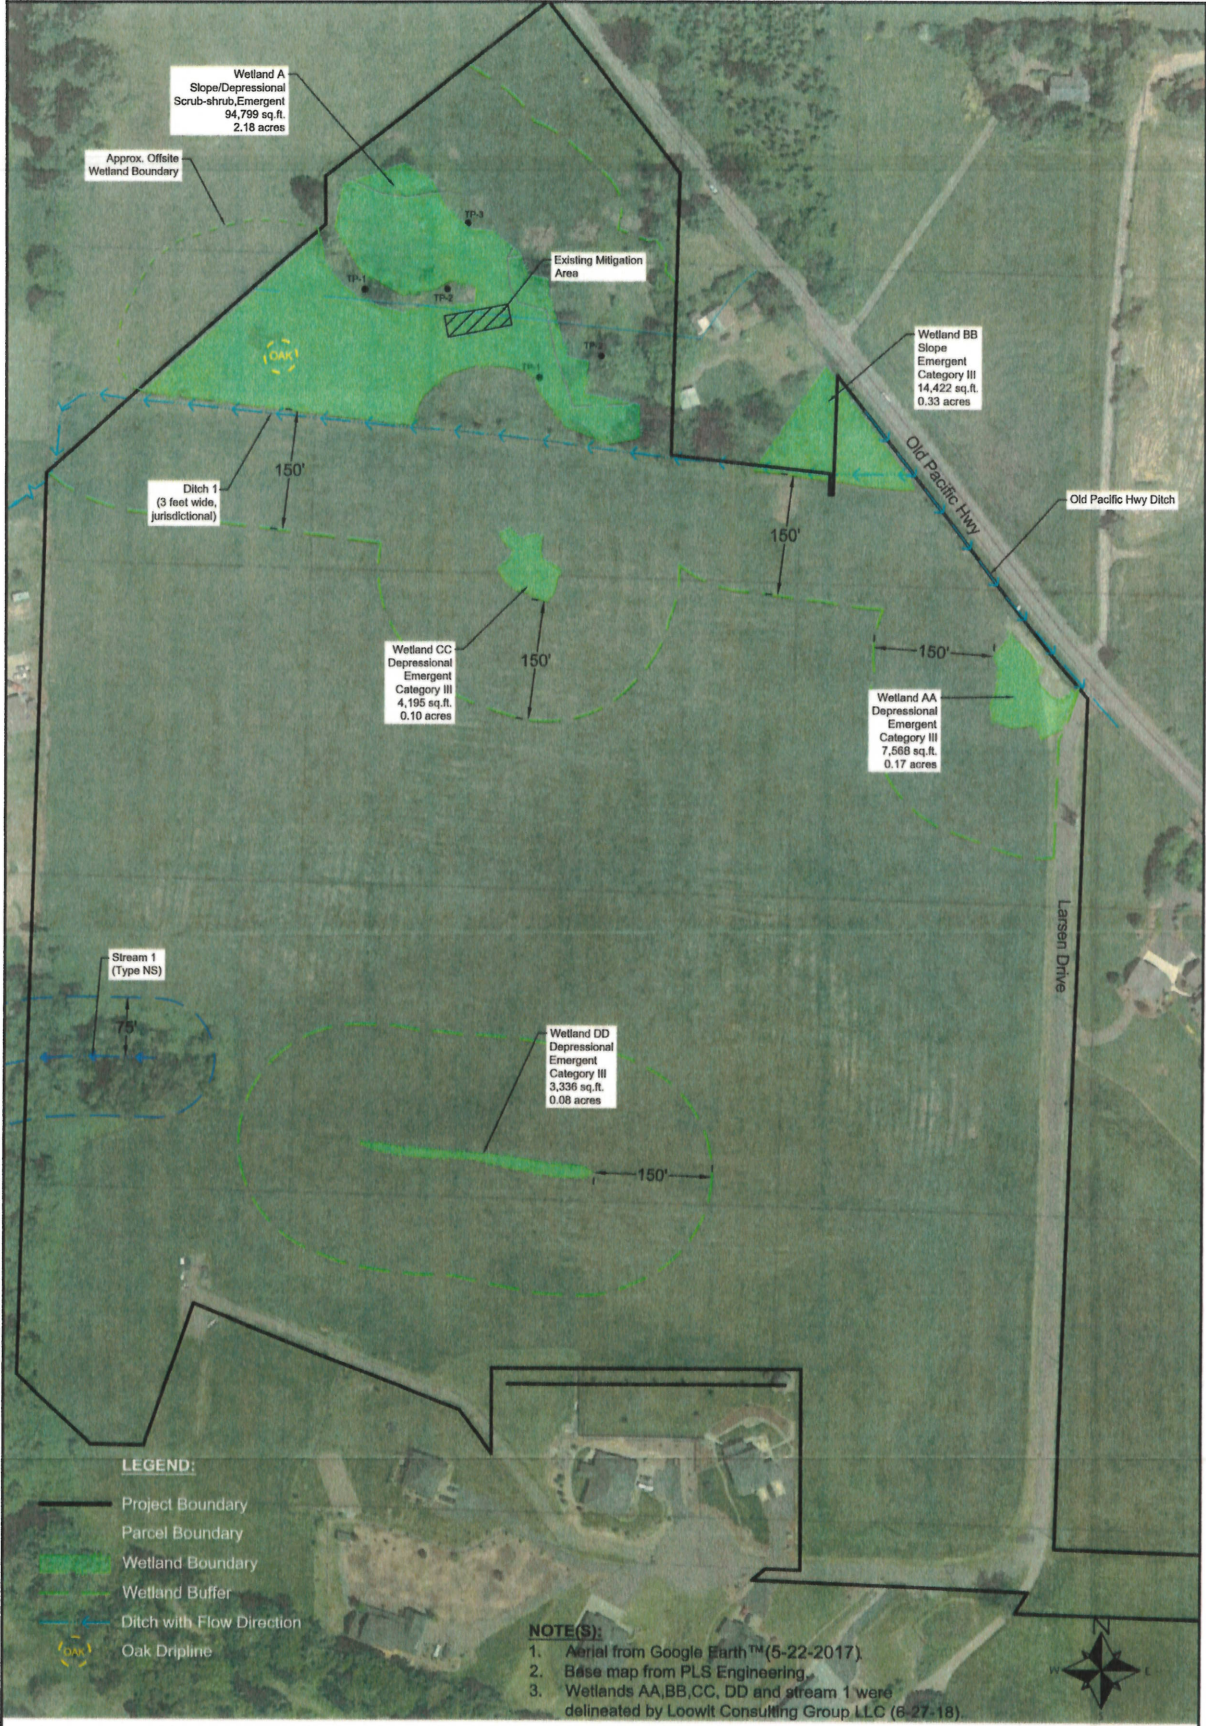
<p>1157 3rd Ave., Suite 220A Longview, WA 98632 Phone: (360) 578-1371</p>	<p>PURPOSE: Development of Subdivision</p> <p>DATUM: NAD83</p> <p>ADJACENT PROPERTY OWNERS: SEE JARPA</p>	<p>EXISTING CONDITIONS SITE MAP</p> <p>APPLICANT: ECM Riverside LLC</p> <p>PROJECT NAME: Riverside Estates</p> <p>REFERENCE #: Not yet assigned</p> <p>SITE LOCATION ADDRESS: 34506 Old Pacific HWY La Center, WA NWS-2018-1167</p>	<p>PROPOSED:Wetland fill</p> <p>IN Onsite Wetlands</p> <p>NEAR: La Center</p> <p>COUNTY: Clark STATE: WA</p> <p>SHEET 2 OF 4</p> <p>DATE: 11/6/18</p>
--	--	---	--

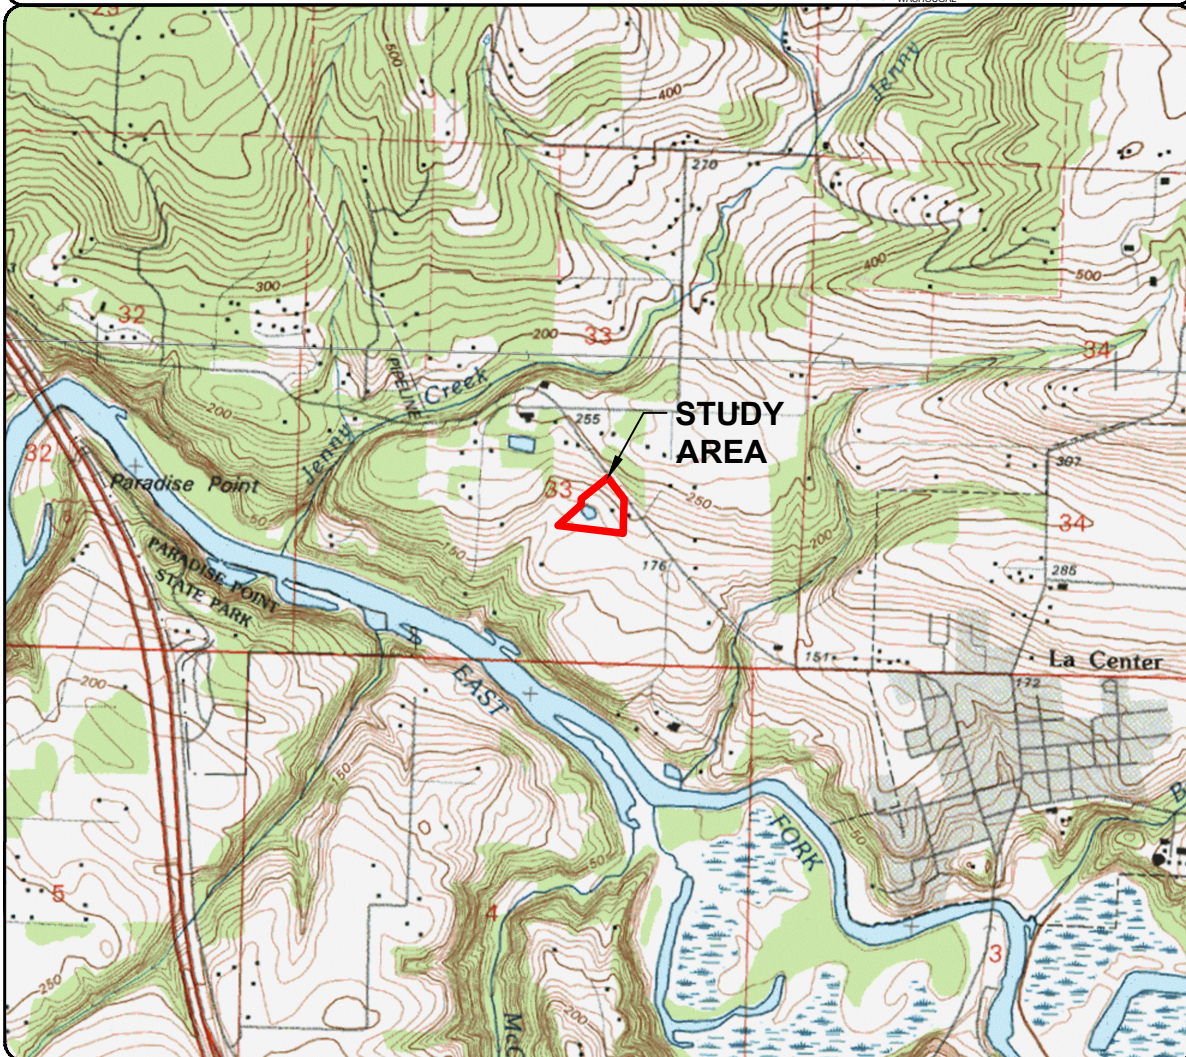
Wetland A
Category III
Depressional,
Slope, Emergent, Scrub/Shrub
(2.18 acres onsite)

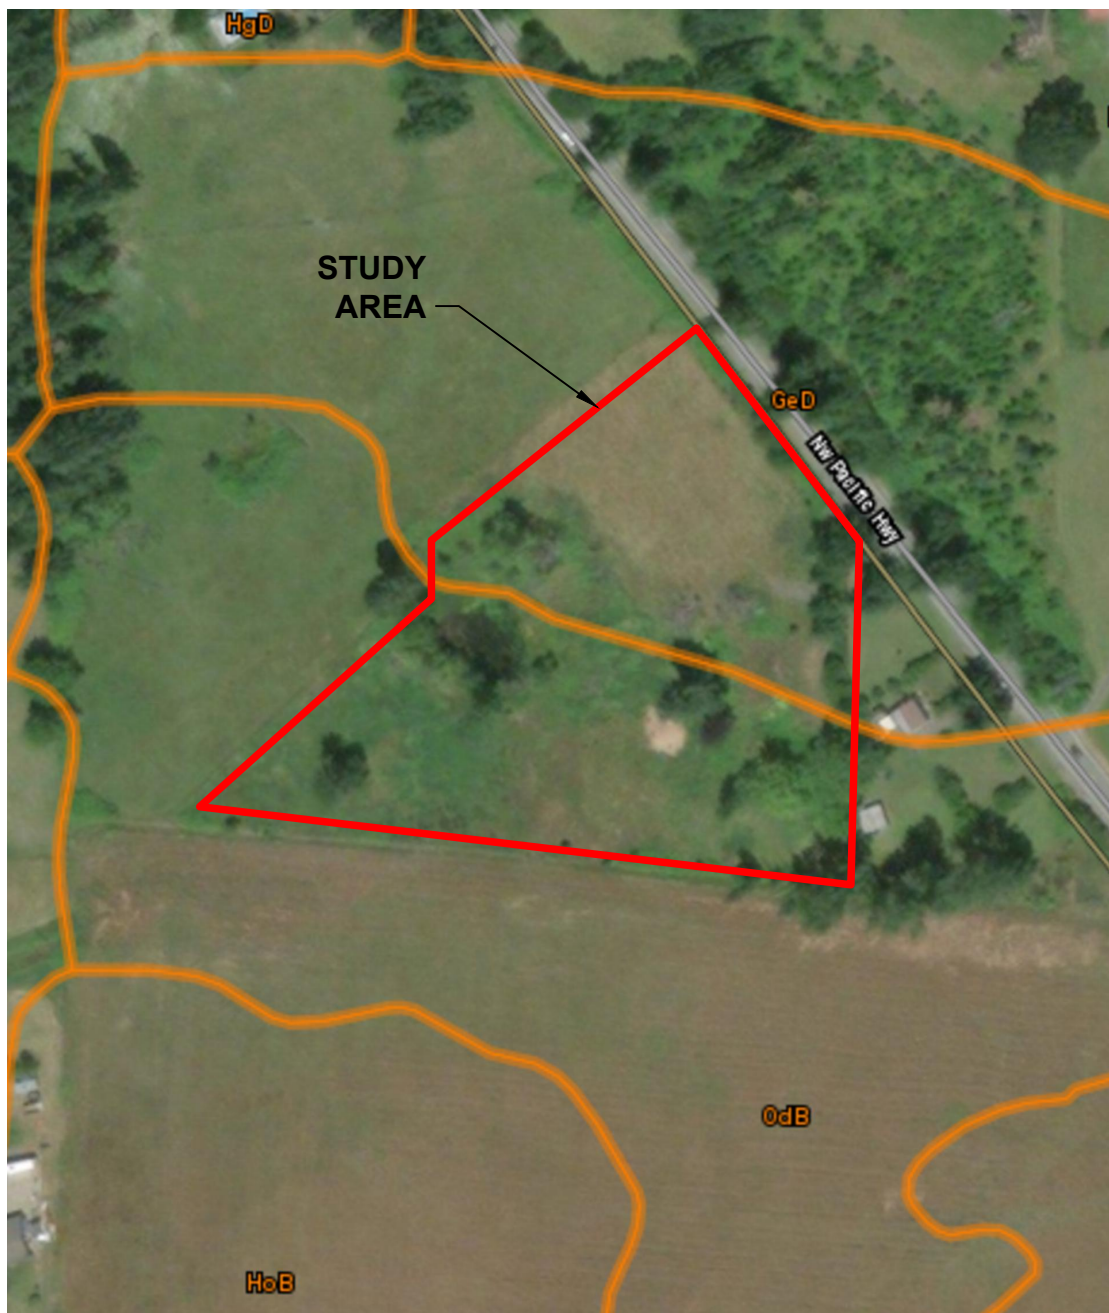
Figure 3
NRCS SOIL SURVEY MAP

- OdB** Odne silt loam, 0 to 5 percent slopes. **Hydric.**
GeD Gee silt loam, 8 to 20 percent slopes. Not hydric.

The Natural Resources Conservation Service (NRCS) designates soils within the study area as Gee silt loam, 8 to 20 percent slopes (GeD) and Odne silt loam, 0 to 5 percent slopes (OdB) (Figure 3). Gee silt loam is characterized as moderately well drained while Odne silt loam is characterized as poorly drained; both soils are found on terraces. Odne silt loam, 0 to 5 percent slopes is considered hydric (NRCS 2017).

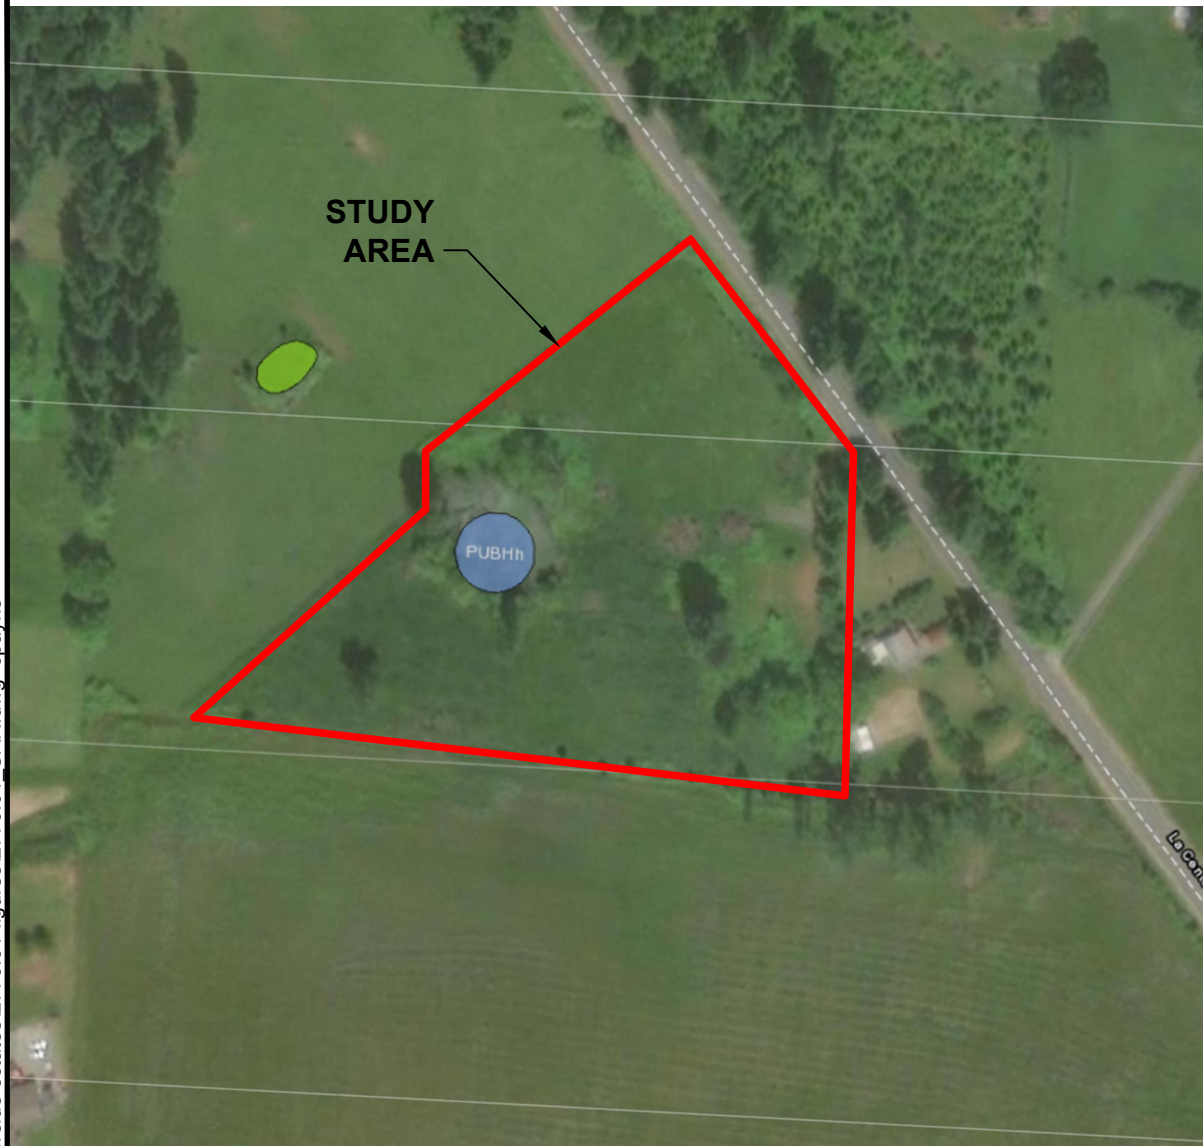
Mapped wetlands indicated onsite by US Fish & Wildlife Service.

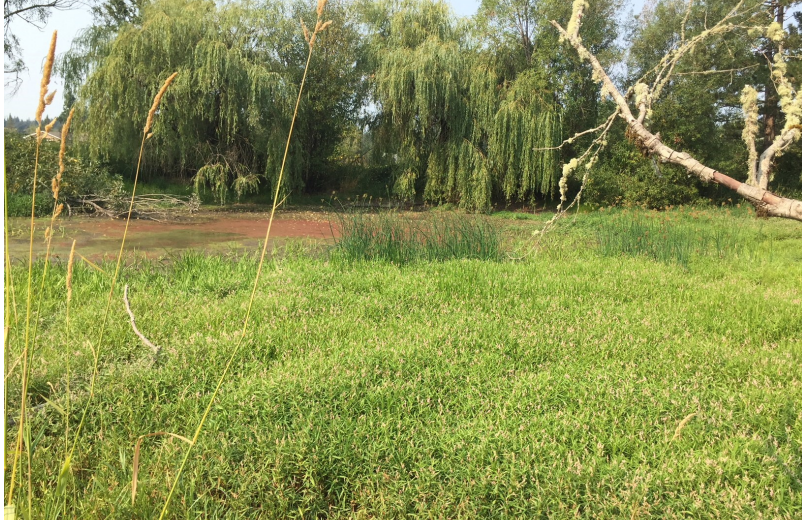
Photo 1: This photo was taken from the top of the berm on the southeastern corner facing northwest across the farm pond.

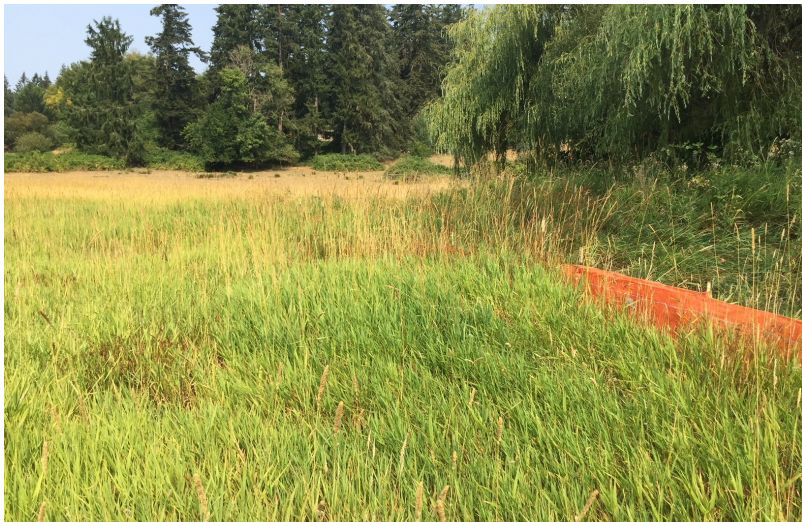
Photo 2: This photo was taken from south of the farm pond facing west. The orange construction fencing surrounds the farm pond.

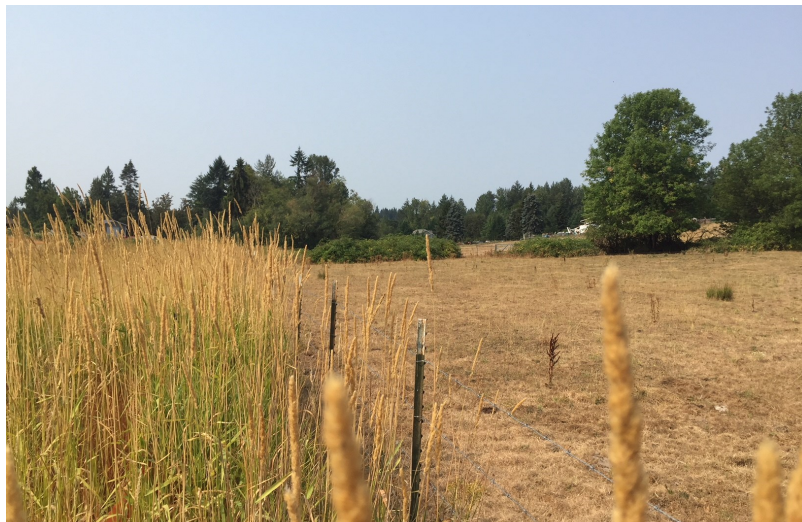
Photo 3: This photo was taken from the eastern site boundary facing southwest along the fence line.

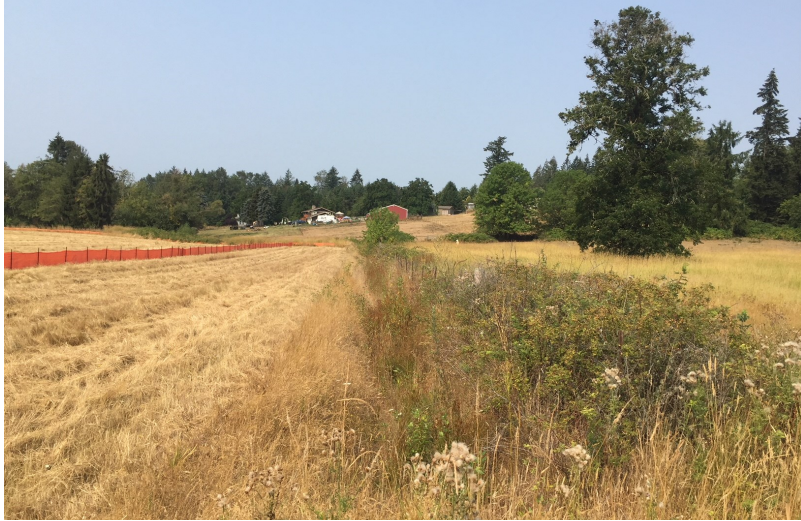
Photo 4: This photo was taken from the farm drive crossing facing east along the ditch. The oak tree can be seen in the background in the right of the frame.

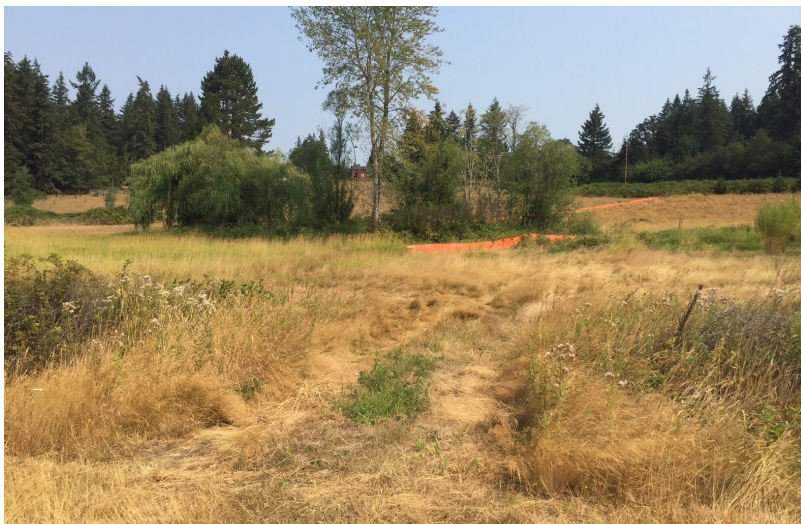
Photo 5: This photo was taken from just south of the farm drive crossing facing north. The orange construction fencing in the background surrounds the farm pond.

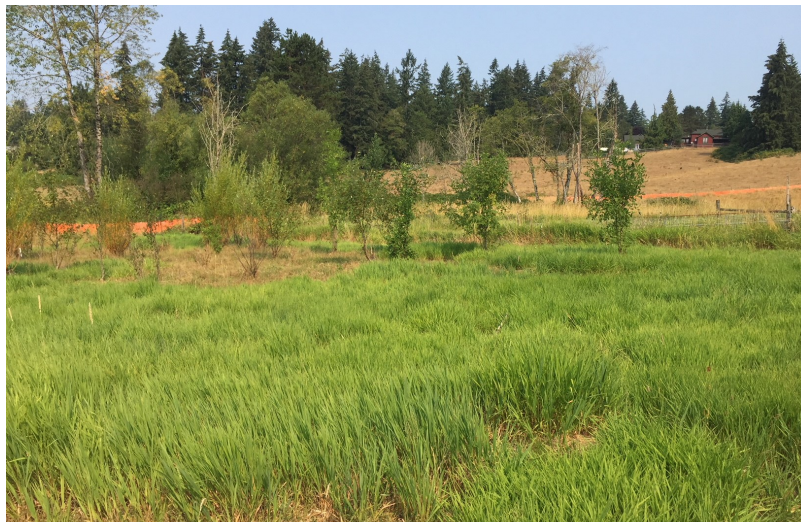
Photo 6: This photo was taken from east of the existing mitigation plantings facing northwest towards the farm pond.
