CRITICAL AREAS REPORT

Stephens Hillside Farm

Date: January 29, 2018

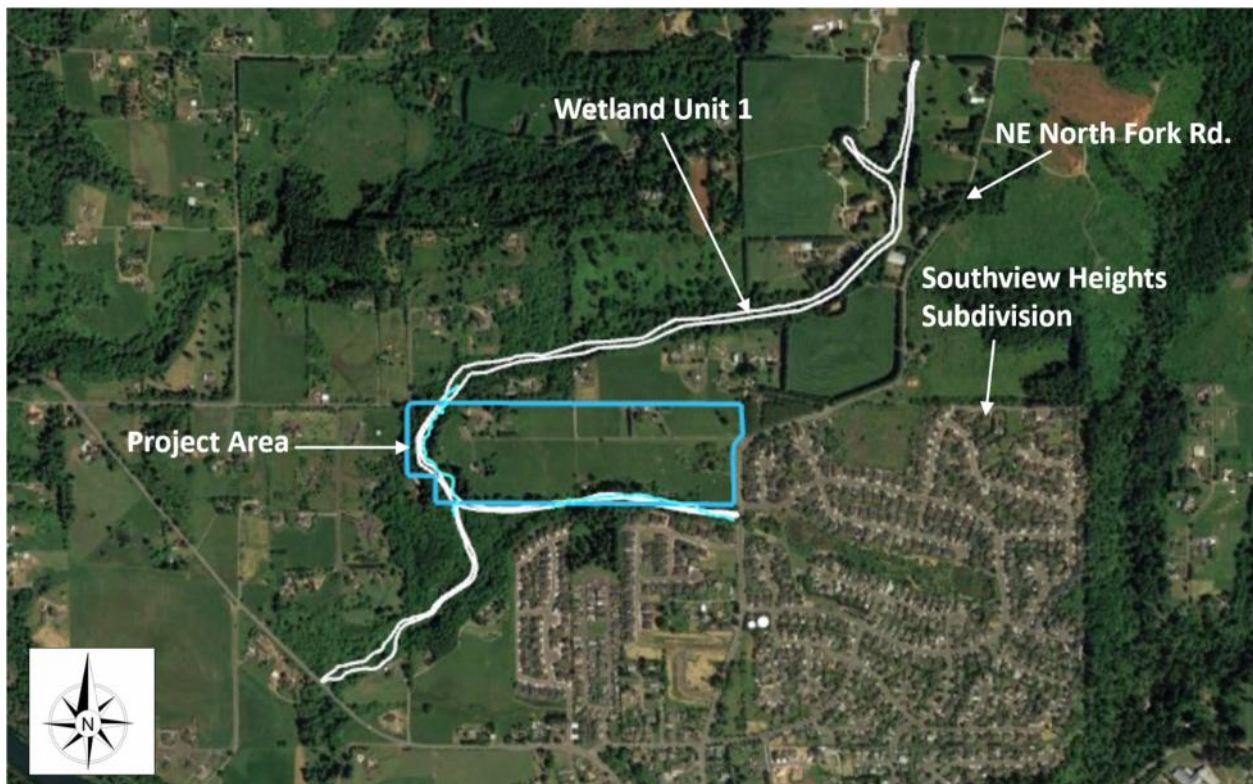
Figure 2. Aerial photo of the project area and surrounding land uses.

The project area is located along the northeast side of the City of La Center. Land uses to the east and south are in residential subdivisions. Open space, forestland, and farmland are the dominant land uses to the north and west. Interstate 5 is 2.7 miles to the southwest.

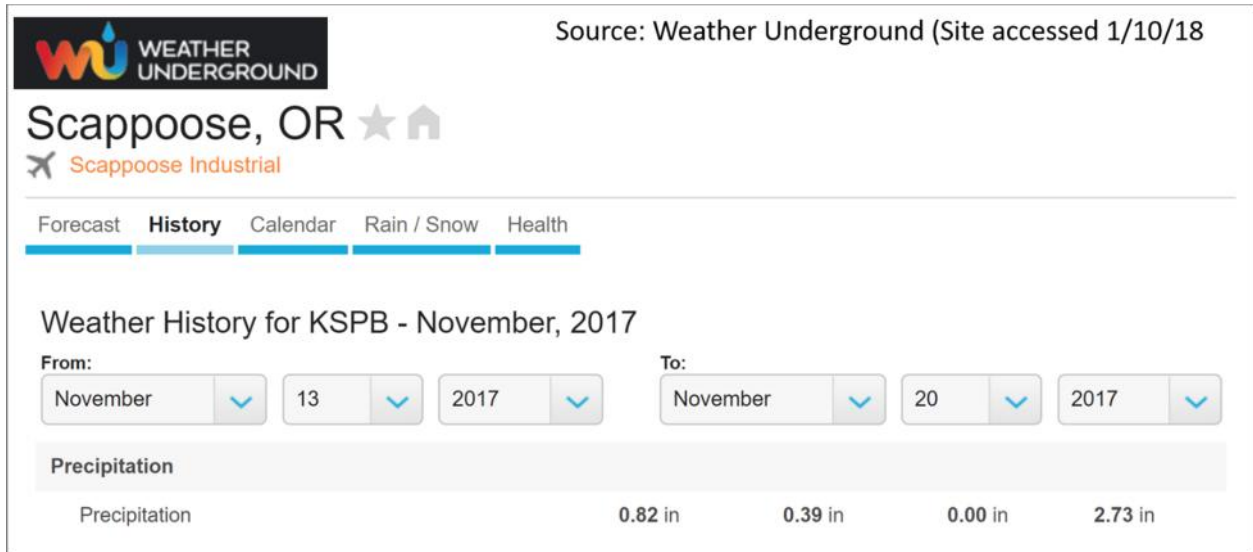
Figure 3. Weather data during period prior to site visit.

A query of the website Weather Underground on January 10, 2018 showed that the area had received 2.73 inches of measurable precipitation in the week leading up to the site visit (Figure

3). In general, the wetlands were saturated within twelve inches of the ground surface. The streams contained relatively high seasonal flow but were within the banks during the site visit. Some small areas of shallow standing surface water were observed in the adjacent floodplain wetlands.

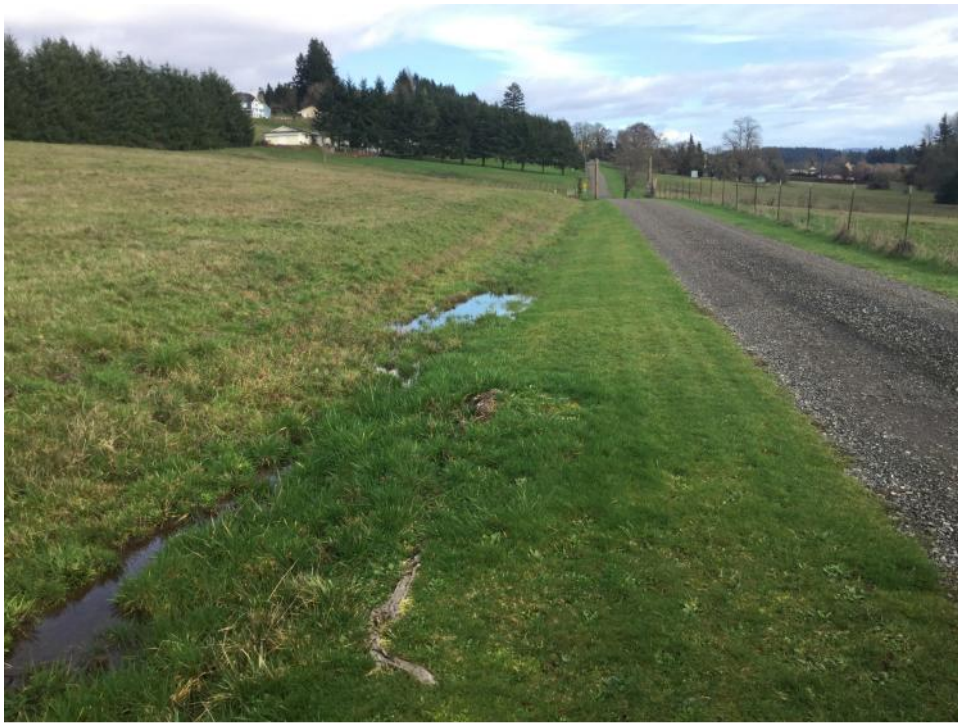
Photo 1 - Drainage ditch along the north side of the driveway accessing the project area from NE North Fork Avenue.

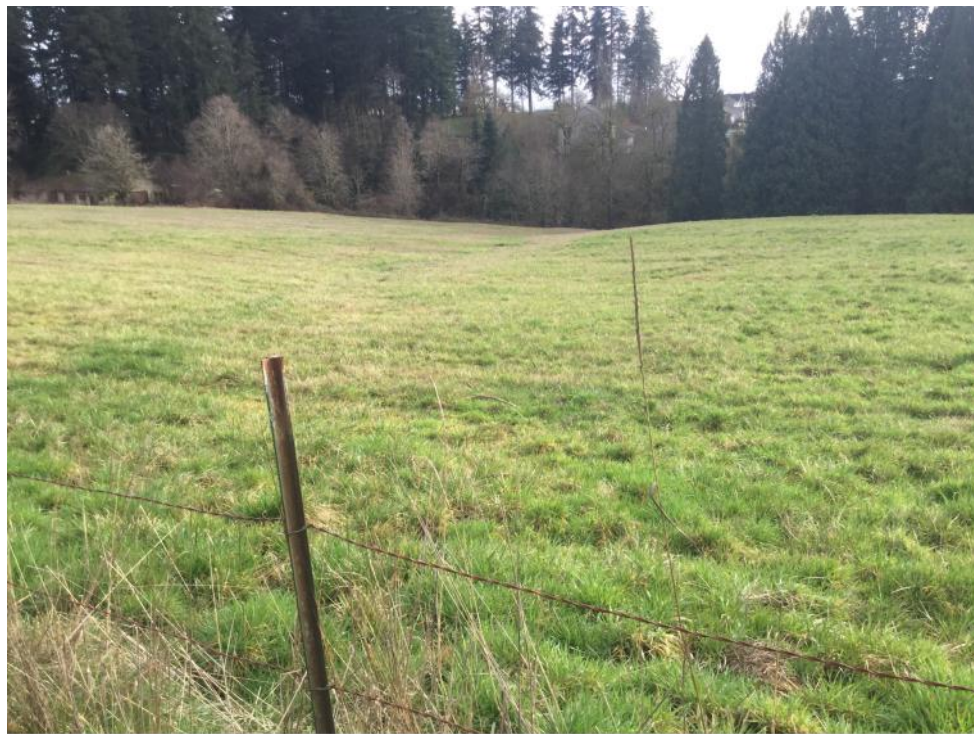
Photo 2 - Pasture area to the south of the driveway leading towards the riparian corridor of the Type F stream along the south boundary of the project area.

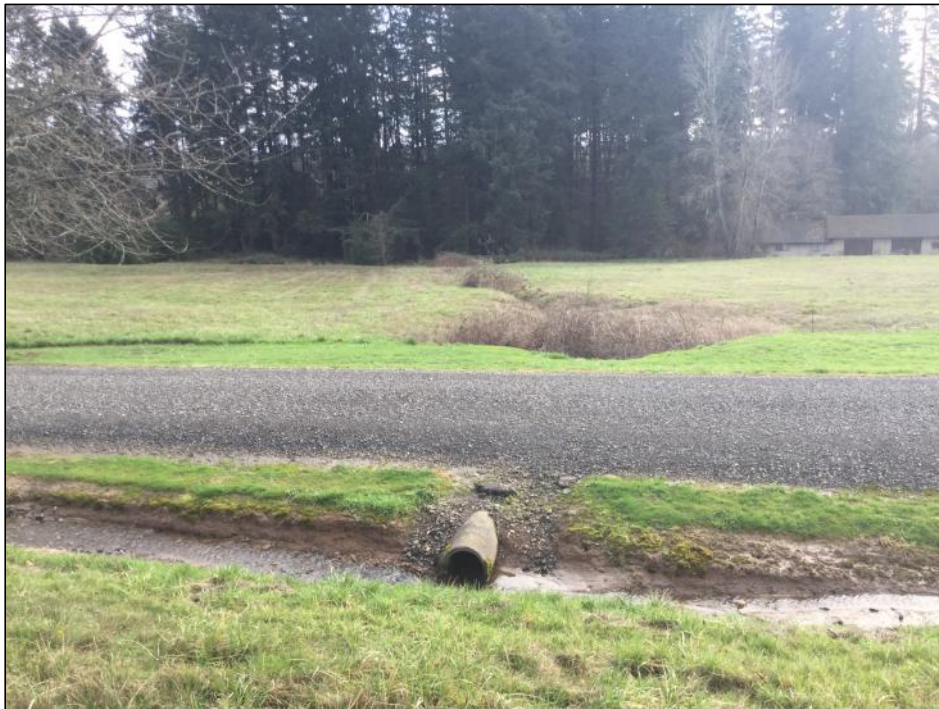
Photo 3 - Drainage ditch along the north side entering culvert to drainage swale/ditch in south pasture of the project area.

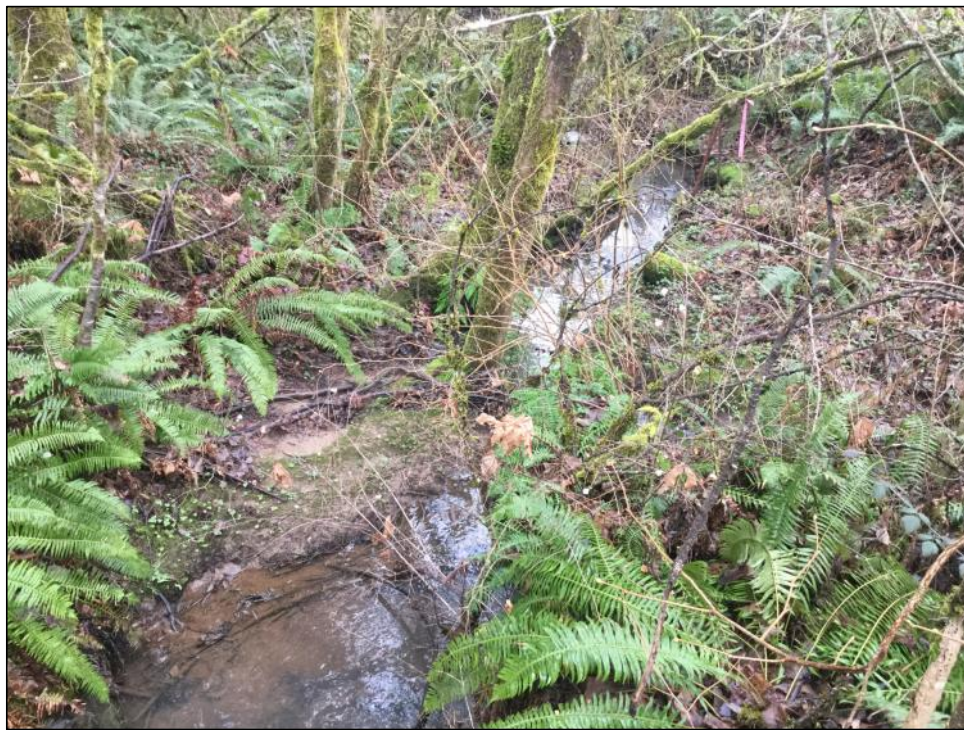
Photo 4 - Type F stream in the west portion of the project area.

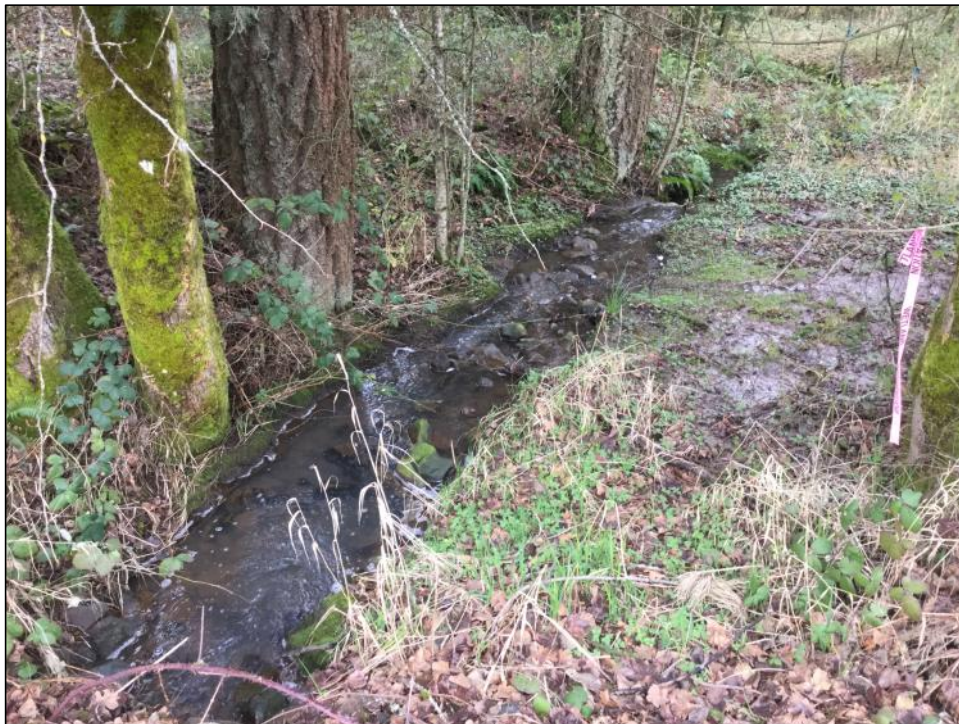
Photo 5 - Type F stream in east part of the project area.

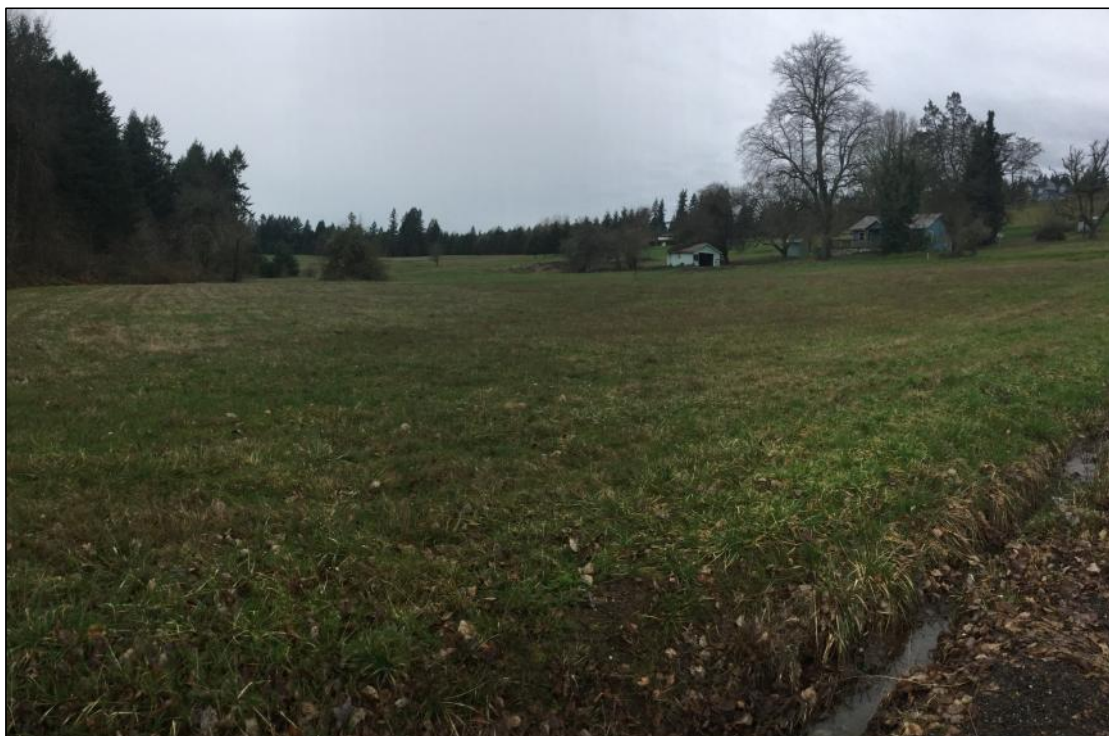
Photo 6 - Photo of project area taken from NE North Fork Road facing west.
