Critical Areas Report

Cowlitz Tribe Reservation Development and I-5/La Center Interchange Improvements

**December 2015
Revised January 2016**

**BergerABAM
210 East 13th Street, Suite 300
Vancouver, WA 98660**

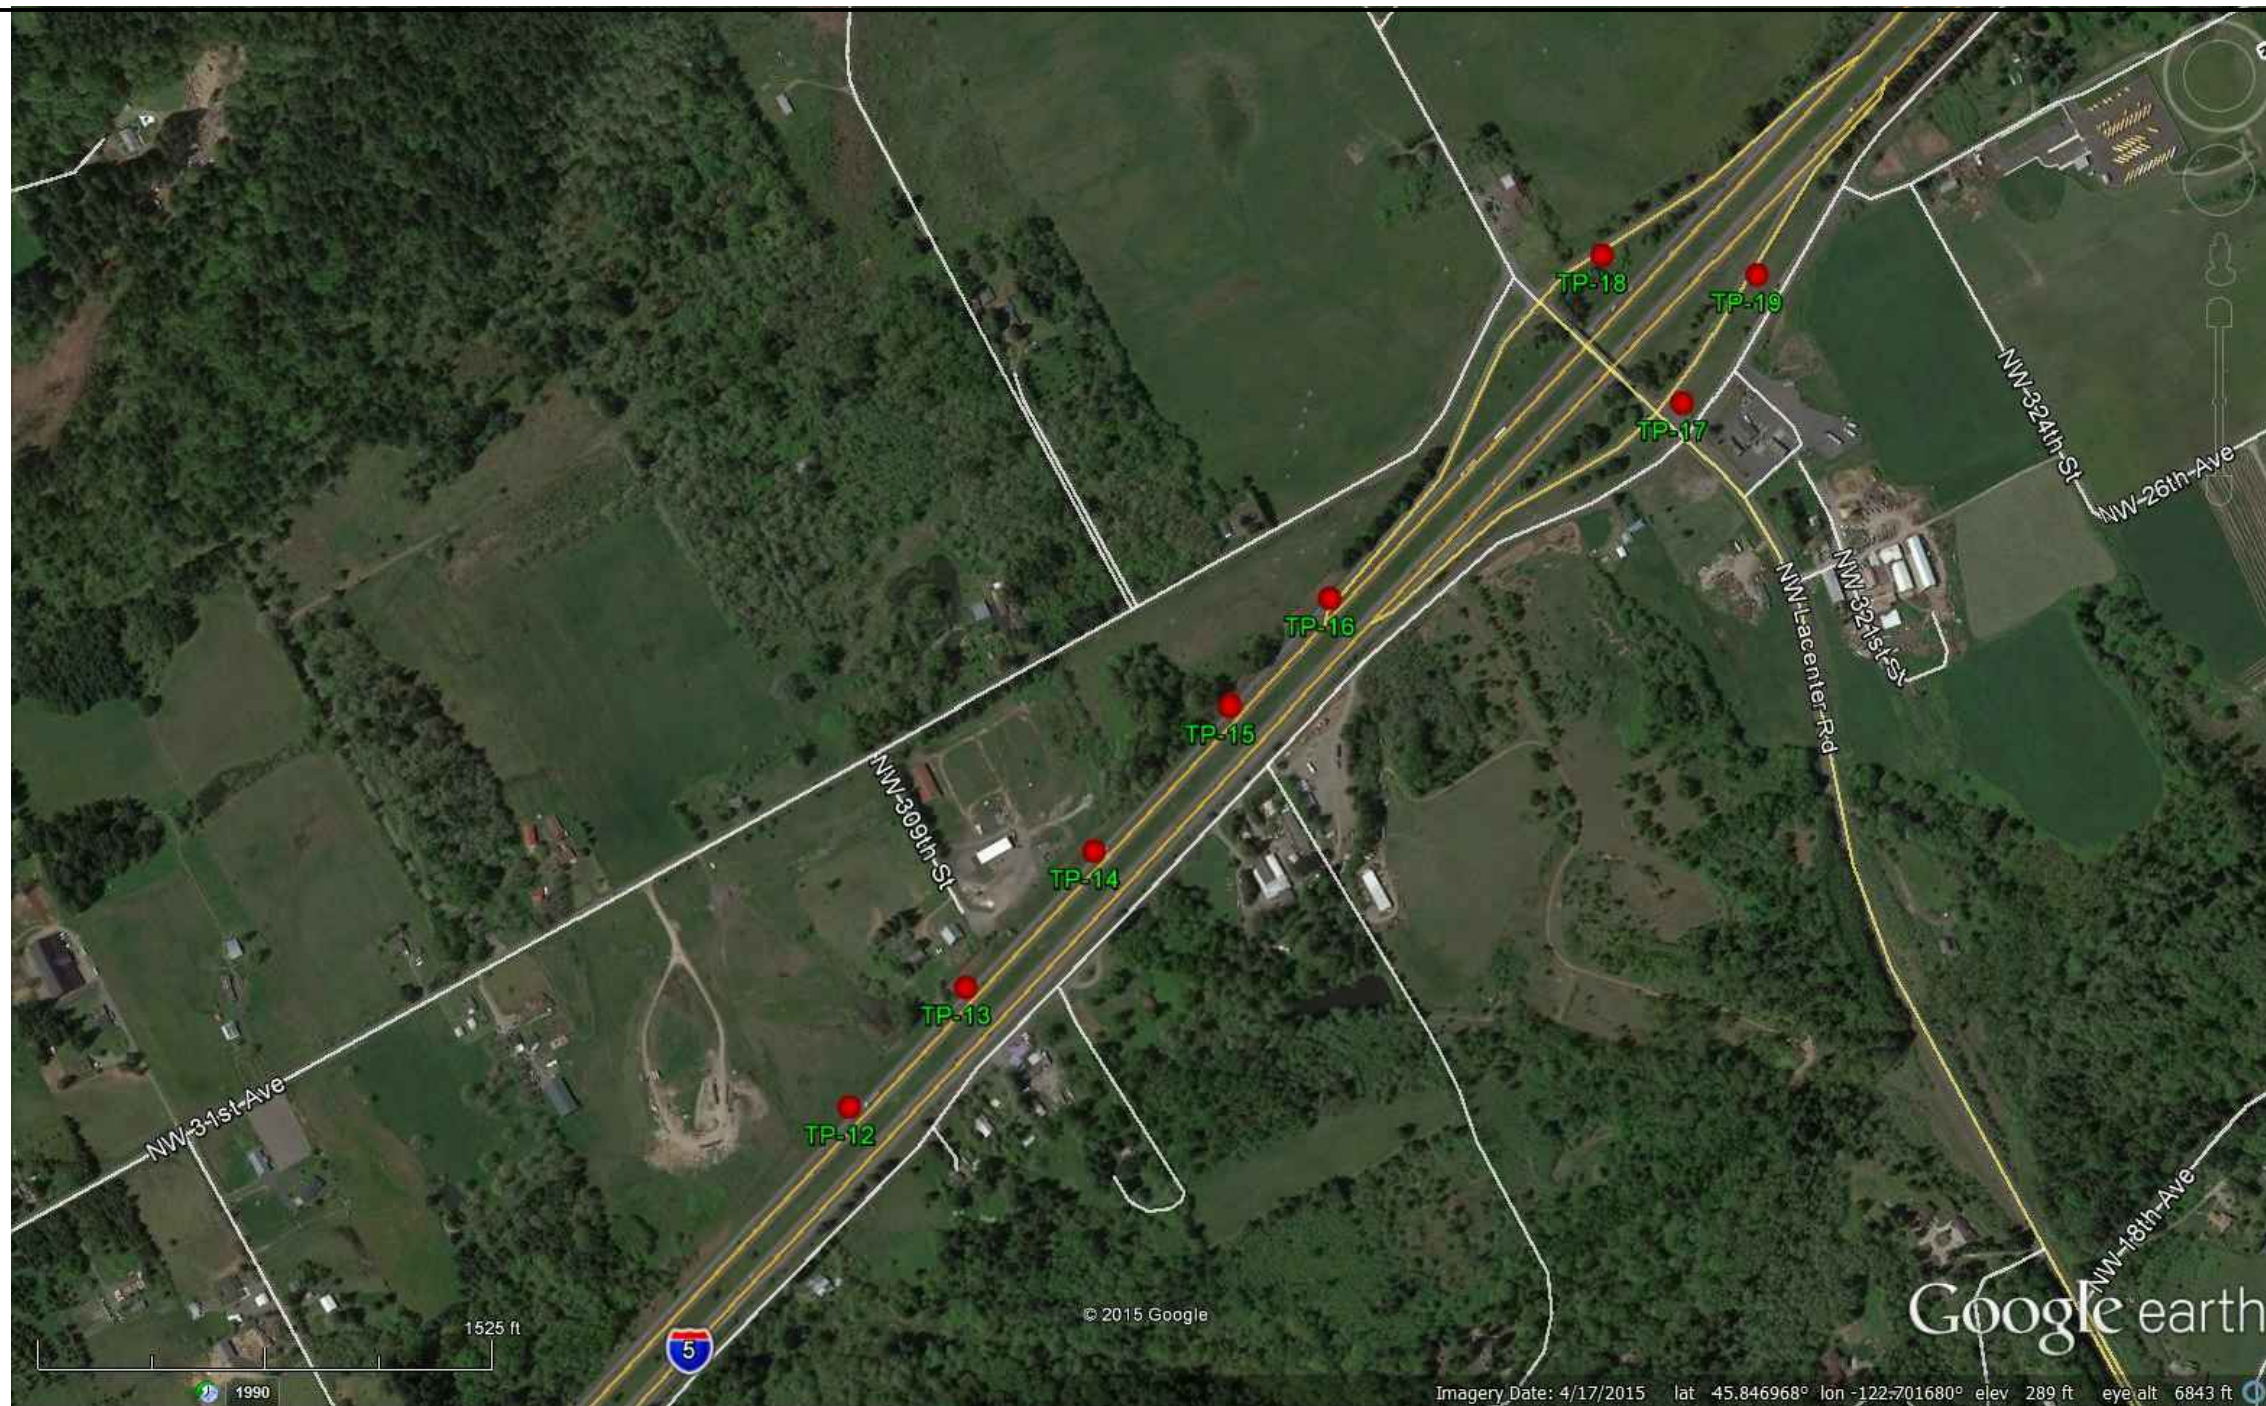
● TP-12 Test Pit Number & Approximate Location

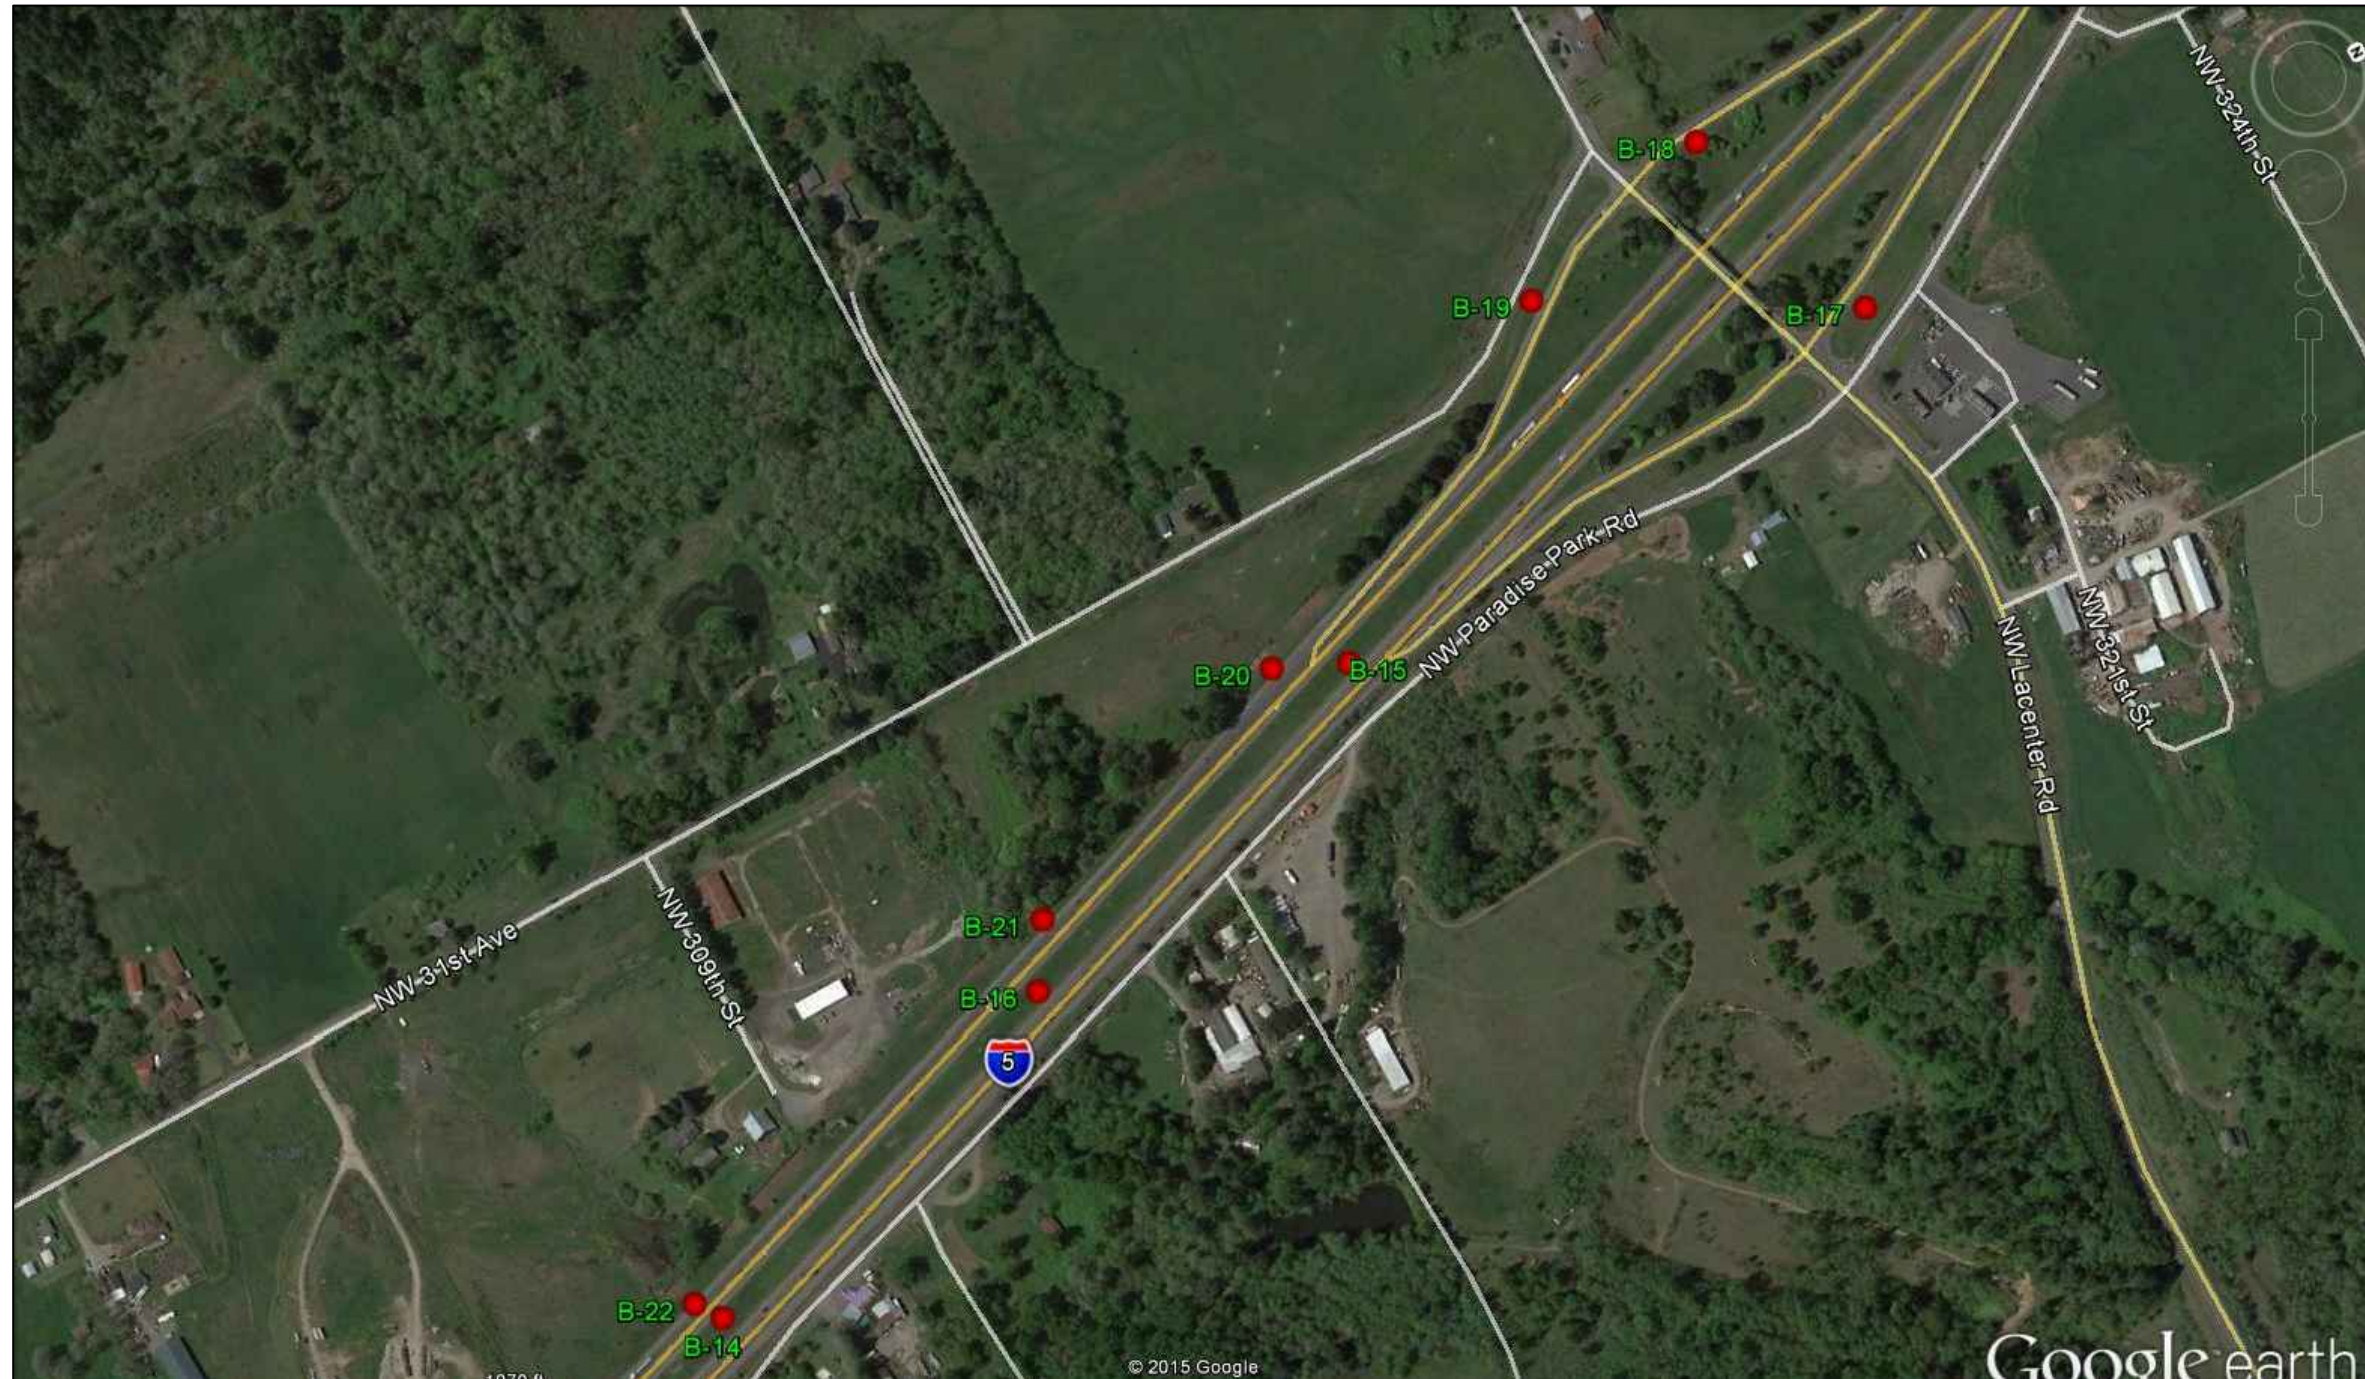
● B-14 Boring Number & Approximate Location
