**Figure A-1  
 VICINITY MAP  
 Fargher Lake Site  
 East Fork Lewis Wetland Mitigation Bank  
 Clark County, Washington  
 Section 23, Township 5N, Range 2E, W.M.**

Figure A-3  
 EXISTING CONDITIONS  
 Fargher Lake Site  
 East Fork Lewis Wetland Mitigation Bank  
 Clark County, Washington  
 Section 23, Township 5N, Range 2E, W.M.

ECOLOGICAL LAND SERVICES, INC. 1157 3rd Ave., Suite 220 Longview, WA 98632 Phone: (360) 578-1371 Fax: (360) 414-9305	<b>FIGURE B-3A GRADING CROSS SECTIONS</b>		GENERAL INFORMATION DESIGNED BY: JTS DRAWN BY: DMC SURVEYED BY: JPS CHECKED BY:
	DATE: FEB. 2010	SHEET NO.	APPROVED BY:

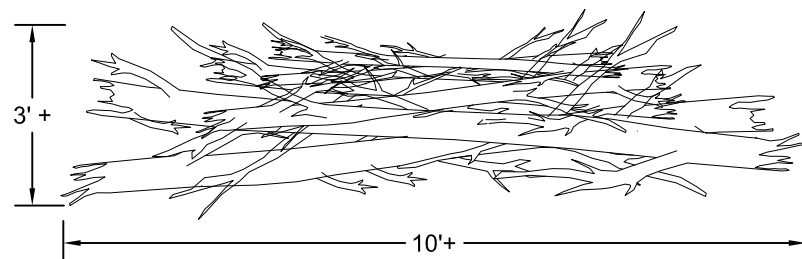
### E. BRUSH PILE

1. Contain 3 layers of brush (ranging from approximately 1/4- to 6-inch in diameter) with the largest diameter brush layer on the bottom of the pile, with progressively smaller diameter brush towards the top of the pile.
