## **FINAL Staff Report and Notice of Decision**

Riverside Phase IV Neighborhood Park

## Type II Preliminary Site Plan Review, Critical Areas Review, and SEPA MDNS (2020-025-SPR/CAR/SEPA) June 7, 2021

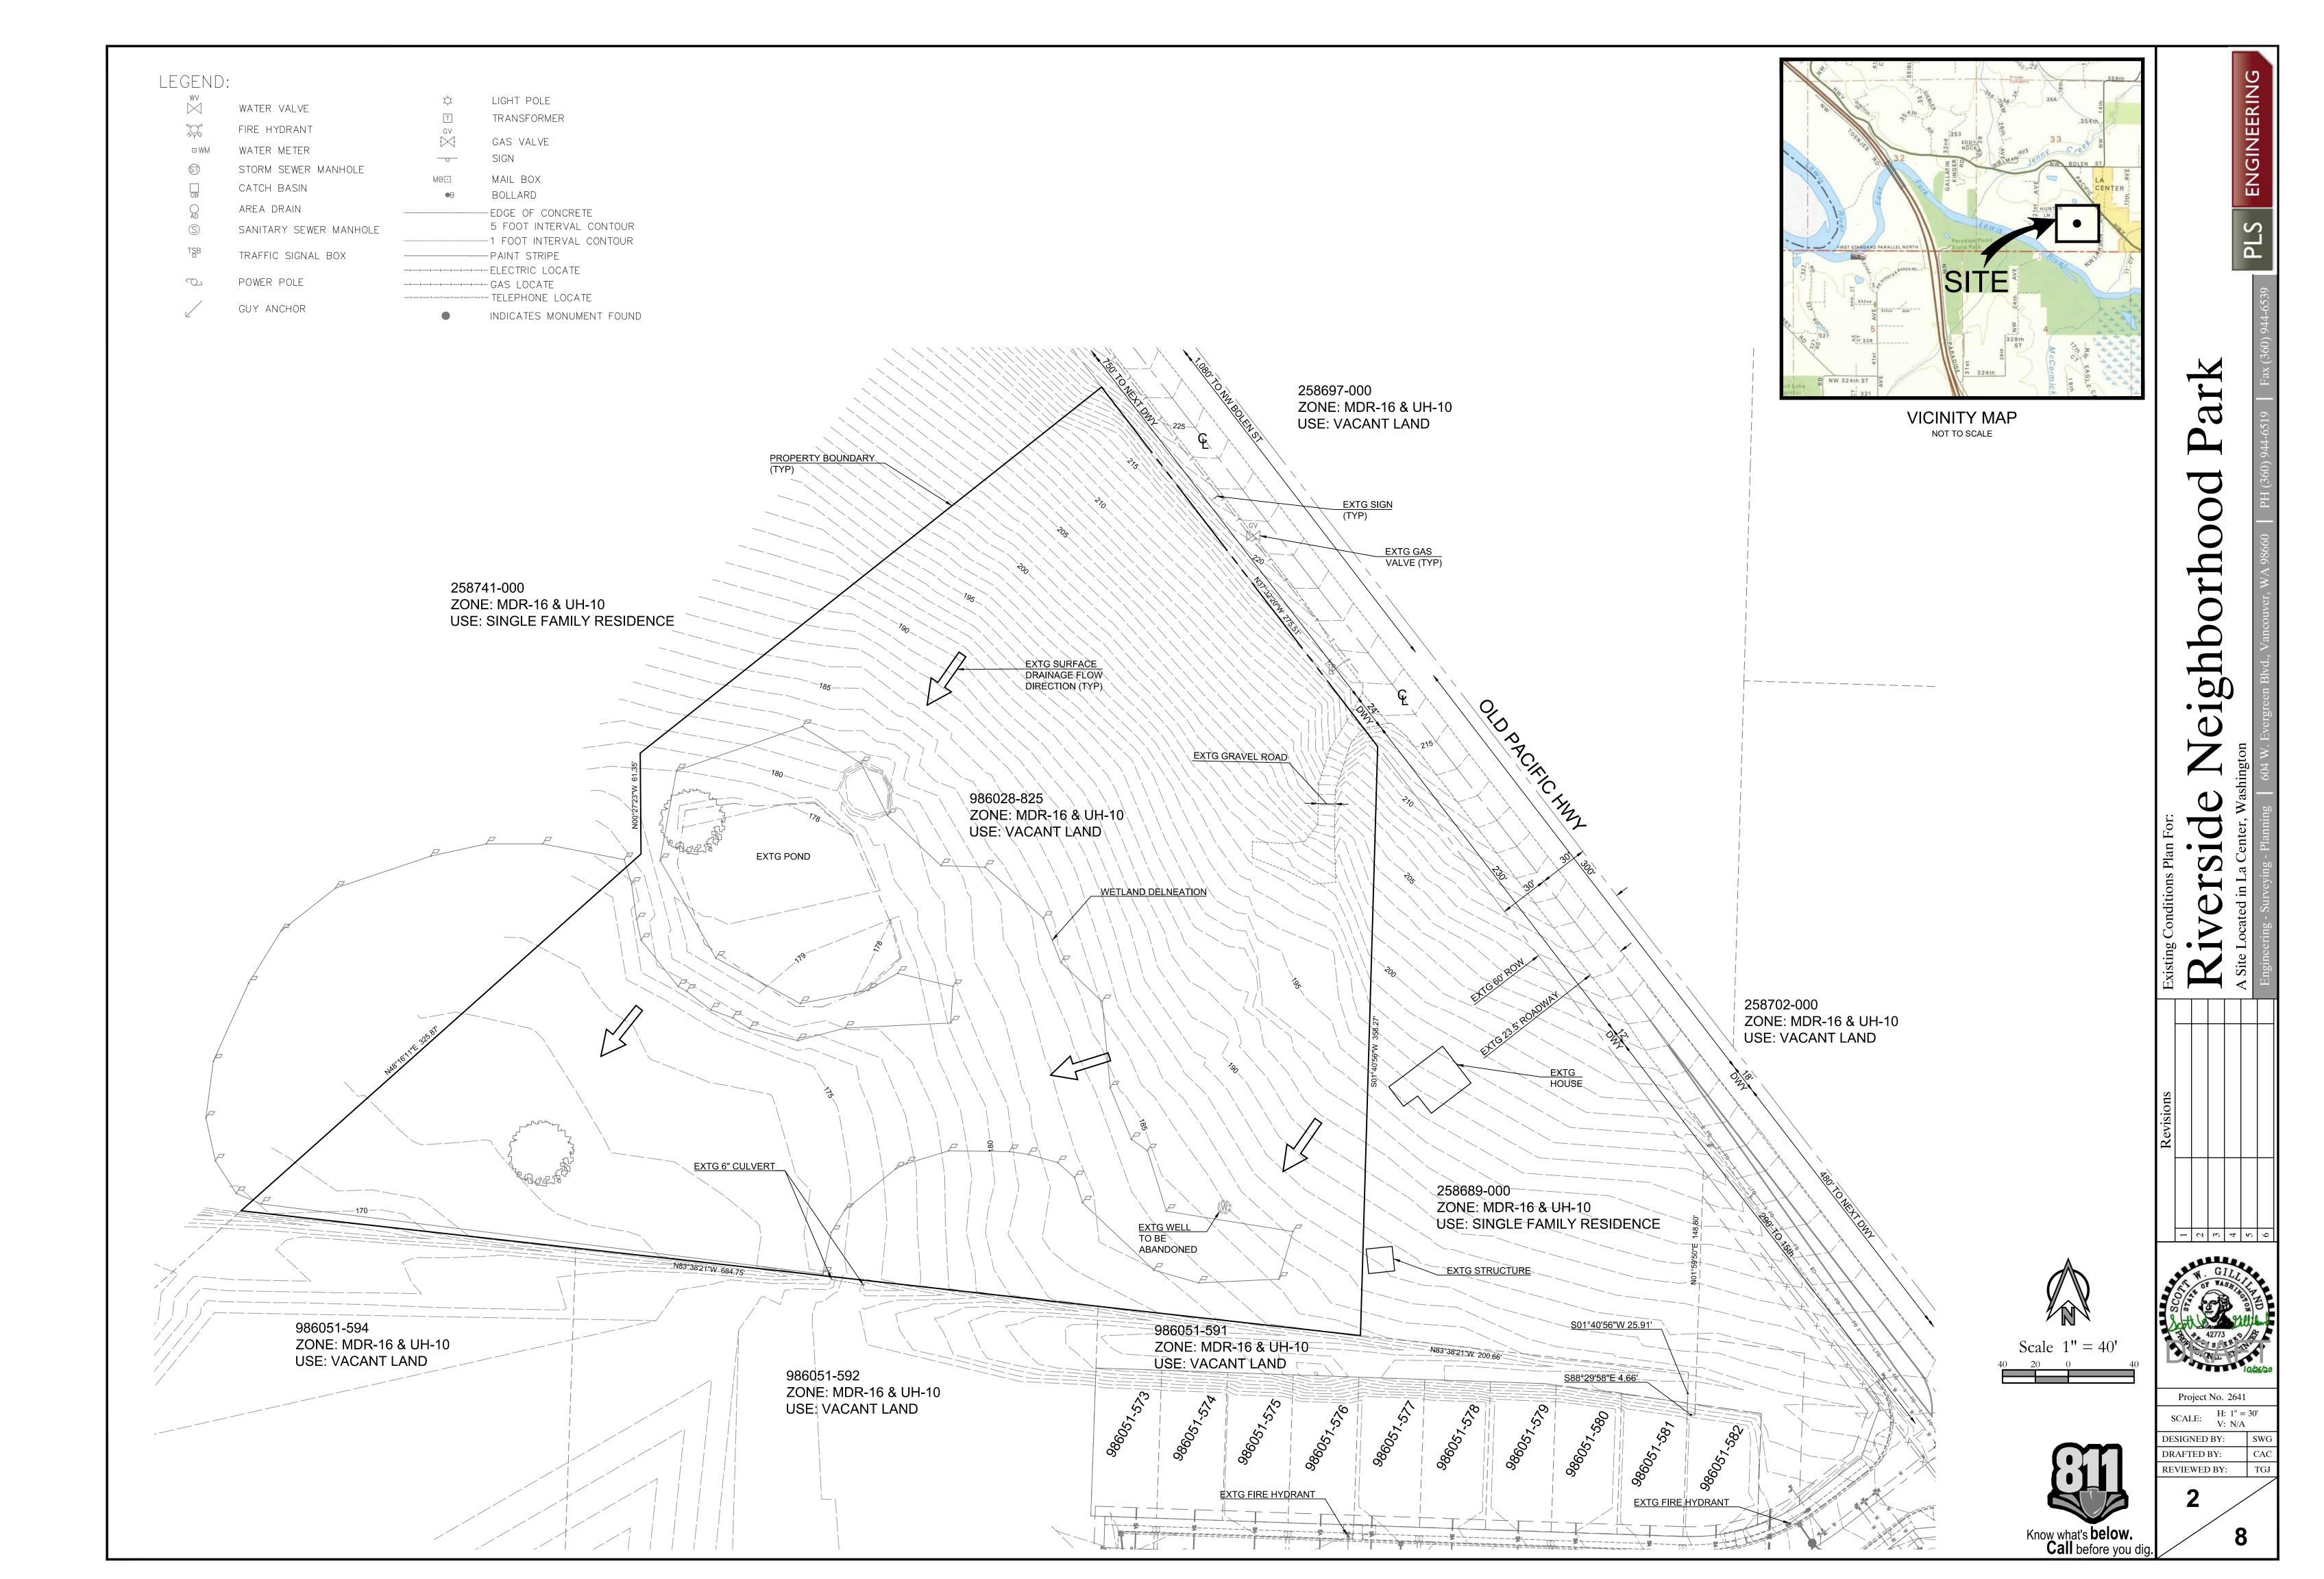
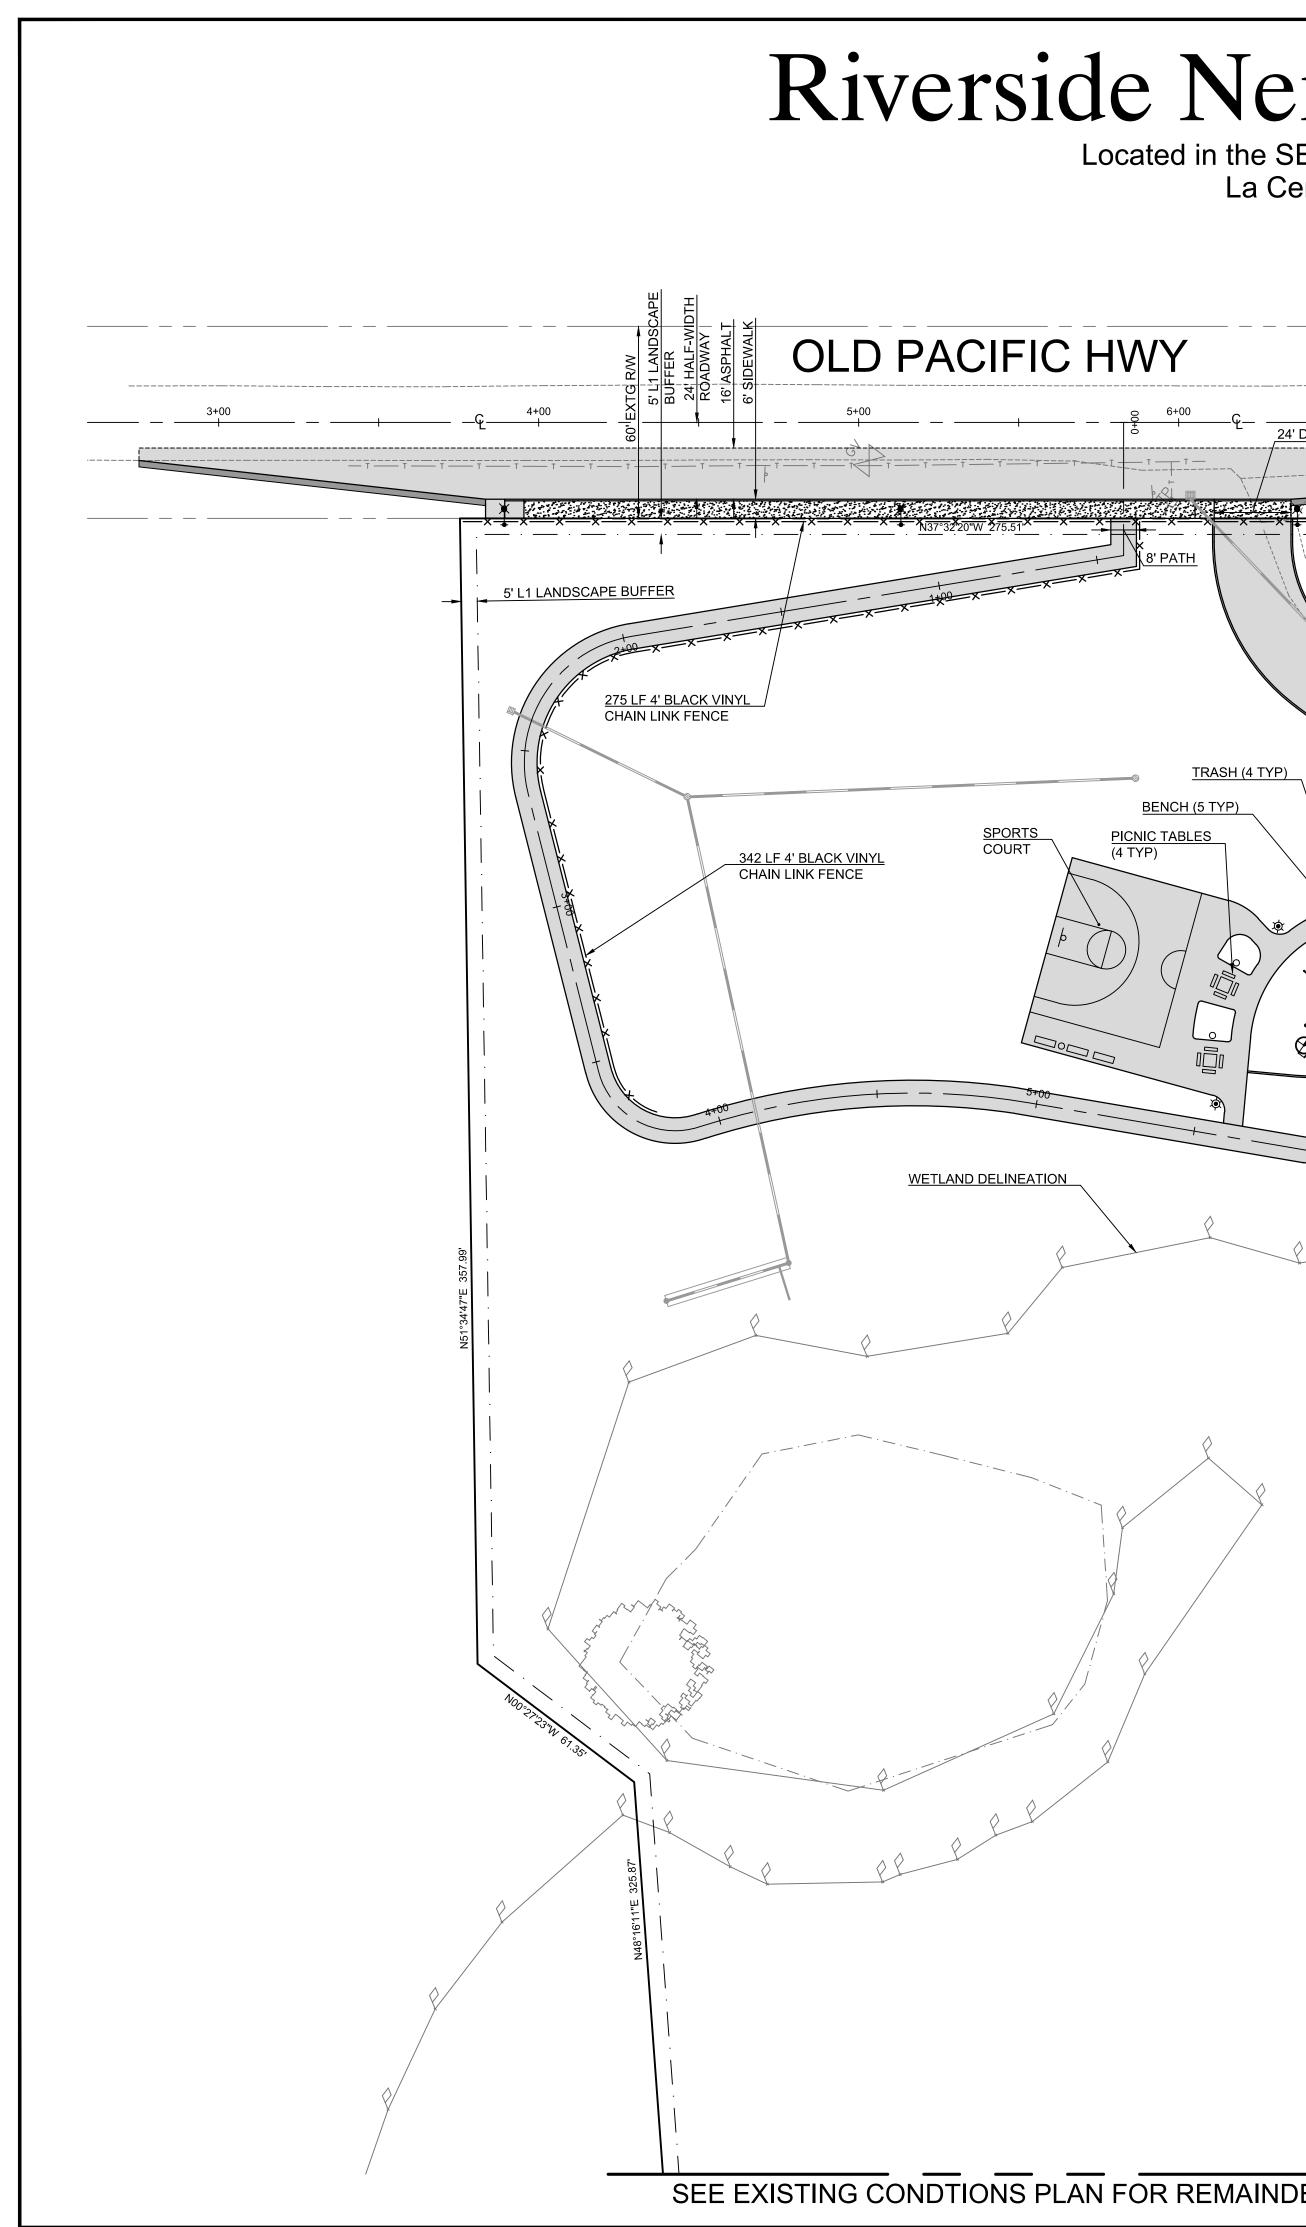
# Riverside Neighborhood Park Located in the SE<sup>1</sup>/<sub>4</sub> of Section 33, T5N, R1E

# 7+00 8+00 9+00 6+00 24' DRIVEWAY - т — т – Scale 1'' = 30'TRASH (4 TYP) BENCH (5 TYP) SPORTS COURT PICNIC TABLES (4 TYP) DRINKING FOUNTAIN THE STORMWATER DETENTION FACILITY and DOG WASTE CLEANUP BAGS EQUIPMENT CURB 6700 - -HANDICAP PARKING STALL WETLAND DELINEATION <u>BIOFILTRATION</u> SWALE SEE EXISTING CONDTIONS PLAN FOR REMAINDER

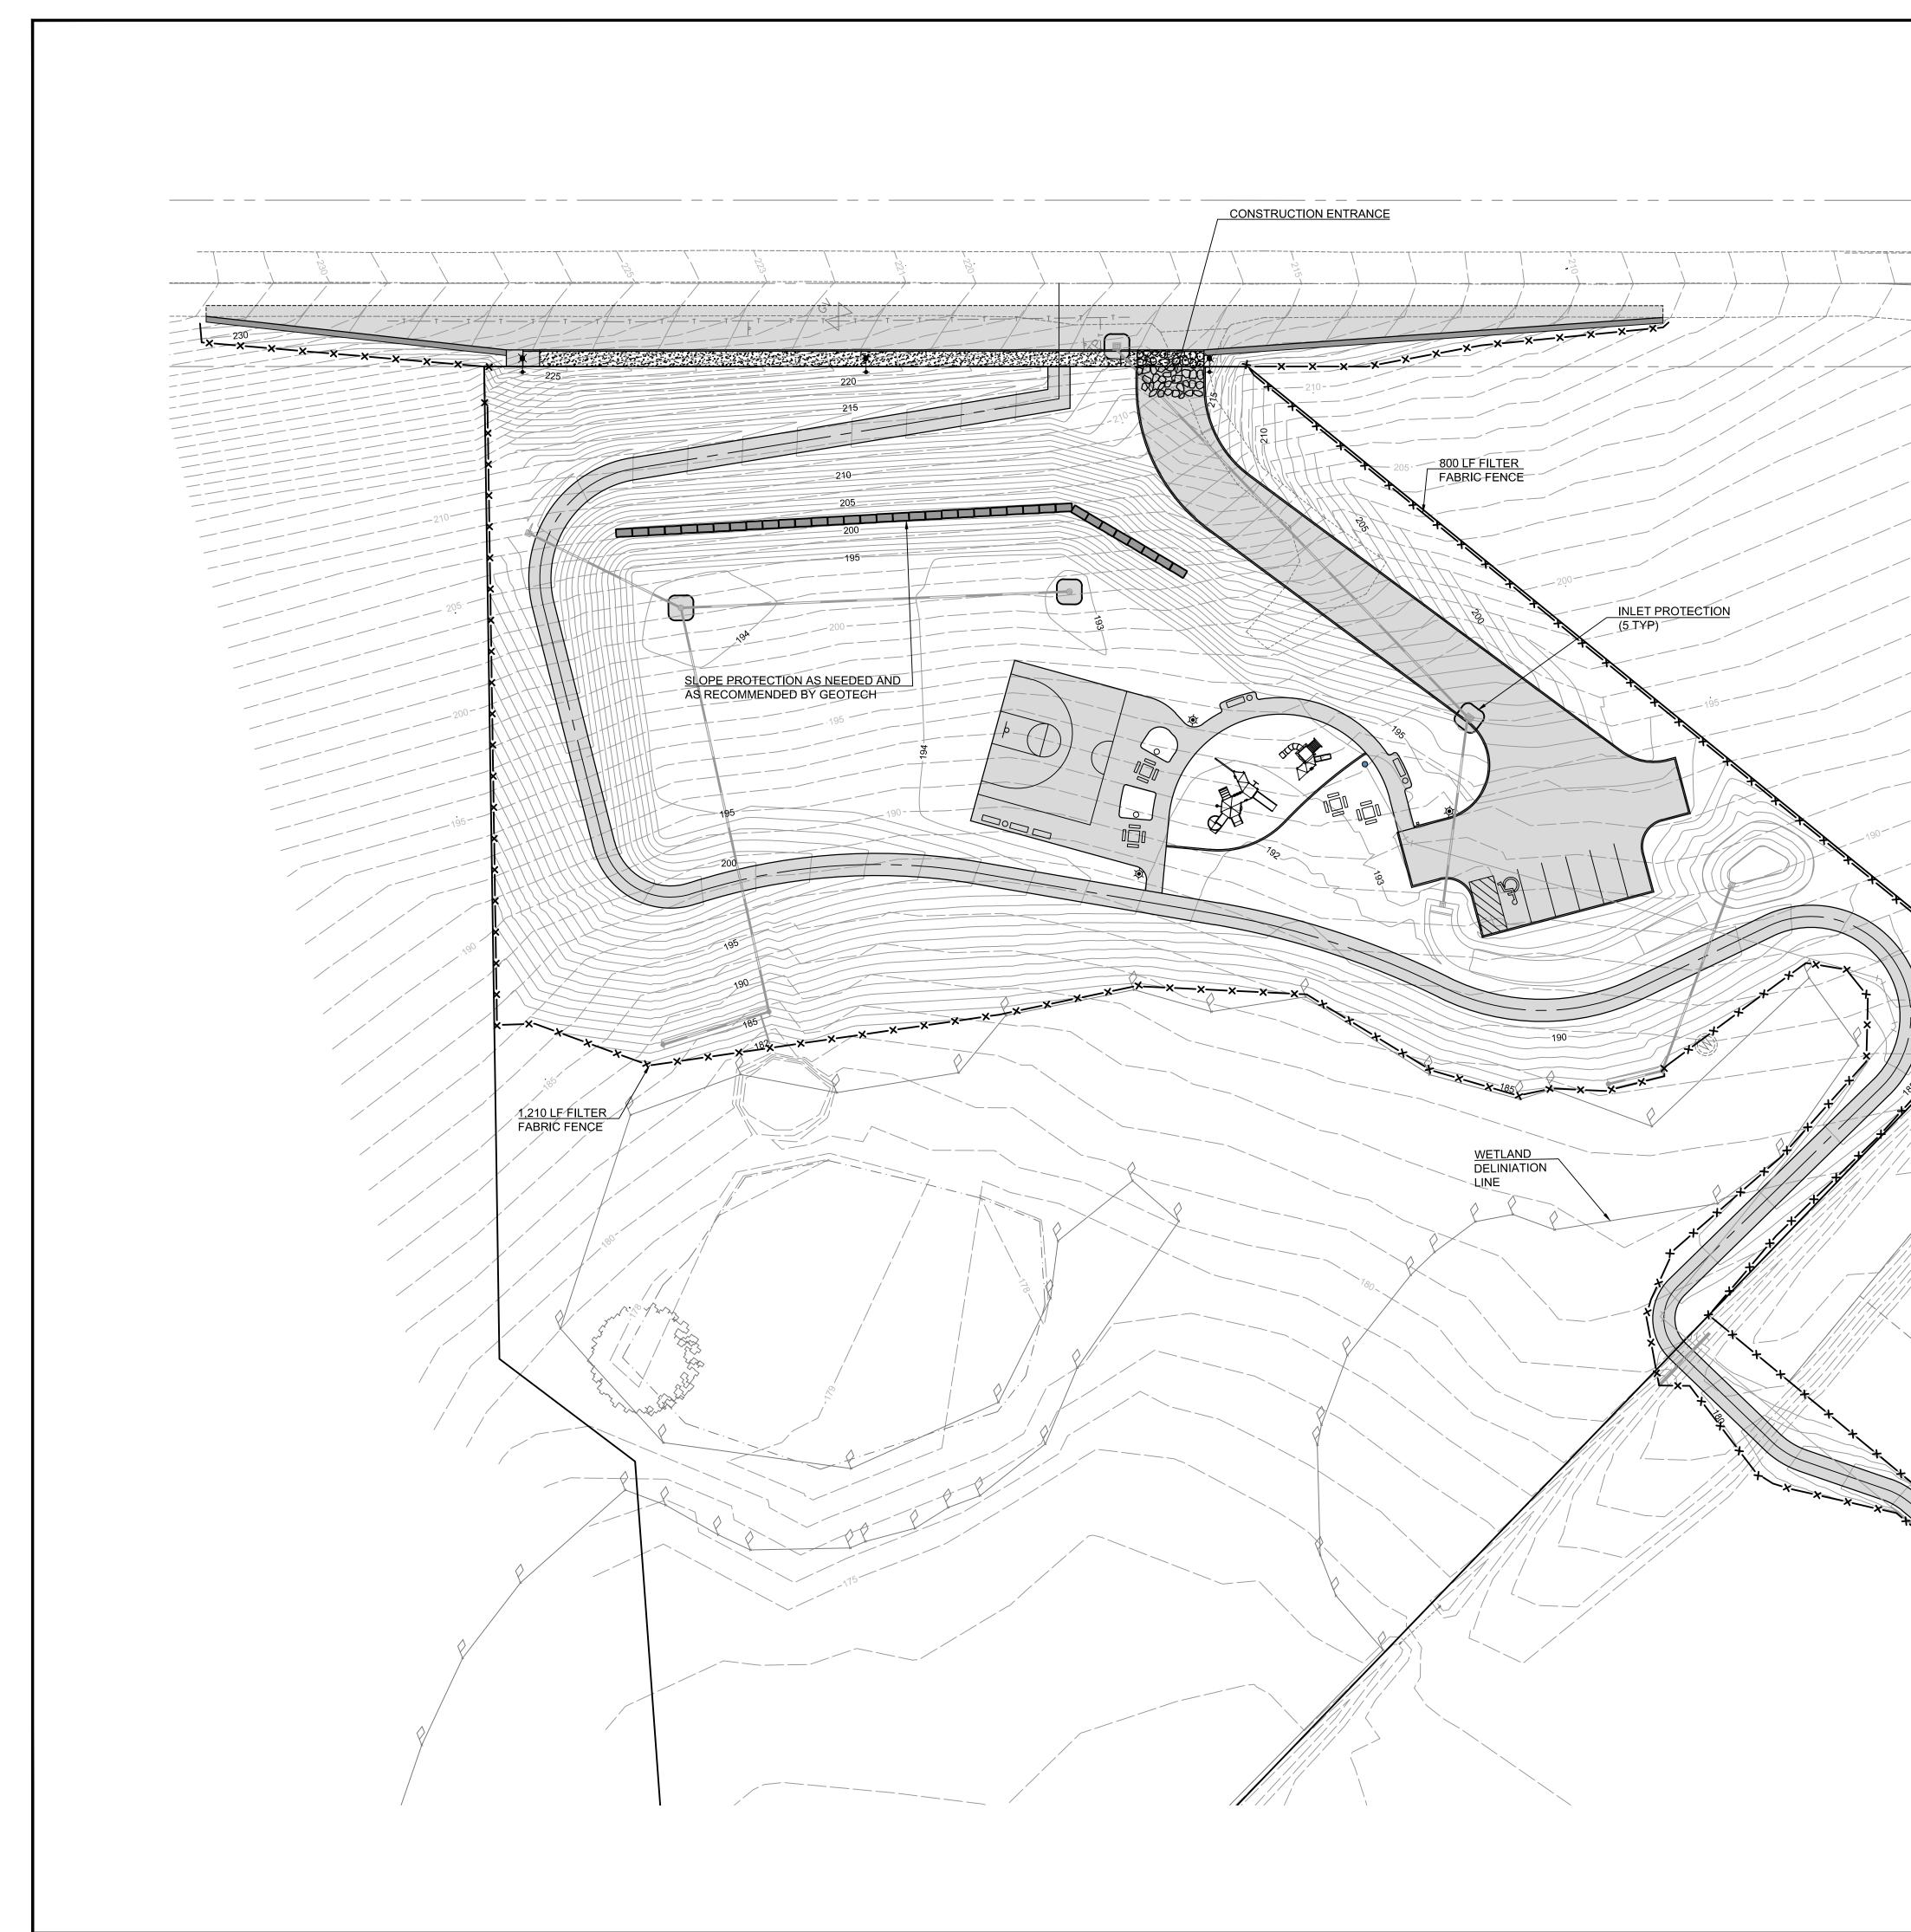
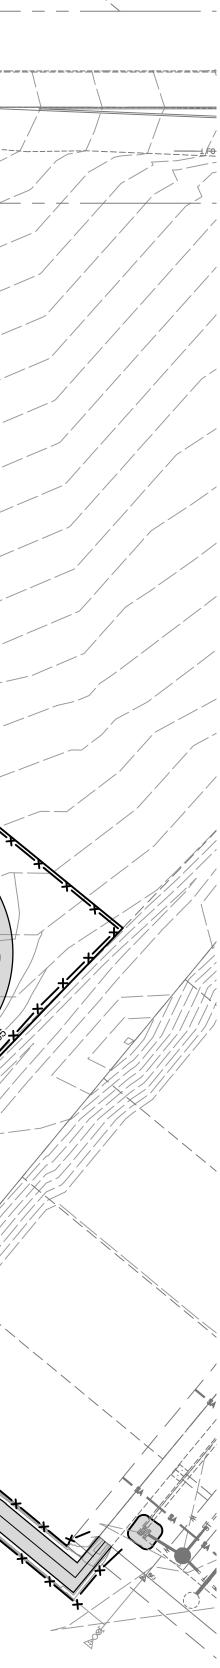
Scale 1" = 30' 30 15 0

CUT VOLUME = 3,800 CY FILL VOLUME = 9,300 CY

2
Preliminary Grading and Erosion Control Plan For:	Ziverside Neighborhood Dark		A Cito I control in I o Conton Workington	A DIE LOCAIEU III LA CEIIEI, WASIIIIGIUI	Engineering - Surveying - Planning   604 W. Evergreen Blvd., Vancouver, WA 98660   PH (360) 944-6519   Fax (360) 944-6539
Revisions					
	oject	2773 8 4 N at No. H:	264 1"	= 30	26/20
DESIG DRAFT REVIE	NED FED I	BY: BY:	N//	2	SWG CAC TGJ
1

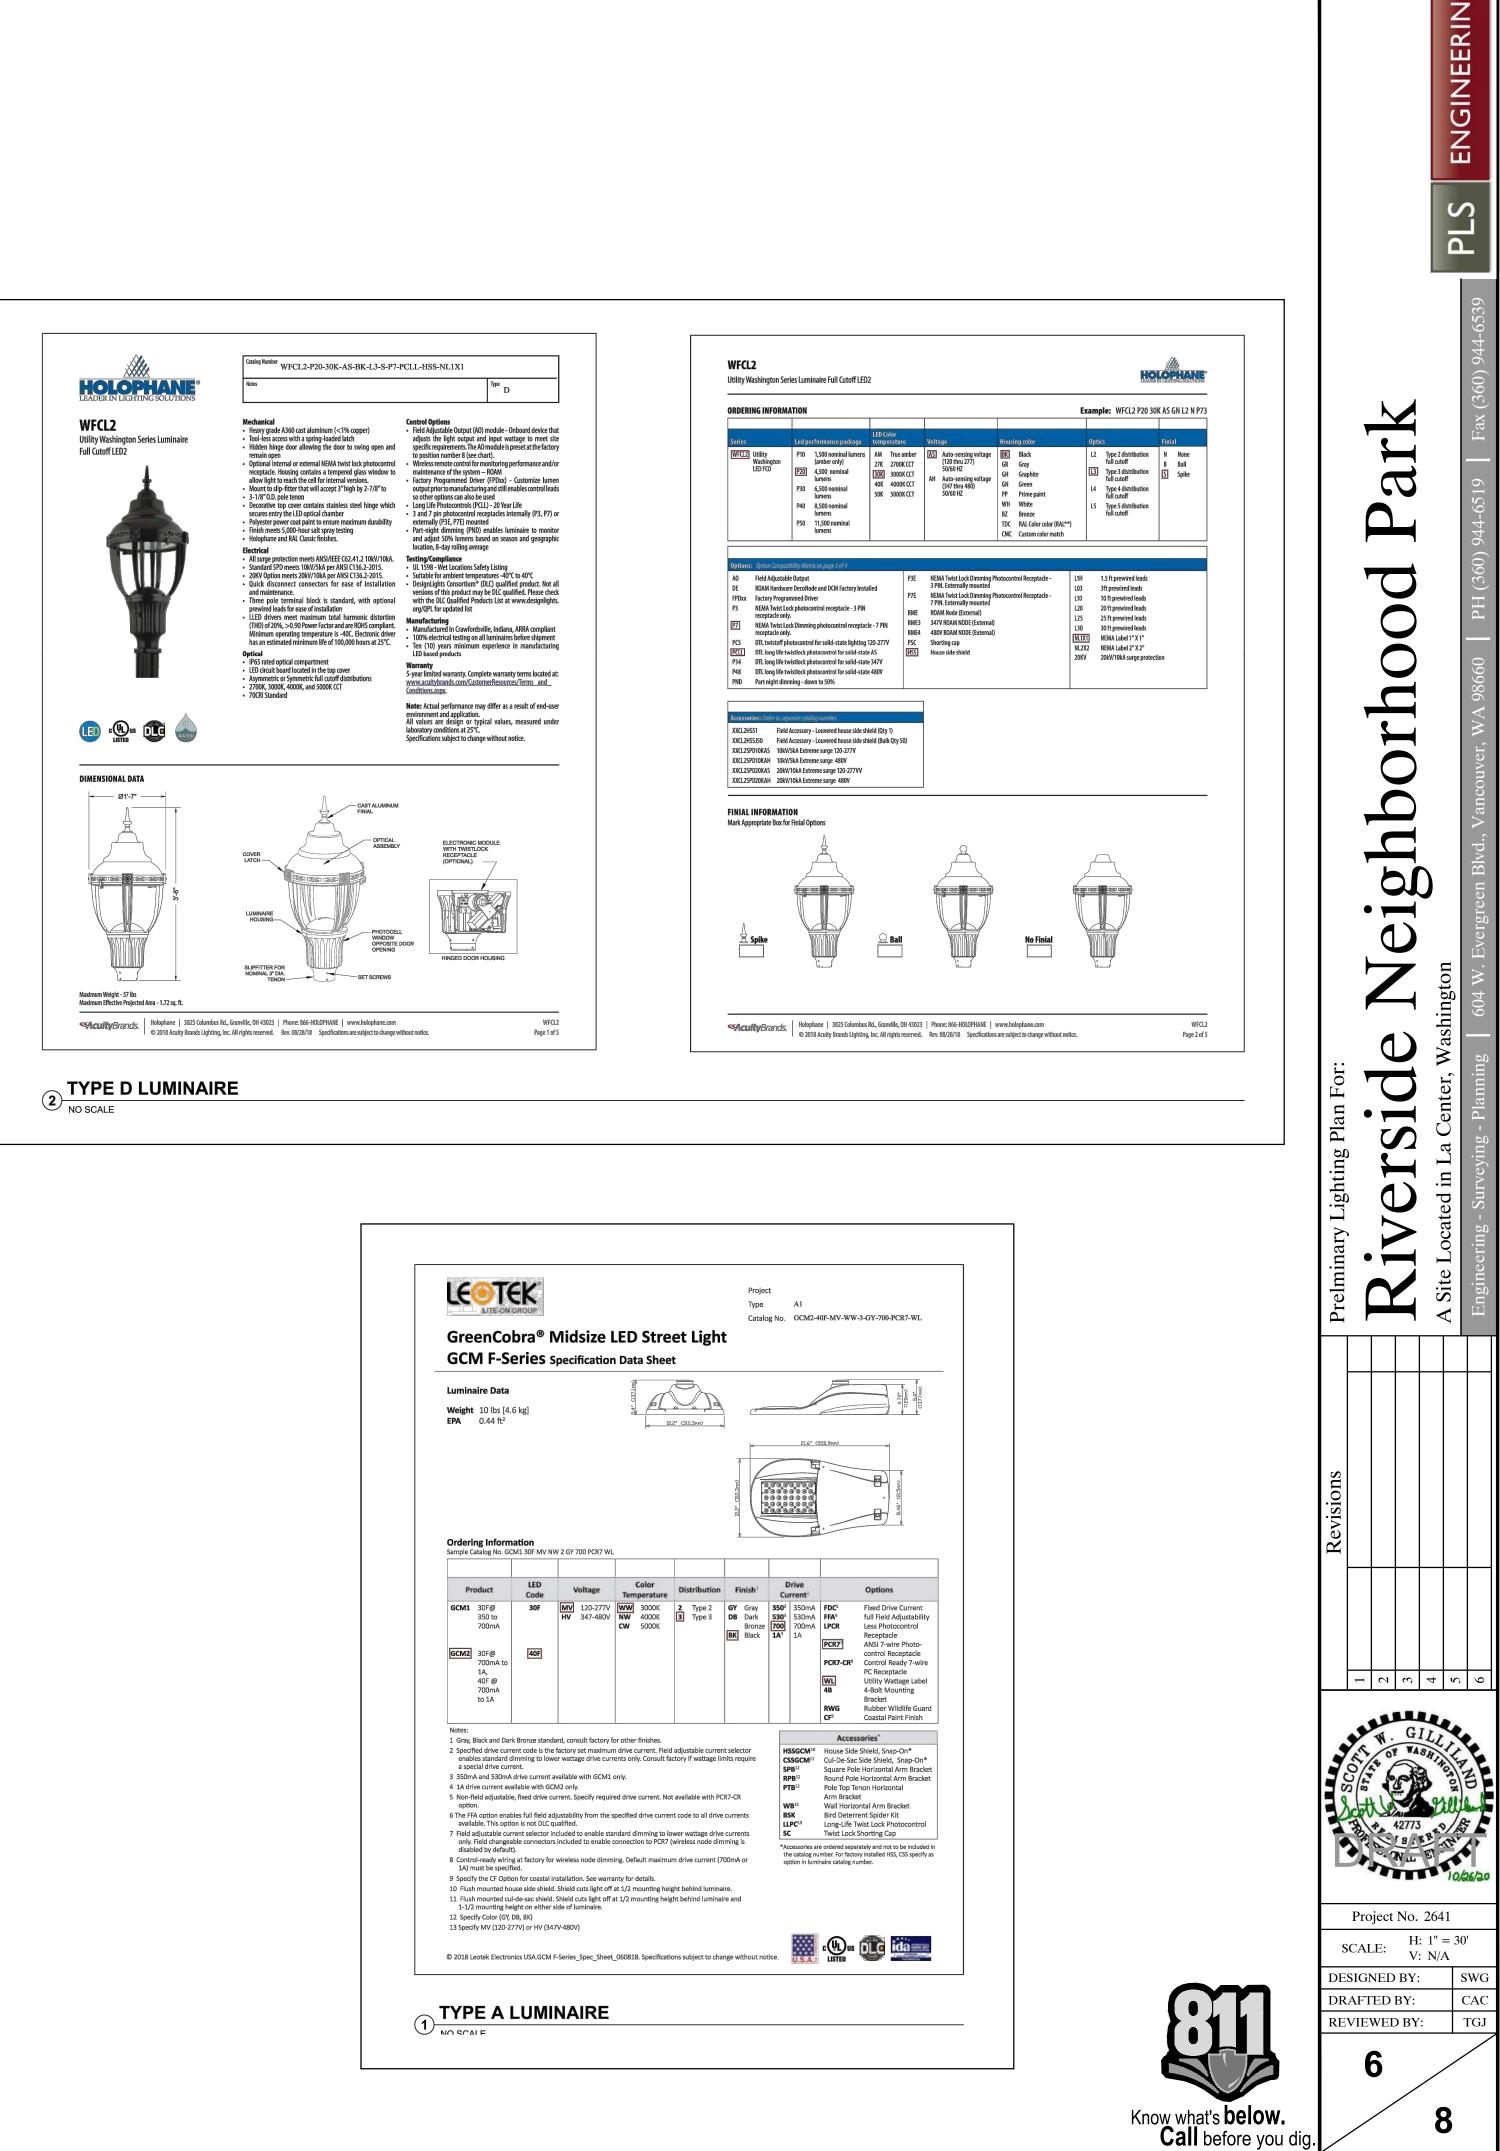
TYPE 'A' STREET LIGHT SHALL BE 3000K LEOTEK GREEN COBRA MIDSIZE LED #GCM2-40F-MV-WW-3-BK-700-PCR7-WL MOUNTED ON CITY OF LA CENTER APPROVED 30 FOOT BLACK POLE WITH 8 FOOT ARM (3 TYP)

*Findings:* According to the lighting plan, the applicant is proposing six light poles; three streetlight poles along the park's street frontage and three light poles in the interior of the park. Additional lighting requirements are included in this staff report (see condition of approvals in Section 18.147.040 and 18.280).

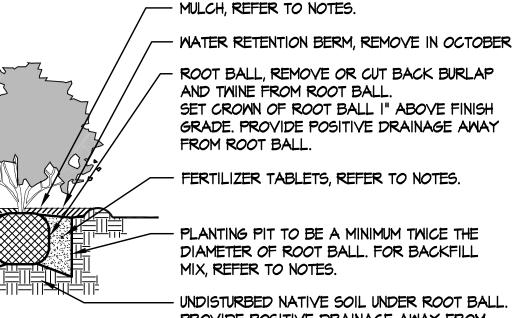
TREE -

PLANTING PIT TO BE A MINIMUM TWICE THE DIAMETER OF ROOT BALL. FOR BACKFILL MIX, REFER TO NOTES.

UNDISTURBED NATIVE SOIL UNDER ROOT BALL. PROVIDE POSITIVE DRAINAGE AWAY FROM ROOT BALL.

# nrub Planting Detail

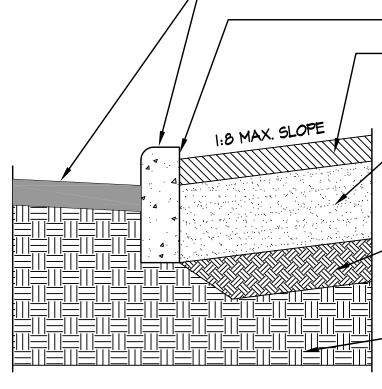
ROADWAY AND CURB

- HIGHEST POINT TO BE IN CENTER

SOIL PREPARATION MAY BE DIMINISHED IN ORDER TO AVOID CONFLICT WITH EXISTING UNDERGROUND UTILITIES.

Soil Section at Curb within Planting Strips & Finger Islands Not To Scale **SECTION**

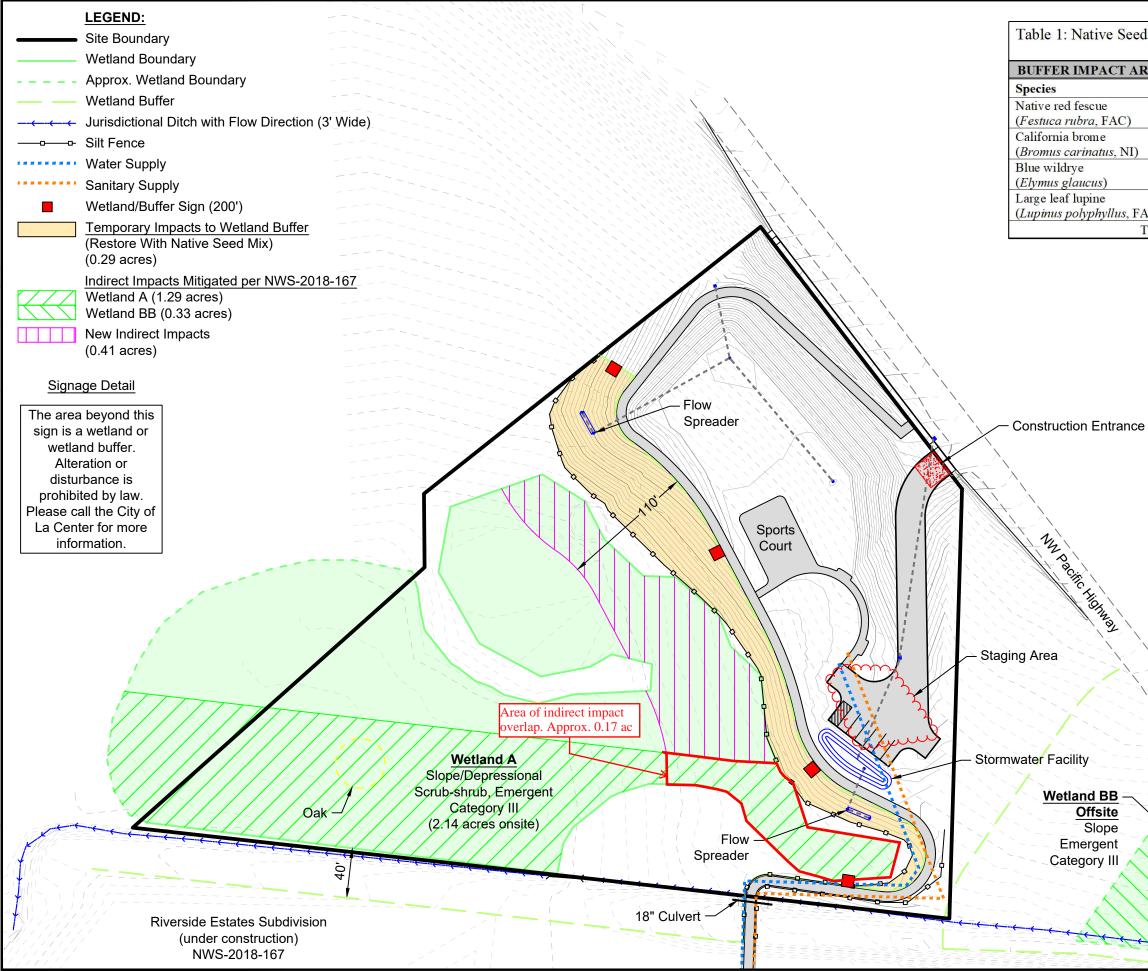
Attachment: Bank Use Plan Sheet 3 – Proposed Conditions Site Map

for Temporar – Sunmark See	ds Stream	Bank Plus	PROPOSED:Indirect Wetland Impacts	STATE: WA
	Composition 50%	Spacing	Quantity	rect V	s s s
	20%		27.0.11	D:Indi	<sup>r</sup> etlanc Center Clark <b>OF</b> 4/20
	20%	2 lb/ 1,000	37.2 lbs (for 18,590	POSE D	IN Onsite Wetlanc NEAR: La Center COUNTY: Clark SHEET 3 OF DATE: 7/24/20
	10%	sq. ft	sq. ft.)	PROF	IN On NEAI COUI SHEE DATI
AC) Total	10%				Park
				PURPOSE: Proposed Conditions Site Map	t of APPLIC od Park PROJEC PROJEC AD83 T PROPERTY OWNERS: SITE LC 34506 OI
				80	FEET 7 3rd Ave., Suite Longview, WA 9 thone: (360) 578
			W	E	Ecological Services

As a **condition of approval**, Wetland A buffer areas that are temporarily disturbed during construction shall be fully restored with native seed mix in accordance with Sheet 3 of the Bank Use Plan prepared by Ecological Land Services, July 23, 2020. The seeding shall occur prior to dedication of the park to the City.
