Public Hearing: Lockwood Meadows Subdivision

Preliminary Plat, Variance, Critical Areas Permit, Legal Lot Determination, Mitigated SEPA DNS, Road Modification, and Public Hearing: Type III Review

Lockwood Meadows Subdivision: Type III

(#2020-004-SUB/VAR/CAR/SEPA) May 9, 2022

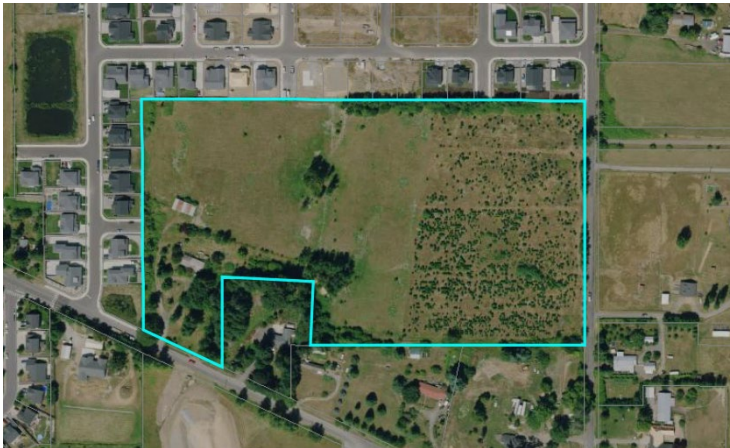
Figure 3 – Proposed Preliminary Plat

Each lot will be served by public utilities including sanitary sewer (City of La Center) and potable water (Clark Public Utilities).

The application requests reviews for the preliminary subdivision, a road modification, legal lot determination, SEPA, and critical areas review for wetland areas.

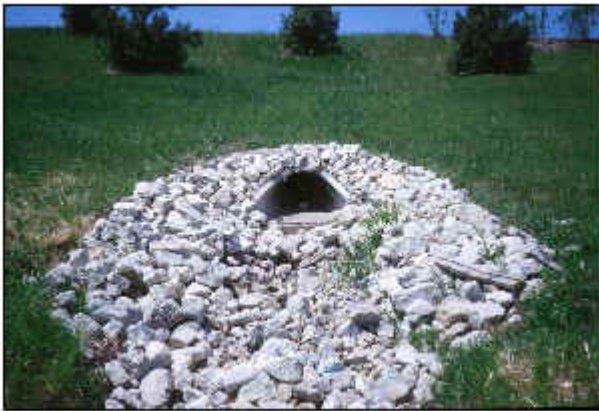
Facility Discharge Point			
Drainage System Feature	Potential Defect	Conditions When Maintenance Is Needed	Minimum Performance Standard
Monitoring	Contaminants in Discharge Water	Any evidence of oil, gasoline, contaminants or other pollutants. Sheen, obvious oil or other contaminants present. • Identify and remove source, AND • Report to Clark County Clean Water Program.	Effluent discharge from facility is clear.
	Receiving Area Saturated	Water in receiving area is causing substrate to become saturated and unstable. • Report to Clark County Clean Water Program for Engineer Evaluation.	Receiving area is sound and not saturated.
	Ditch or Stream Banks Eroding (via Off Site Assessment)	Erosion, scouring, or headcuts in ditch or stream banks downstream of facility discharge point due to flow channelization or higher flows. • Report to Clark County Clean Water Program for Engineer Evaluation.	Ditch or stream banks are stable.

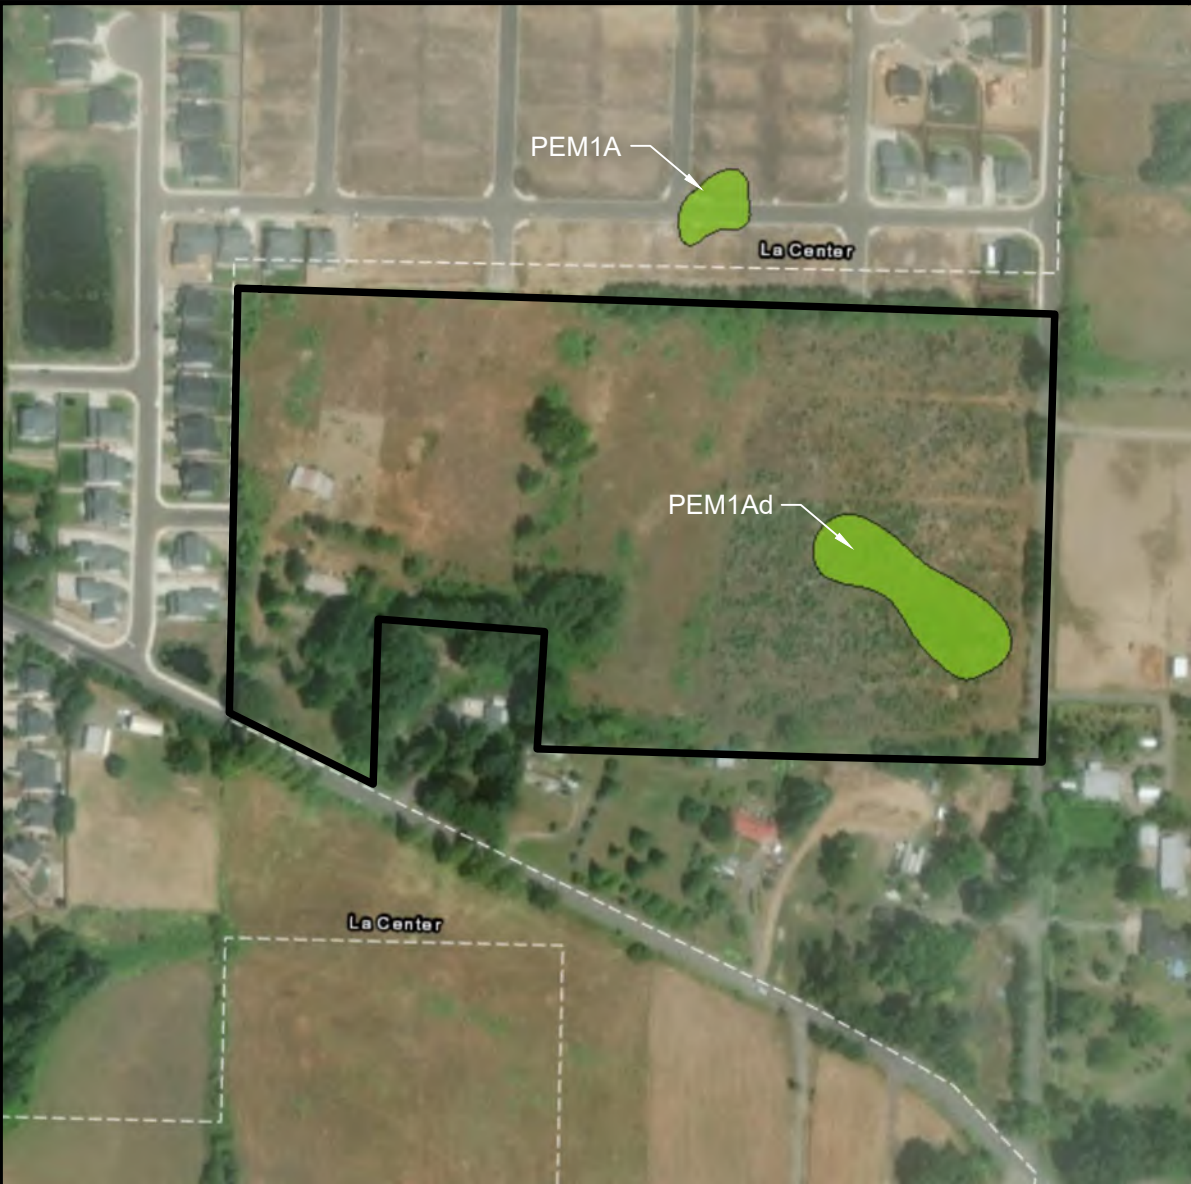
IN Wetland
NEAR: La Center
COUNTY: Clark
SHEET 6 OF 10
DATE: 3/24/21
STATE: WA

Mapped wetlands indicated onsite by US Fish & Wildlife Service.

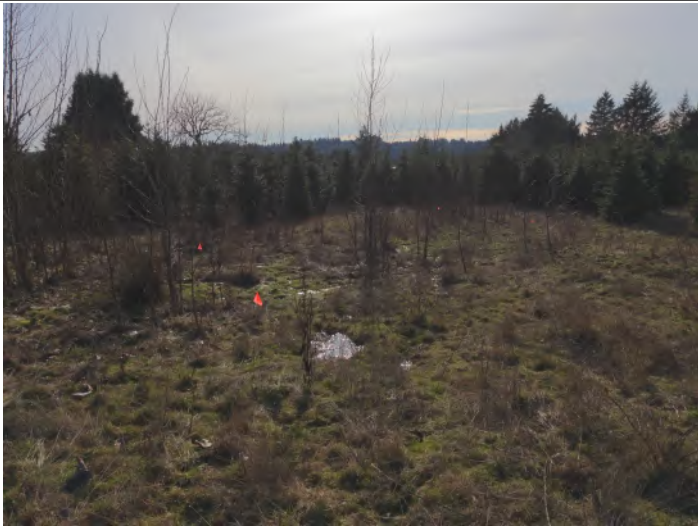
Photo 5. View facing southwest near TP-A1, within Wetland A. Nordmann firs can be seen outside the wetland boundary in background. Photo taken February 2021.

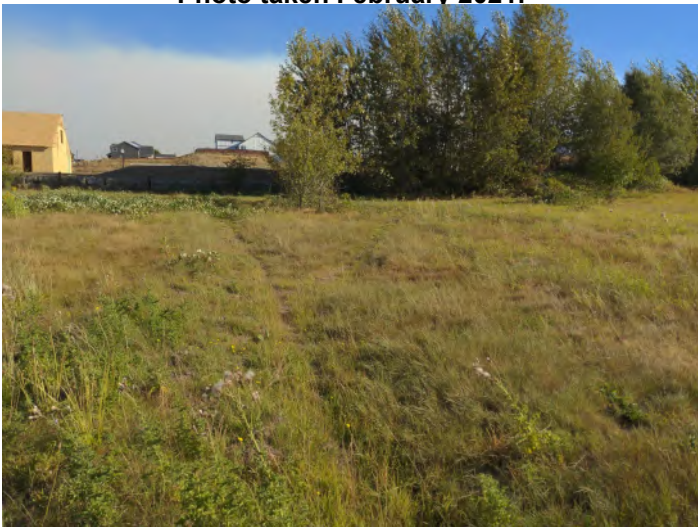
Photo 7. View facing north of tile location where Type Ns stream is mapped. Photo taken September 2020.

ELS biologists did not observed flowing water, nor any signs of a waterbody in the onsite mapped area onsite. According to *LCMC 18.300.030 Definitions*, “streams” are defined as “those areas where surface waters produce a defined channel or bed excluding streams and lakes regulated under the State Shorelines Management Act.” The presence of a stream can be indicated by either hydraulically sorted sediments or by the removal of vegetation from the action of moving water. Photos 7 and 8 show the onsite mapped area, which does not feature a channel, bed, bank, or signs of regular water flow, seasonal or otherwise. An ordinary high water mark (OHWM) could not be delineated because, although slight changes in topography were present, the area does not exhibit changes in vegetation or sediment. Test plots located along the mapped riparian area (TPs 3, 4, and 6) did not contain hydric soils, nor hydrologic indicators. Therefore, ELS has determined that the mapped stream does not meet stream criteria.

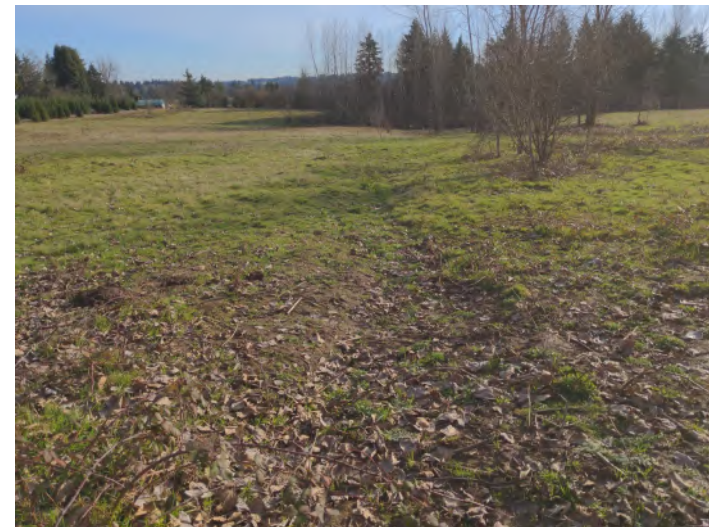
Photo 8. View facing south of tile location where Type Ns stream is mapped. Photo taken February 2021.

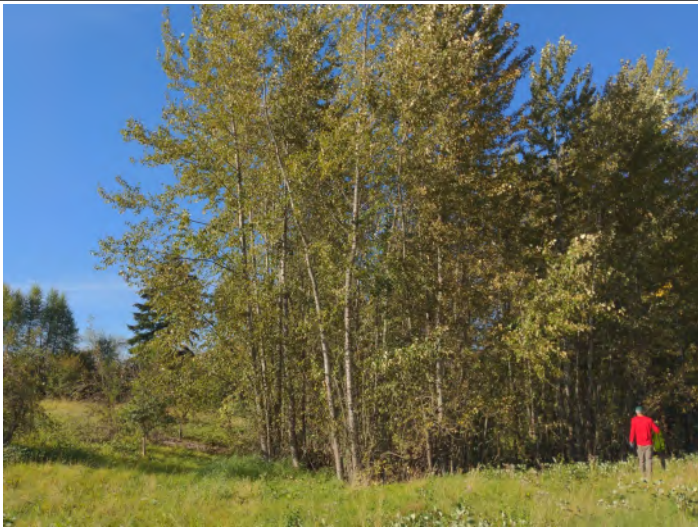
Photo 9. View of Wetland B facing south. Photo taken September 2020.

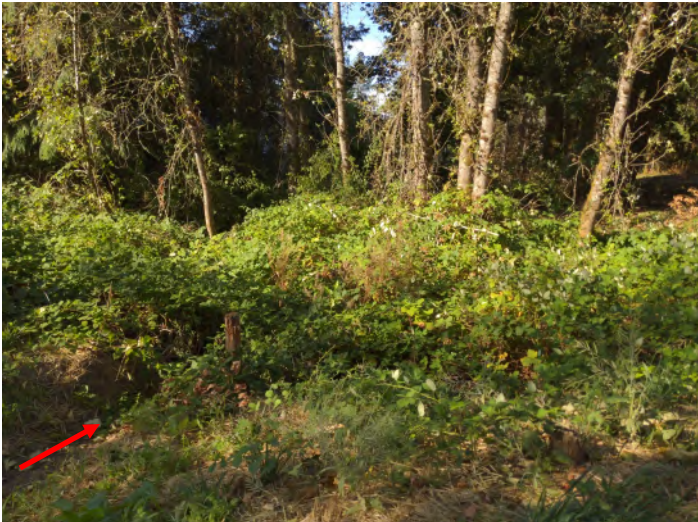
Photo 11. Seasonal drainage south of Wetland B. Arrow shows drainage path through blackberry bushes offsite. Photo taken September 2020.

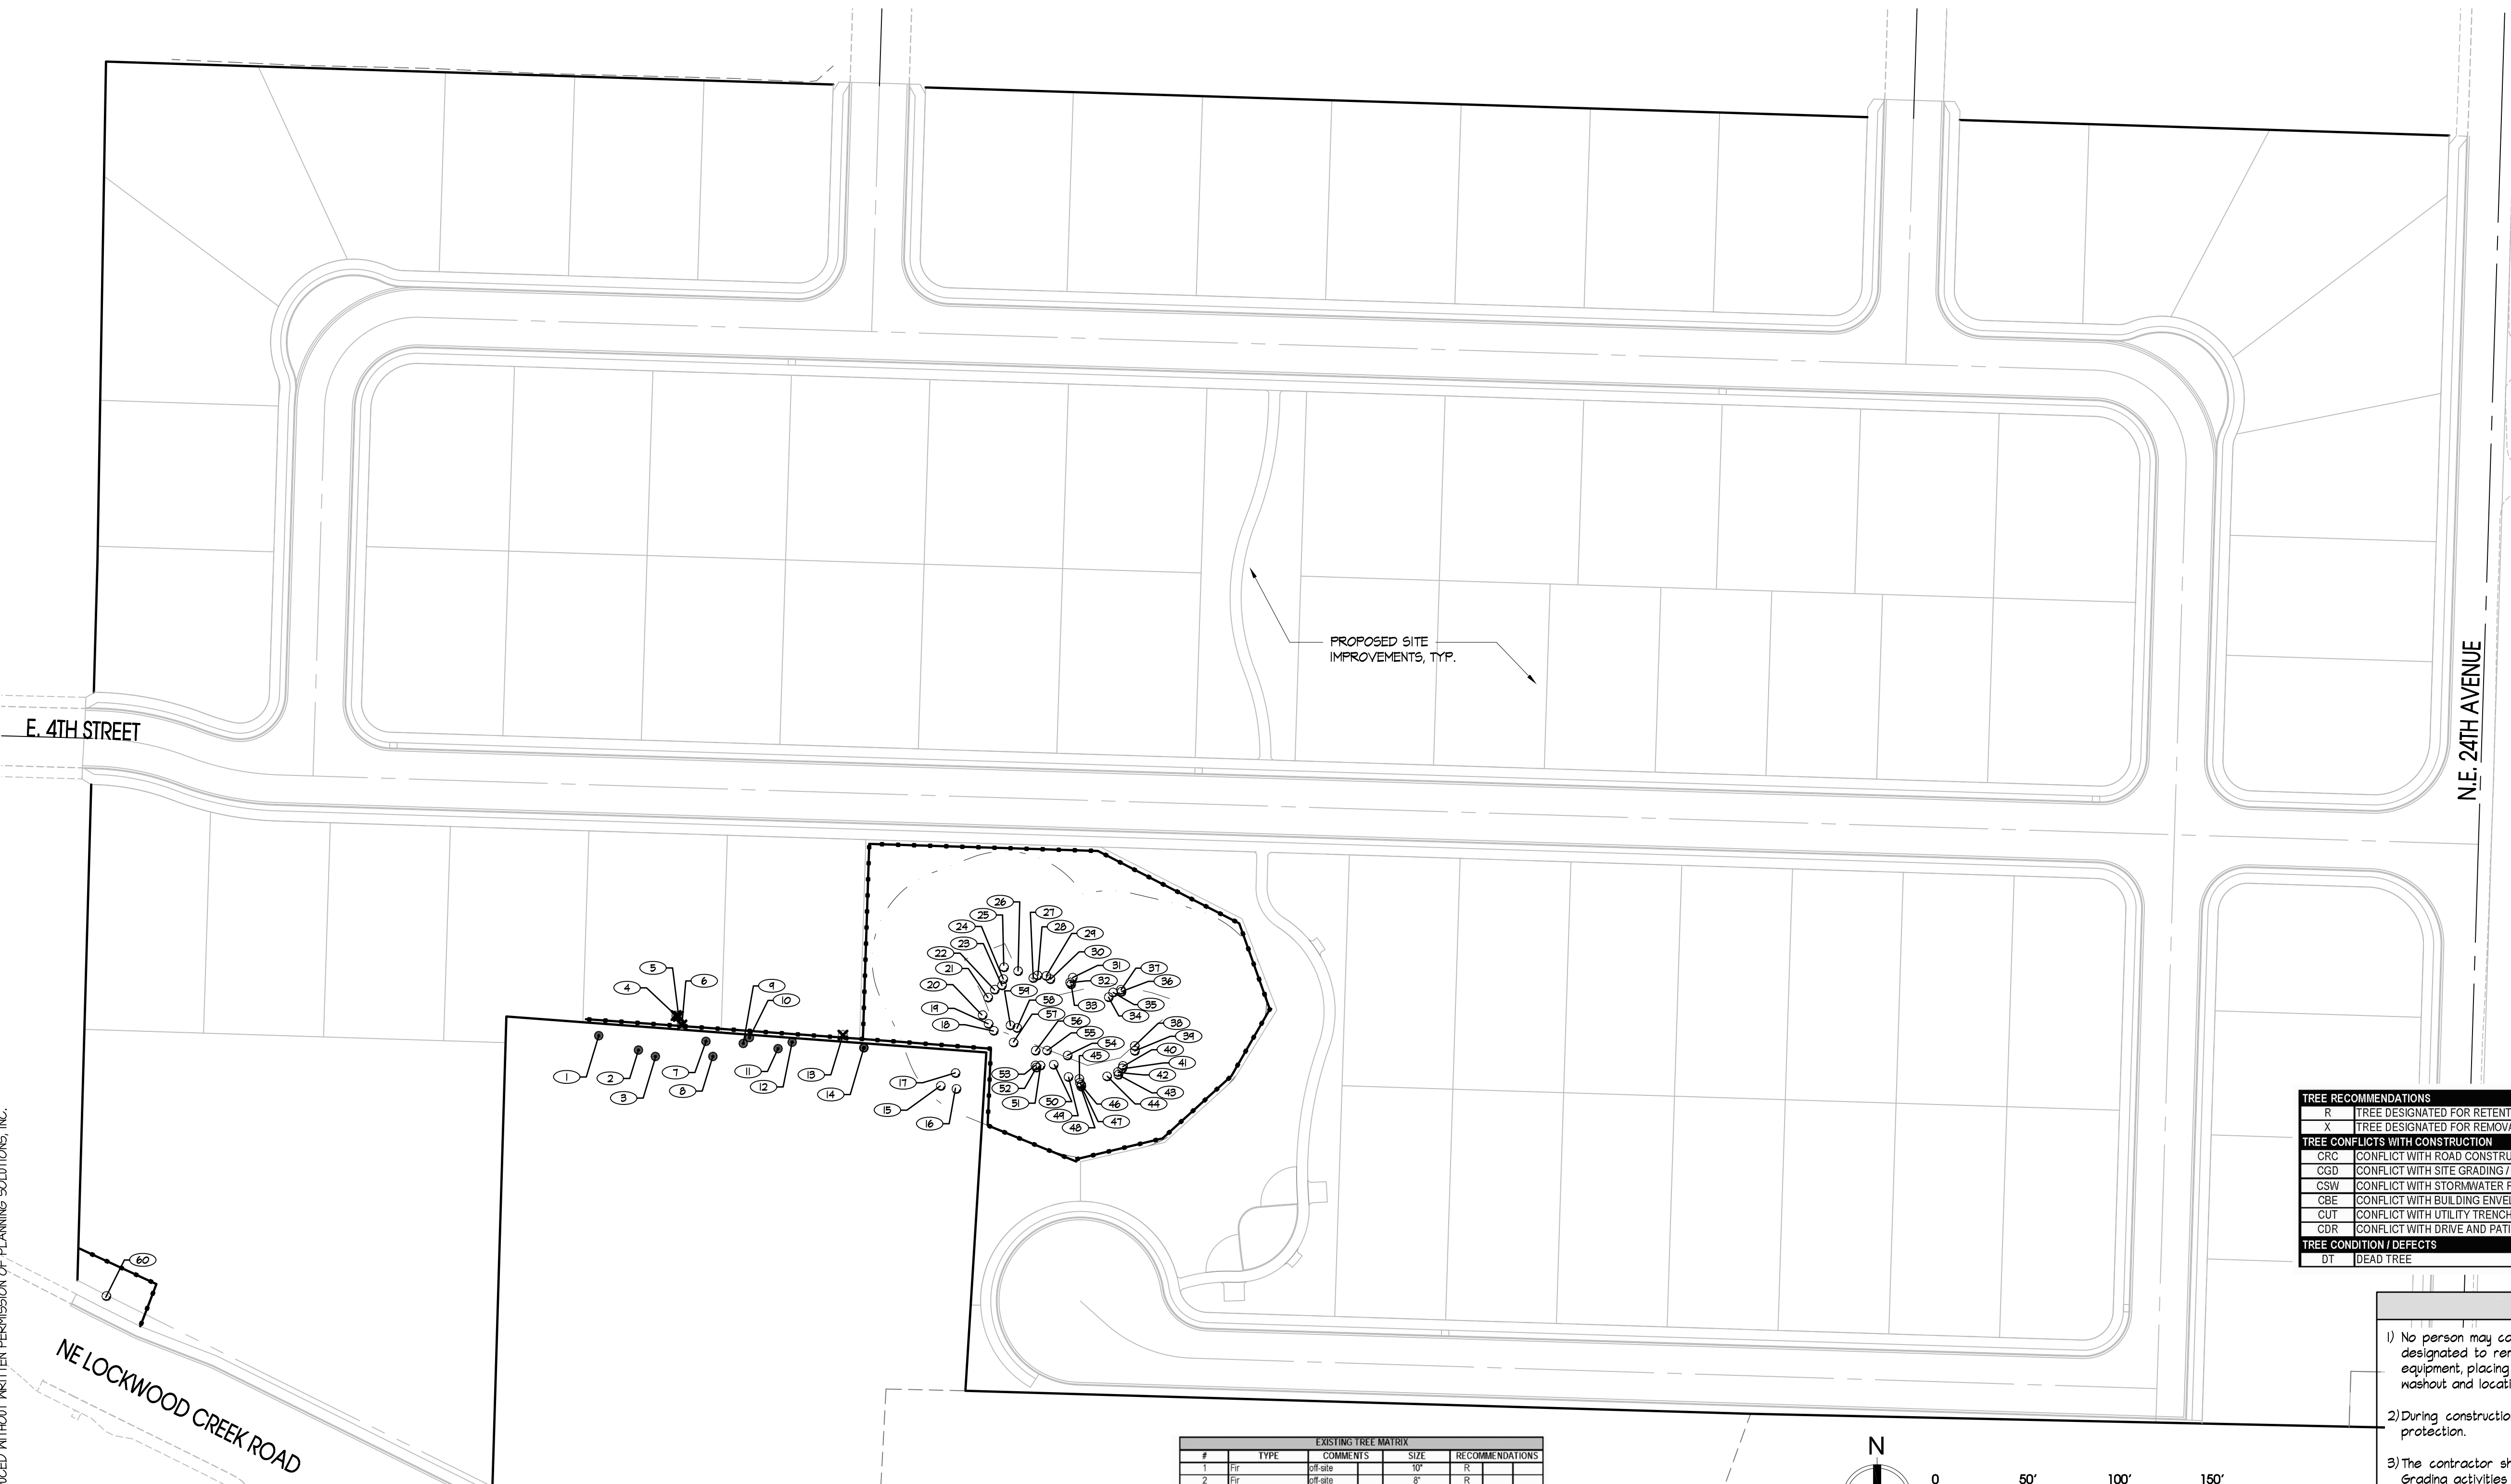
TREE RECOMMENDATIONS	
R	TREE DESIGNATED FOR RETENTION (RETAIN & PROTECT DURING CONSTRUCTION)
X	TREE DESIGNATED FOR REMOVAL
TREE CONFLICTS WITH CONSTRUCTION	
CRD	CONFLICT WITH ROAD CONSTRUCTION
CGD	CONFLICT WITH SITE GRADING / DRAINAGE
CSW	CONFLICT WITH STORMWATER FACILITY
CBE	CONFLICT WITH BUILDING ENVELOPE
CUT	CONFLICT WITH UTILITY TRENCH
CDR	CONFLICT WITH DRIVE AND PATIO LOCATION
TREE CONDITION / DEFECTS	
DT	DEAD TREE

- TREE PROTECTION NOTES**
- No person may conduct any of the following activities within the drip line of the trees designated to remain including, but not limited to: parking equipment, fueling, servicing equipment, placing solvents, storing building material and soil deposits, dumping concrete washout and locating burn holes.

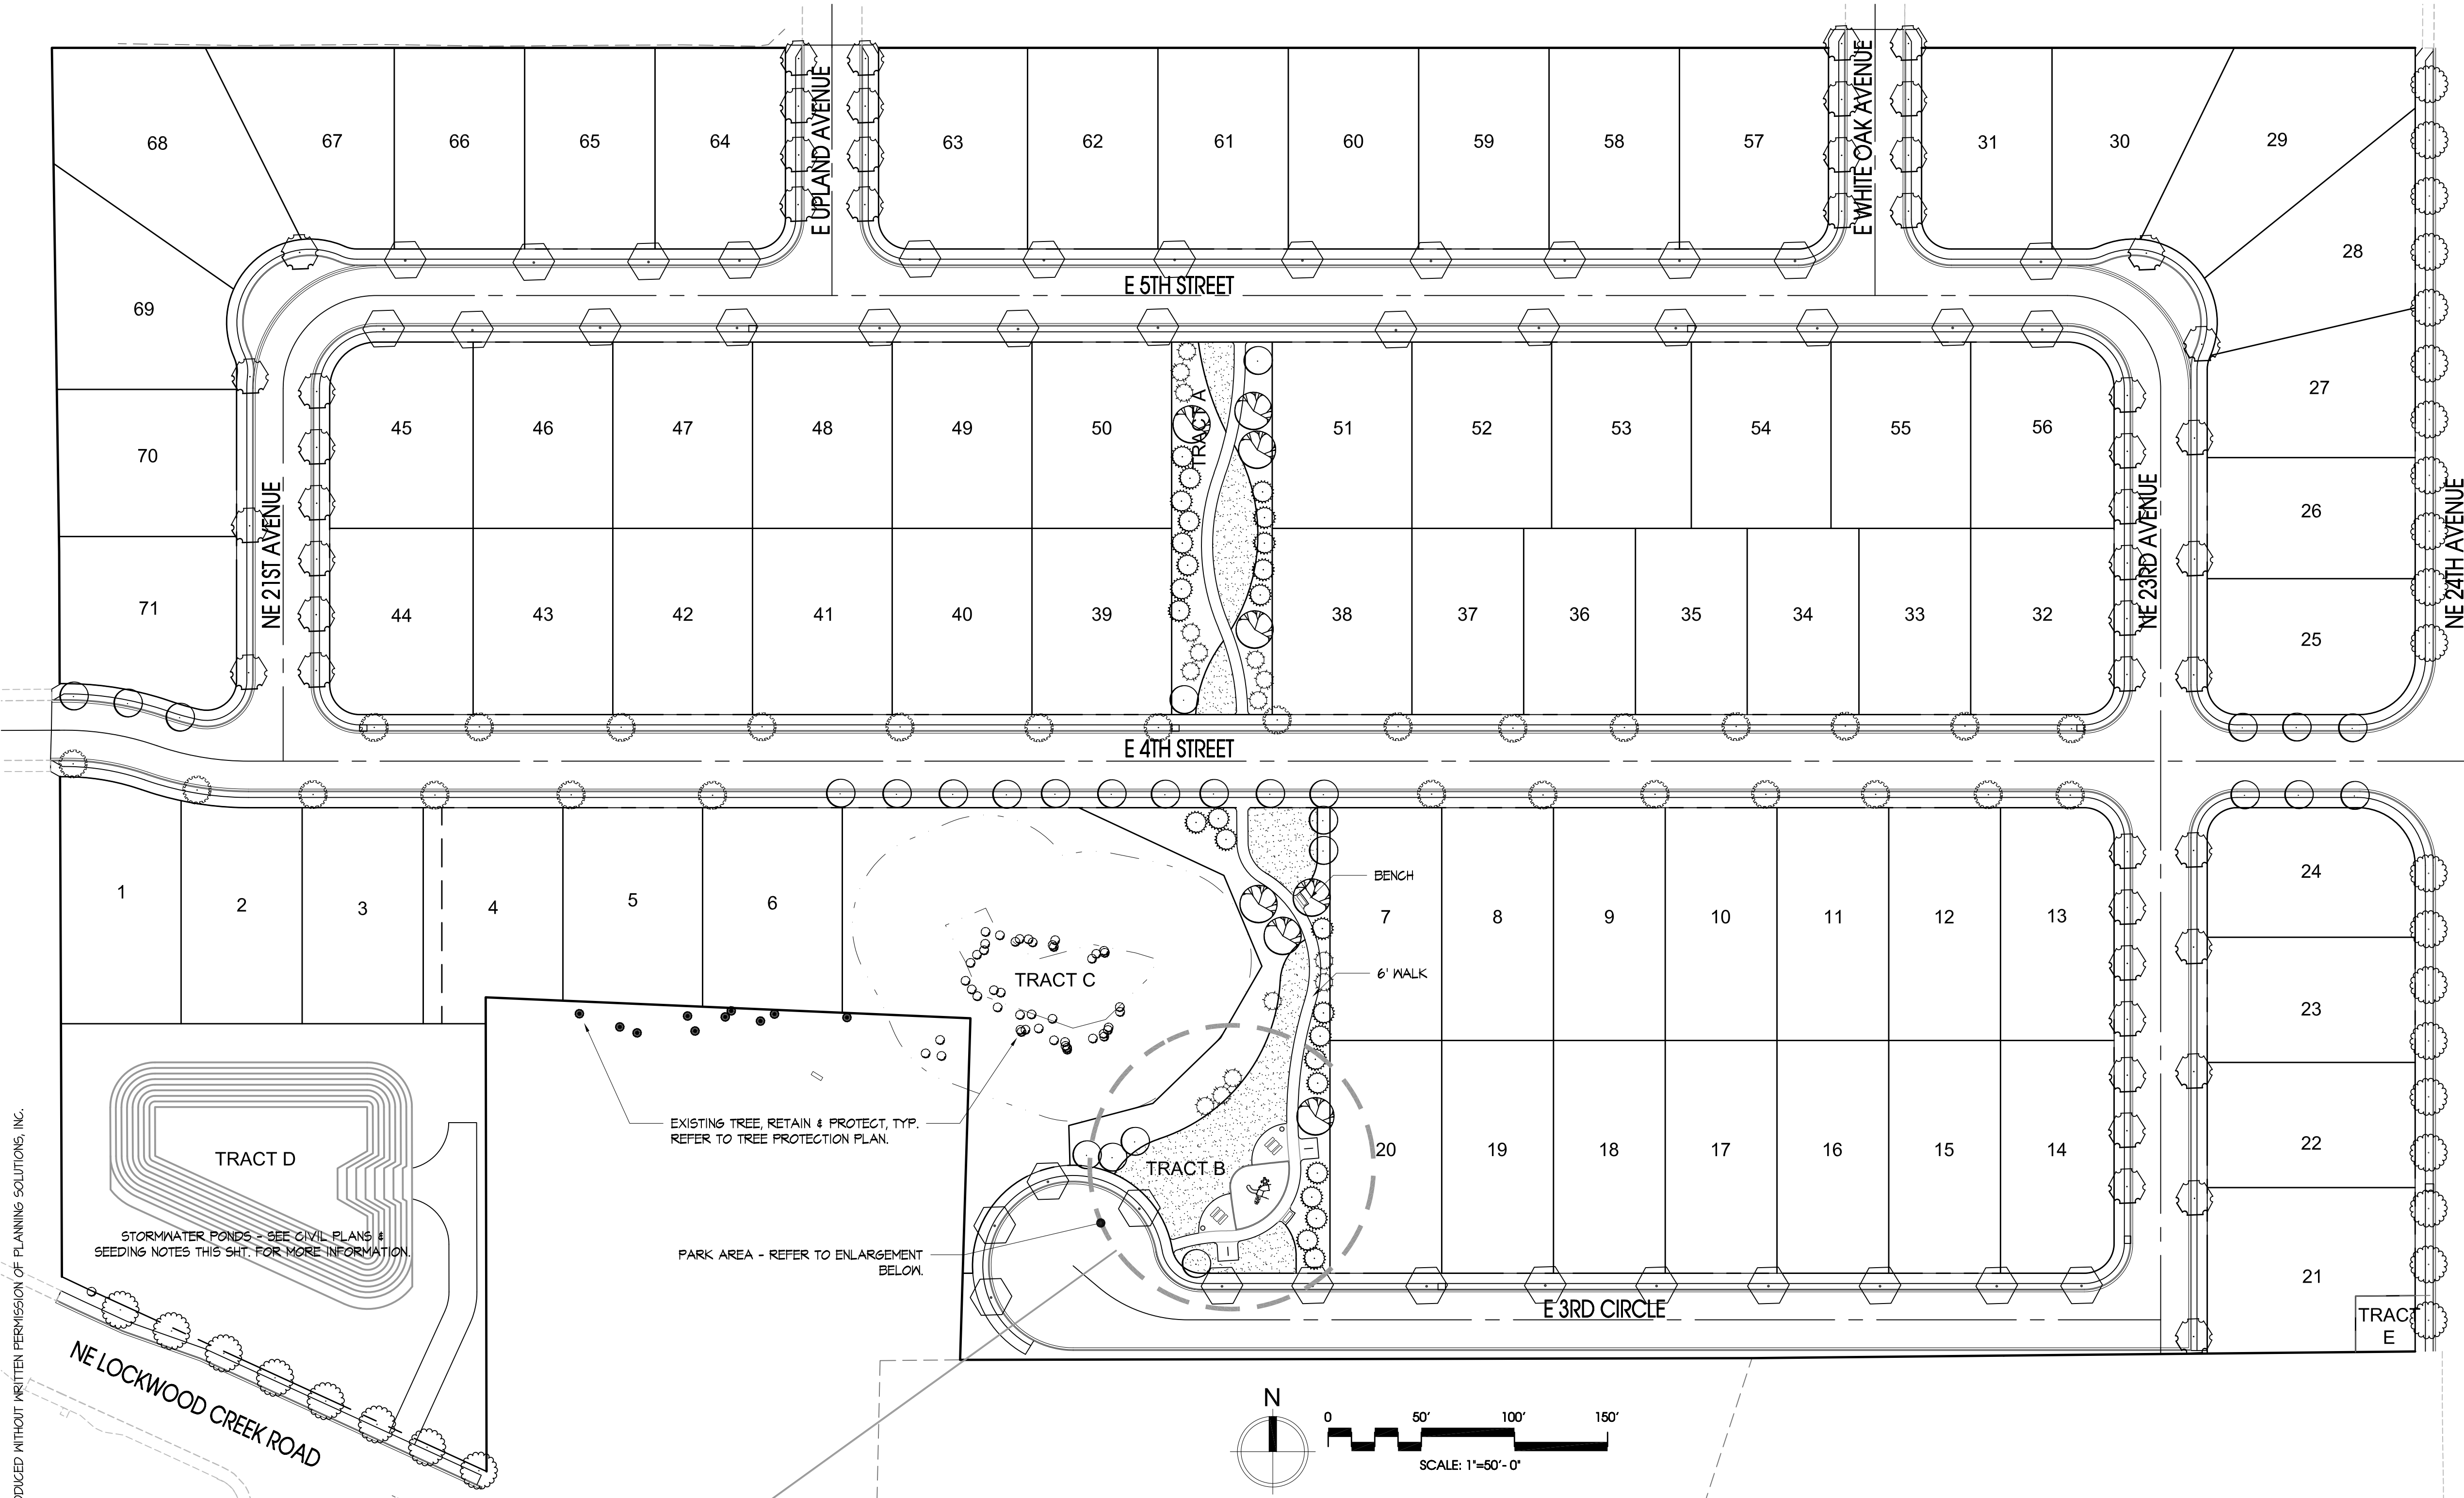
PRELIMINARY LANDSCAPE & PARK PLAN

PLANT LEGEND			
SYMBOL	BOTANICAL / COMMON NAME	SIZE	QTY
TREES			
	ACER RUBRUM 'ARMSTRONG' / ARMSTRONG MAPLE	2" Cal. Min.	44
	ACER RUBRUM 'RED SUNSET' / RED SUNSET MAPLE	2" Cal. Min.	28
	CALOCEDRUS DECURRENS / INCENSE CEDAR	6' ht. Min.	26
	CUPRESSUS NOOTKATENSIS / ALASKAN CEDAR	6' ht. Min.	15
	PARROTIA PERSICA / PERSIAN PARROTIA	2" Cal. Min.	28
	PYRUS CALLERYANA 'CAPITAL' / CAPITAL ORNAMENTAL PEAR	2" Cal. Min.	27
	TILIA CORDATA 'GREENSPIRE' / GREENSPIRE LINDEN	2" Cal. Min.	8
	ZELKOVA SERRATA / VILLAGE GREEN SELKOVA	2" Cal. Min.	34
SHRUBS			
FESTUCA GLAUGA / BLUE FESCUE			
ILEX X MESERVEAE 'BLUE BOY' / BLUE BOY HOLLY			
KALMIA LATIFOLIA 'ELF' / ELF MOUNTAIN LAUREL			
MAHONIA AQUIFOLIUM 'COMPACTA' / COMPACT OREGON GRAPE			
MISCANTHUS SINENSIS 'MORNING LIGHT' / MORNING LIGHT MAIDEN GRASS			
NANDINA DOMESTICA 'FIREPOWER' / FIREPOWER NANDINA			
NANDINA DOMESTICA 'MOONBAY' / MOONBAY NANDINA			
PIERIS JAPONICA 'CAVATINE' / CAVATINE PIERIS

PIERIS JAPONICA 'VARIEGATA' / VARIEGATED PIERIS			
PRUNUS LAUROCERASUS 'SCHIPKAENSIS' / SCHIPKA CHERRY LAUREL			
VIBURNUM DAVIDII / DAVID VIBURNUM			
GROUND COVER			
NO SYMBOL	ARCTOSTAPHYLOS UVA-URSI / KINKIKINICK (ALL PLANTER STRIPS)	1 GAL. Min.	36' O.C.
	TURF, DROUGHT RESISTANT, SUN & SHADE MIX (SEED OR SOD)
