CRITICAL AREAS REPORT

Juniper Ridge Subdivision

July 19, 2024

The information in this report was compiled to meet the requirements of the La Center Municipal Code (LCMC) Section 18.300.090.2 Fish and Wildlife Habitat Conservation Areas and Section 18.300.090.5 Wetlands. This report has been prepared under the supervision and direction of the undersigned, a qualified professional following LCMC 18.300.090.

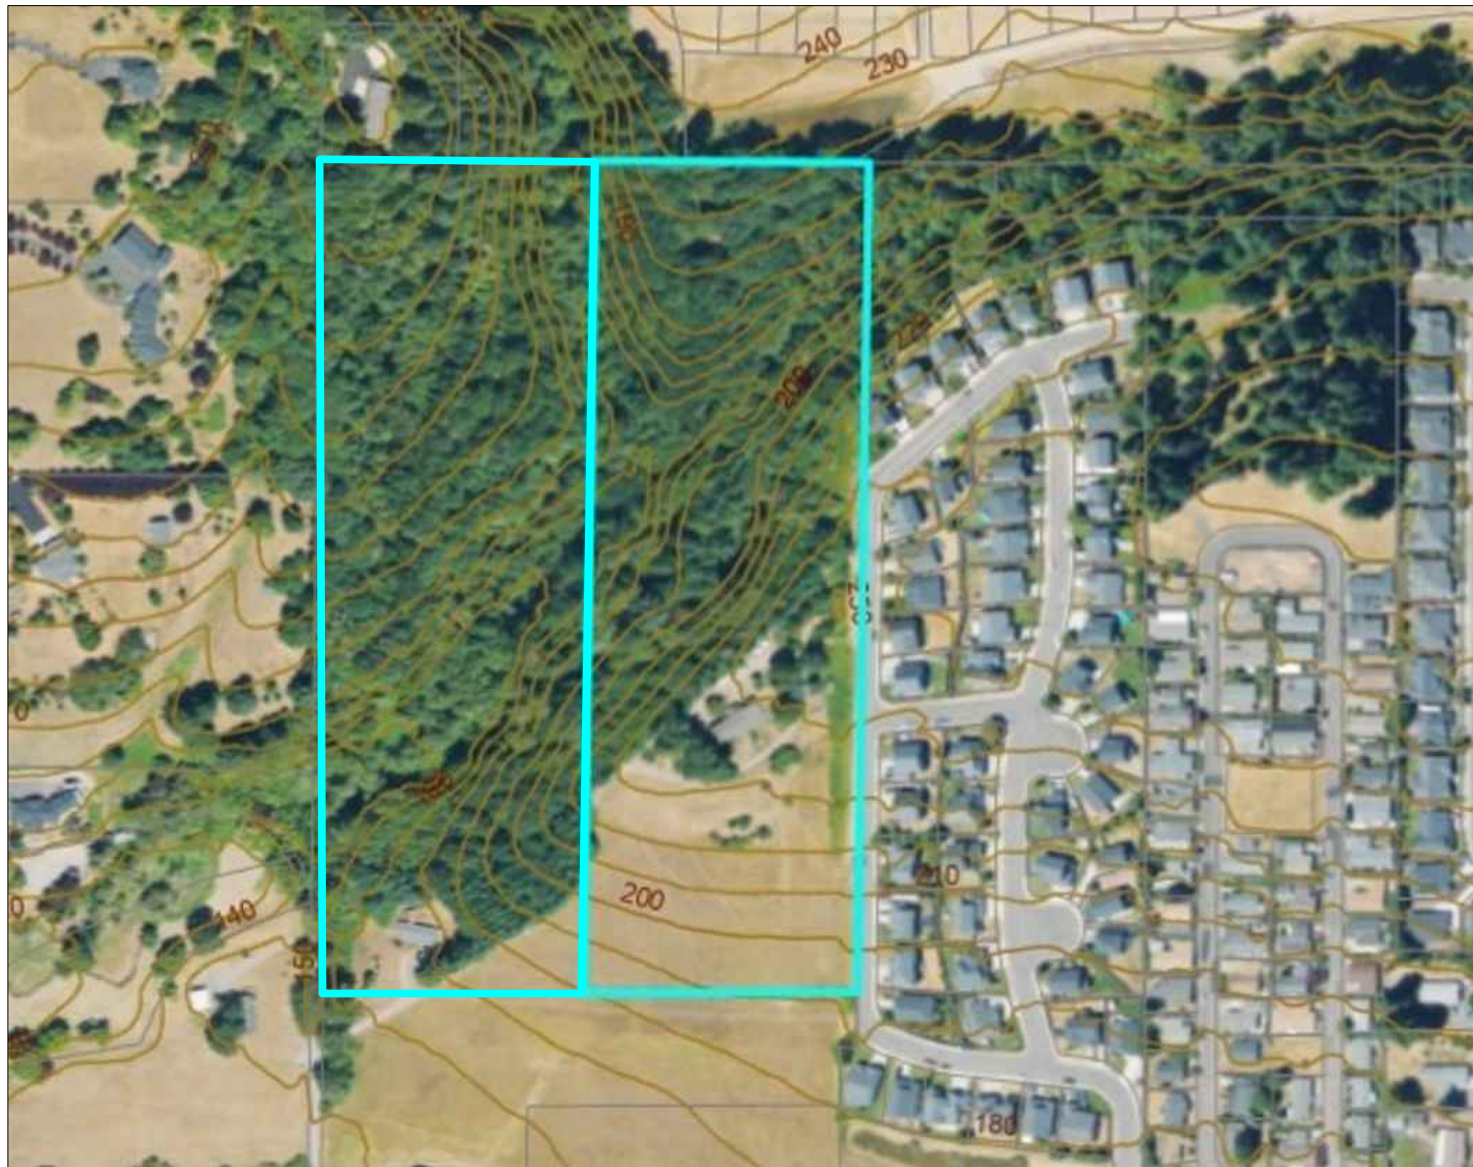
PROPOSED: XX
Add 2
IN: La Center
NEAR: XX
COUNTY: Clark **STATE:** WA
FIGURE: 2
DATE: 7-10-24

The site is highly constrained by critical areas due to steep slopes and the presence of a riparian habitat corridor within the central portion of the site. An unnamed stream, and riverine wetlands associated with the stream, bisect the site from northeast to southwest, with only the far south-southeastern limits of the site located outside of critical area constraints. The northern limits of the site sits at approximately 250 feet in elevation, with the lowest point near the southwest corner site at approximately 150 feet in elevation, Figure 2.

AERIAL PHOTO & TOPO MAP

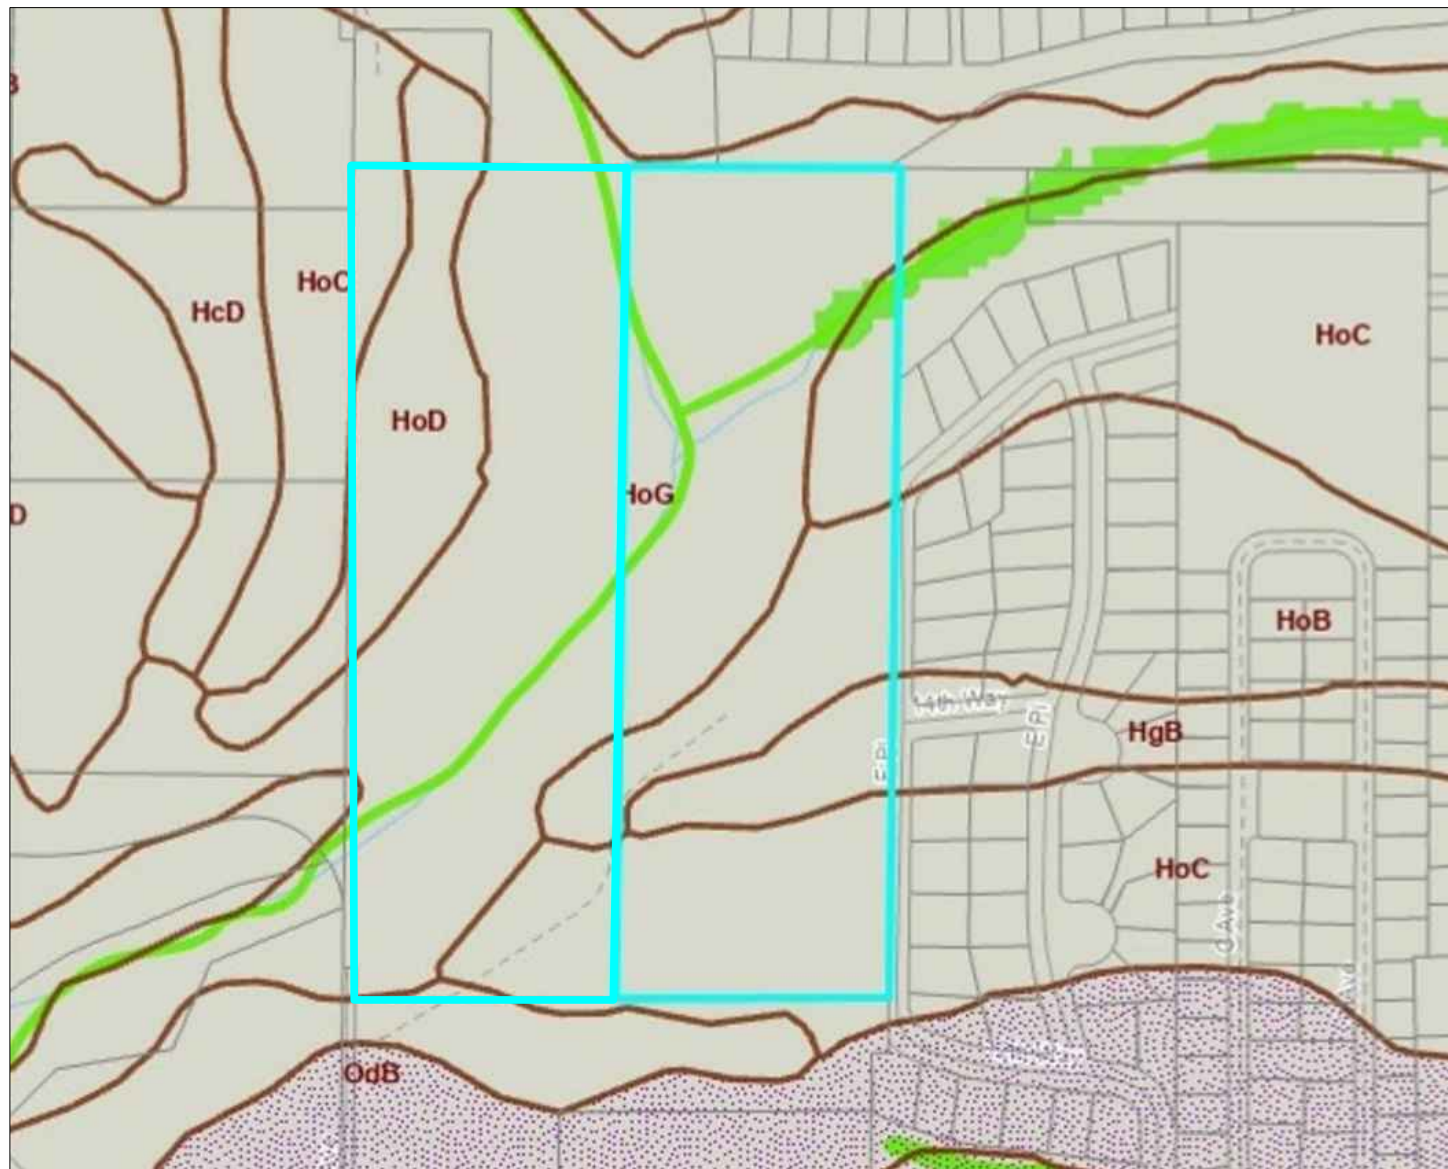
PROPOSED: XX
Add 2
IN: La Center
NEAR: XX
COUNTY: Clark **STATE:** WA
FIGURE: 3
DATE: 7-10-24

percent slopes (HoC), Hillsboro silt loam, 15-20 percent slopes (HoD), Hillsboro silt loam, 30-65 percent slopes (HoG), and Hesson gravelly clay loam, 0-8 percent slopes (HgB), Figure 3.

“Potential wetland presence” associated with the onsite unnamed stream in the central portion of the subject site is mapped by the Clark County Geographic Information Systems (GIS) website, Figure 3.

**SOIL SURVEY &
NATIONAL WETLANDS INVENTORY MAP**
APPLICANT: TD West LLC
PROJECT NAME: Juniper Ridge Subdivision
PARCEL #: 258944000, 258945000
SITE LOCATION ADDRESS:
34017 NW 9th Ave.

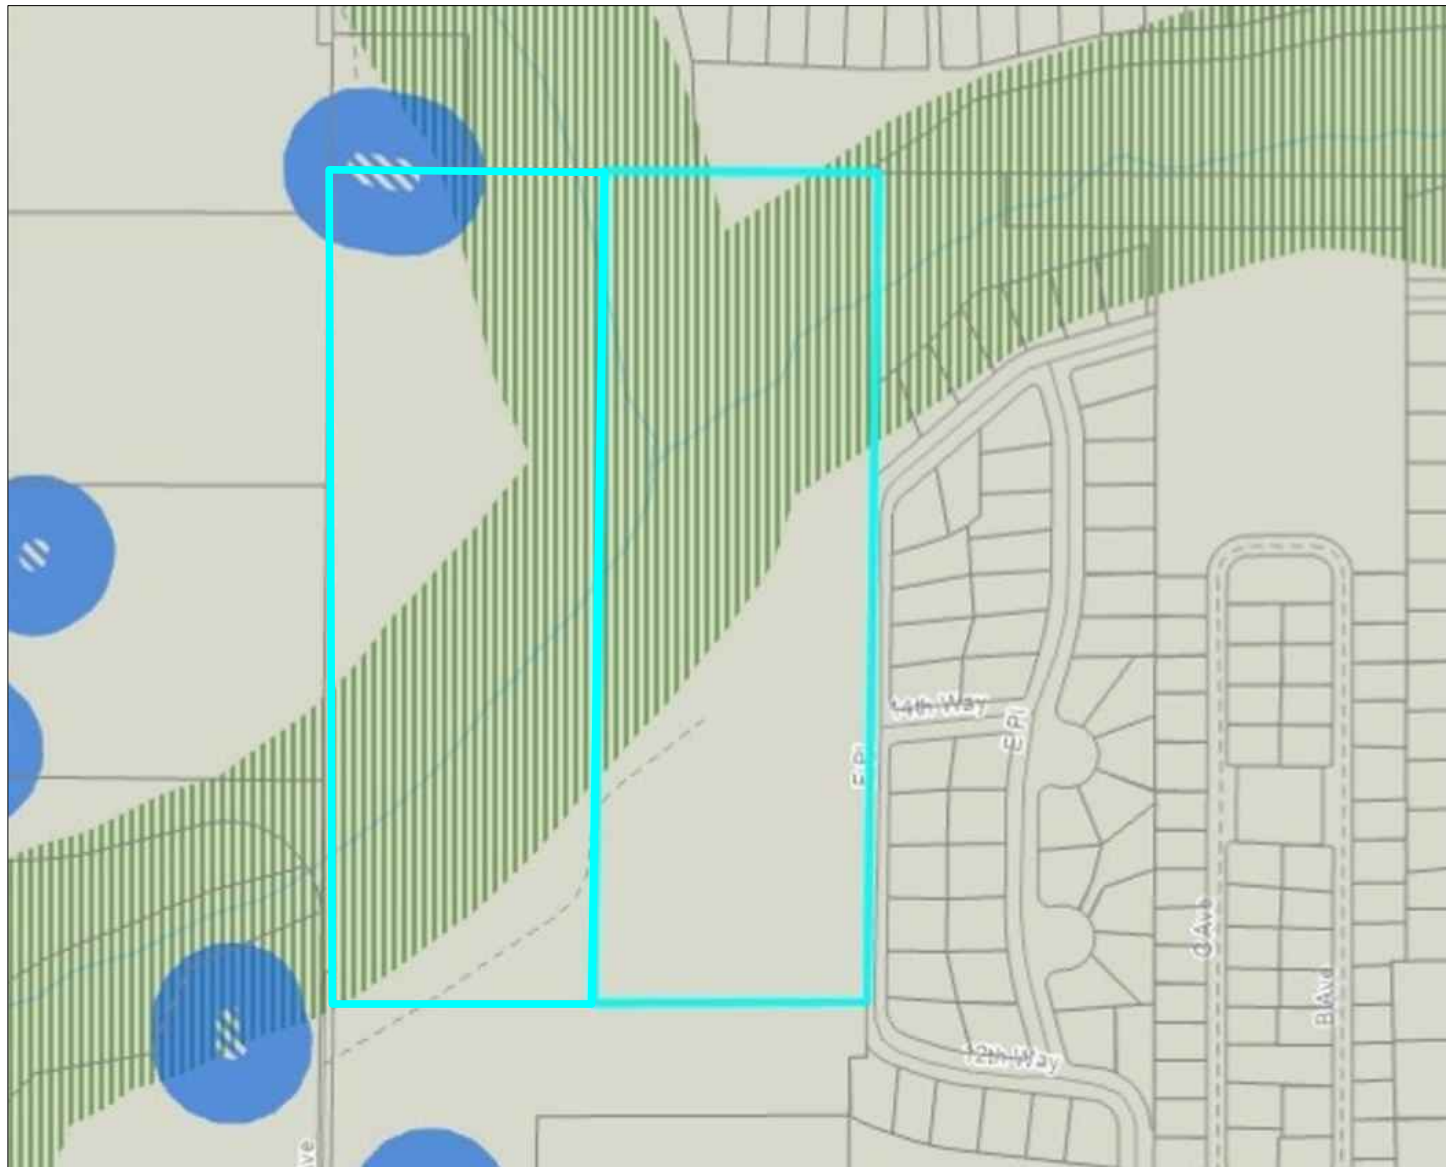
FIGURE: 5

The Washington Department of Fish and Wildlife (WDFW) maps the presence of an Oregon white oak directly offsite from the far northwest corner of the subject site, Figure 5. The project is not located within the vicinity of the mapped oak and no other Oregon white oaks were identified onsite within the limits of the project by AES.

PRIORITY HABITAT MAP

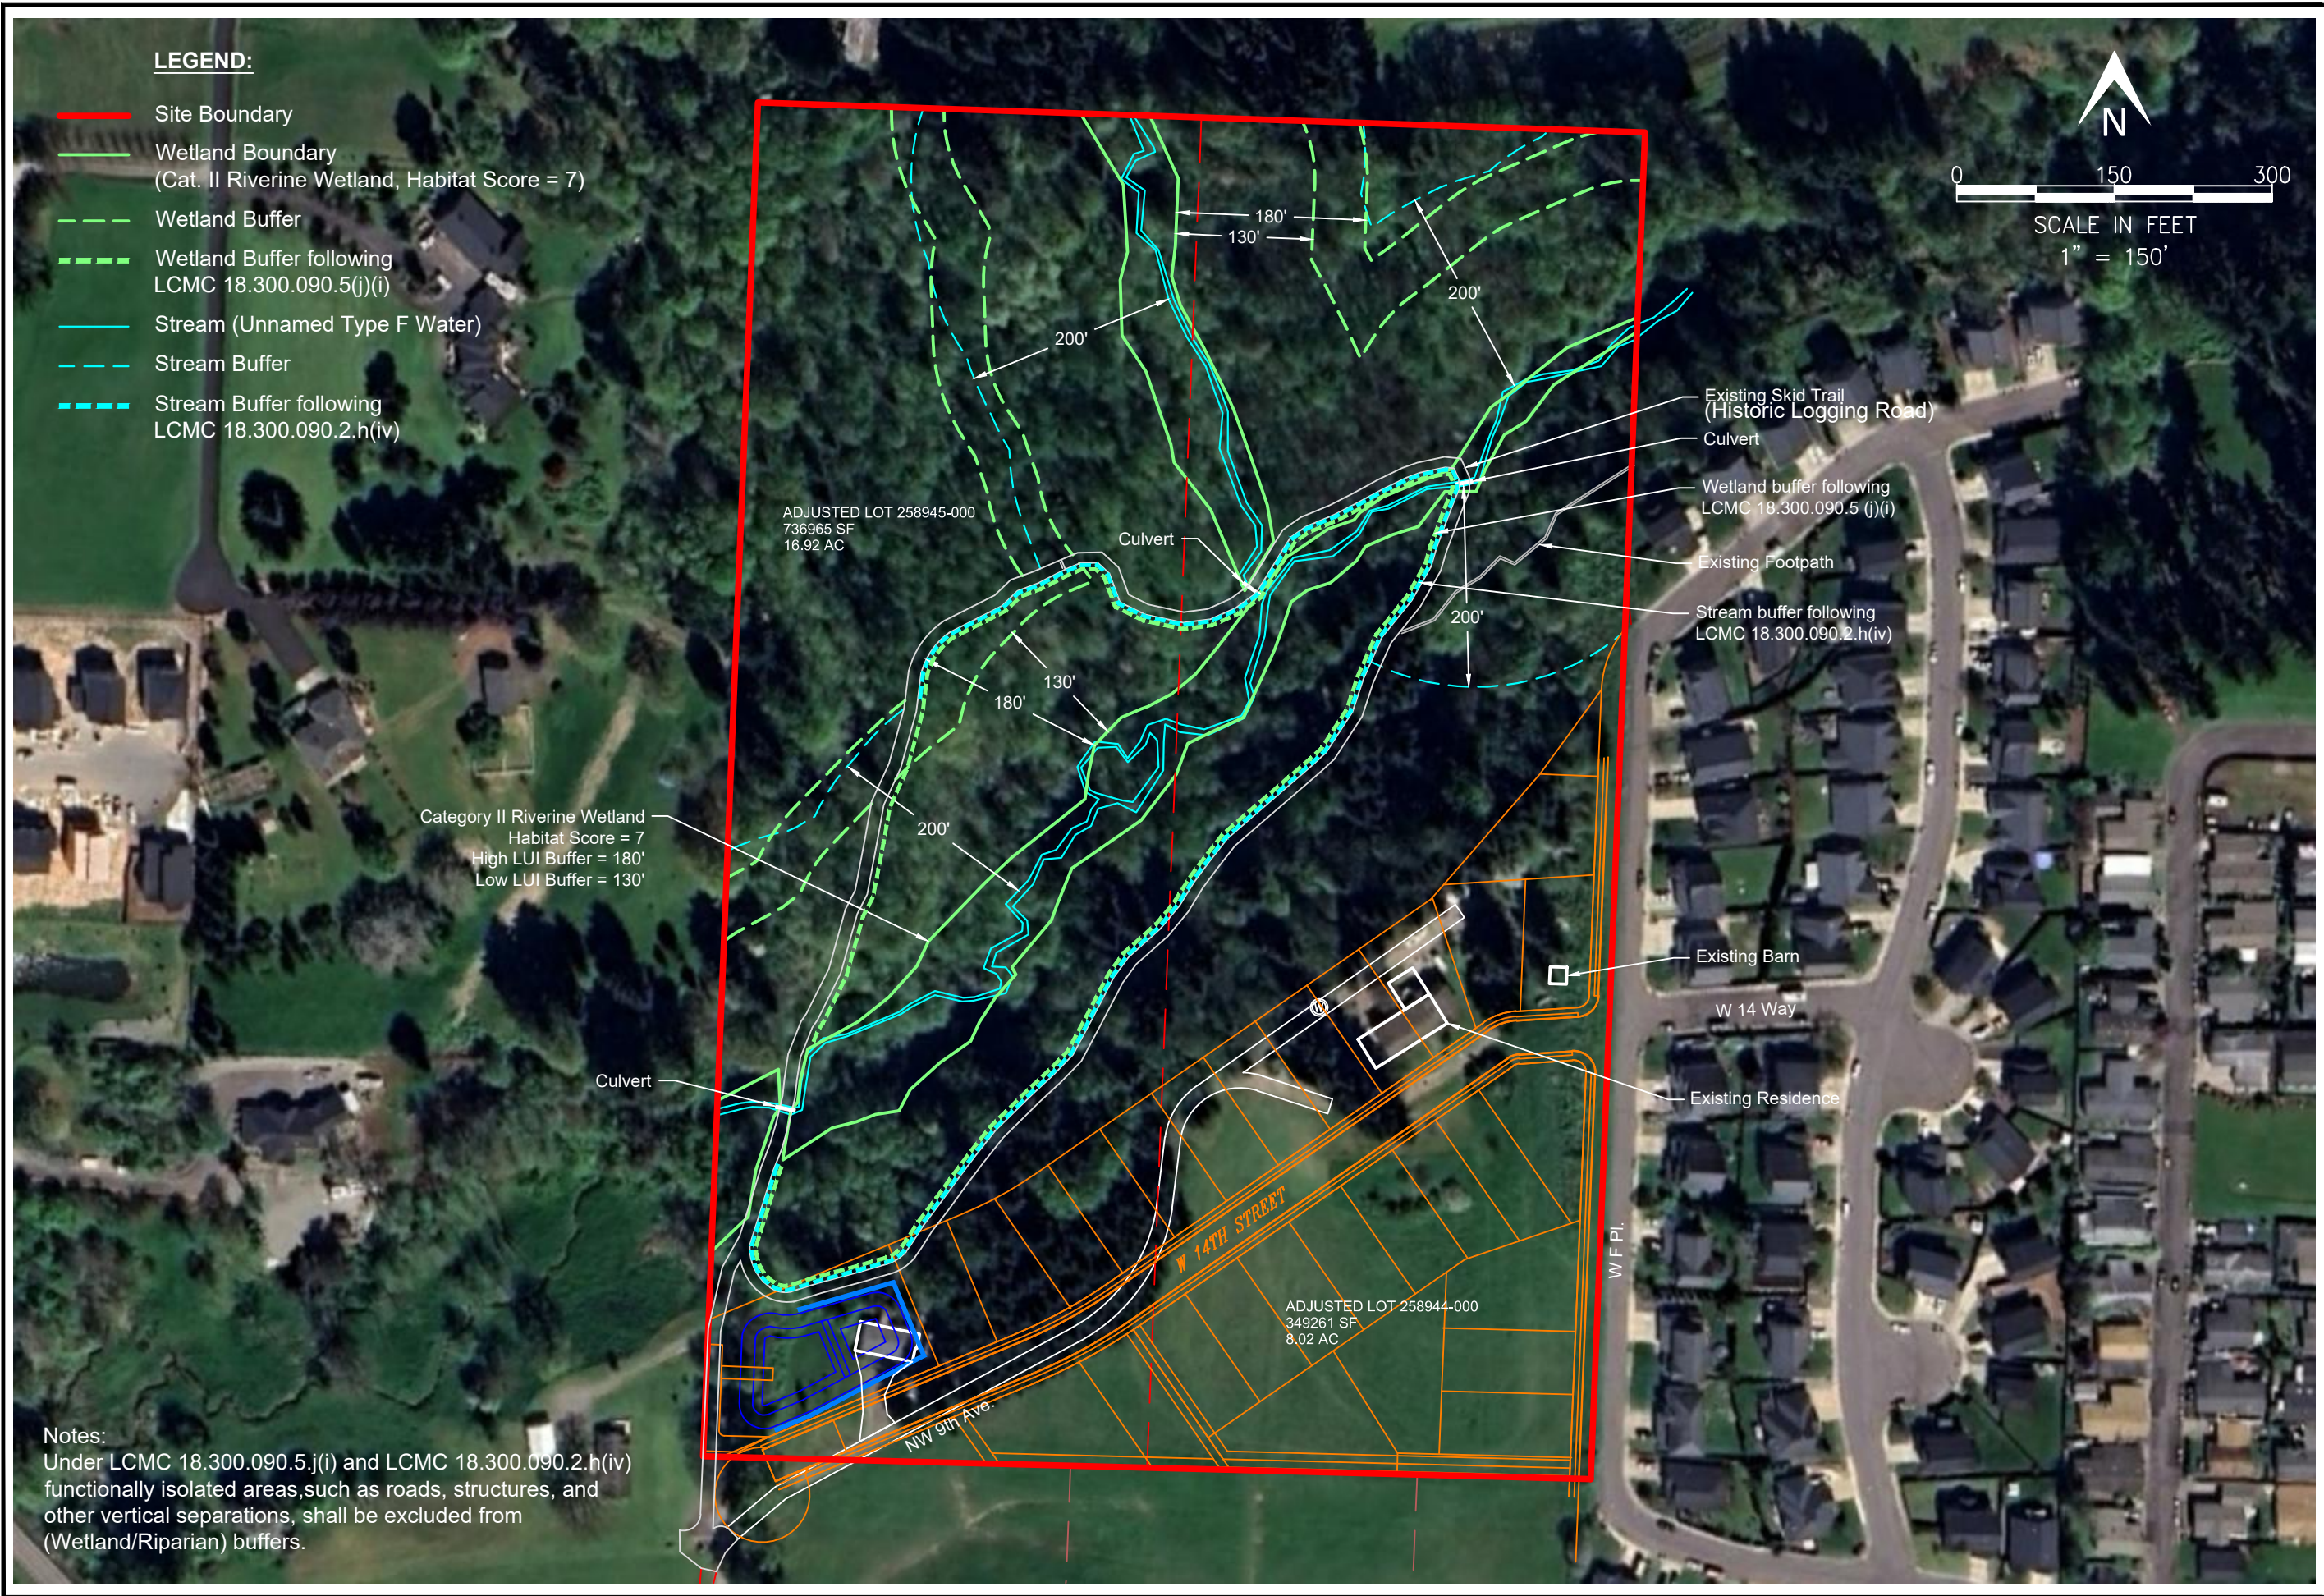
| PURPOSE: XX Line 1 Line 2 | PROPOSED SITE PLAN | PROPOSED: XX Add 2 |

Following LCMC 18.300.090.5.j(i), functionally isolated buffer areas, such as roads, structures, and other vertical separations, shall be excluded from wetland buffers. Due to existing vertical separations in slope and the presence of the old logging road, portions of the onsite wetland buffer will stop at the inner (waterward) edge of road, Figures 6 and 7.

Following 18.300.090.2.h(iv) the buffer of a stream shall not extend landward beyond an existing substantial improvement such as an improved road, dike, levee, or a permanent structure which reduces the impact proposed activities would have on the river or stream. Due to the presence of the old logging road, portions of the onsite riparian buffer will stop at the inner (waterward) edge of road, Figures 6 and 7.

The subject site is highly constrained due to critical areas and steep slopes that surround the riparian corridor where the unnamed stream and associated wetlands are located, Figure 6. The proposed project avoids direct impacts to the highest functioning wetland and riparian habitat located within the central portion of the site, and preservation of this habitat corridor. The project has also been designed to avoid new impacts to the onsite wetland and riparian buffer habitat. The project footprint has been located outside of the onsite critical areas and utilizes the historically impacted areas within the far southeast portion of the site. The historically impacted areas include existing building footprints, gravel parking and driveway areas, maintained lawn areas, a small Douglas-fir tree plantation and the open agriculture field that has been highly managed over the history of the site.
