CRITICAL AREAS REPORT & MITIGATION PLAN

Vineyard Vista Subdivision (2022-039-PAC)

Tax Parcels 63472945 & 258903000

Date: April 3, 2024

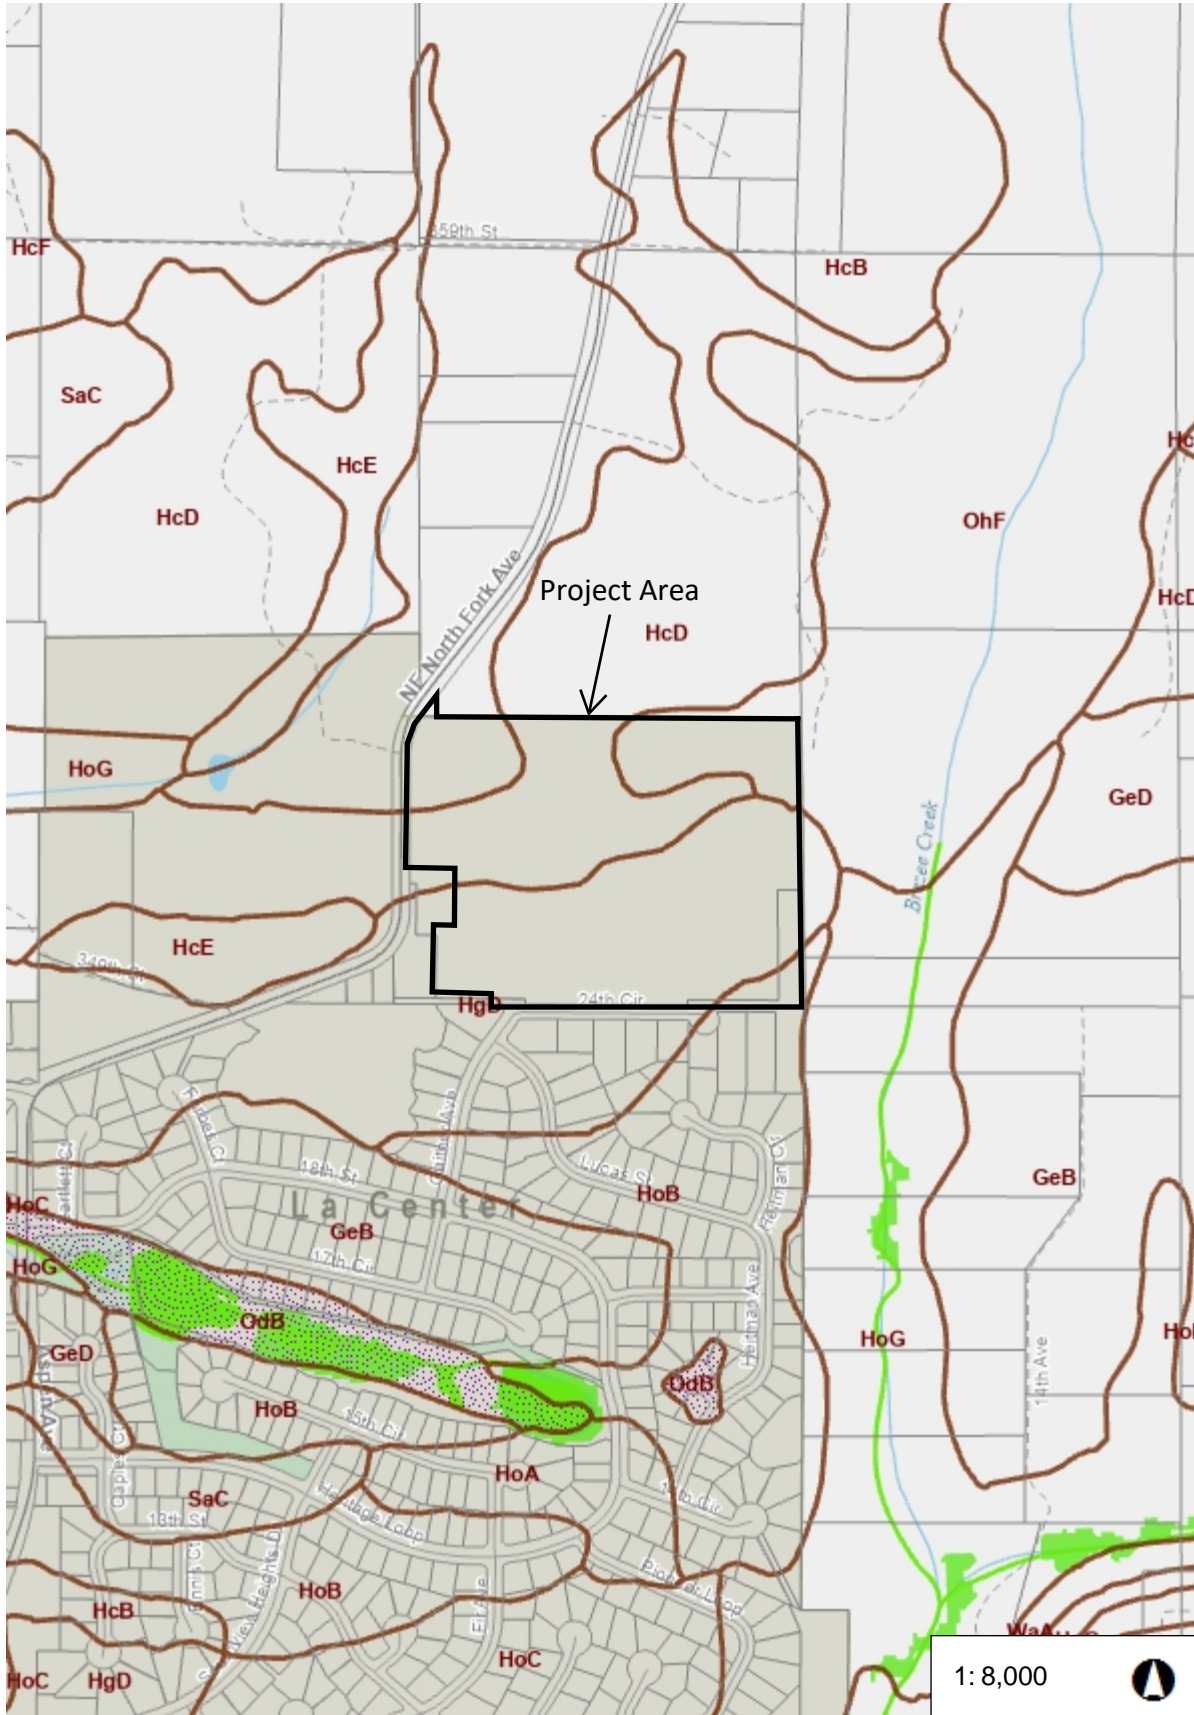
Figure 2 of 5. Soils and Wetlands Inventory
 Critical Areas Report & Mitigation Plan
 Project: Vineyard Vista Subdivision

The presence of critical areas was assessed by traversing the property on foot. Observation of vegetation, hydrology, and soils in conjunction with data from National Wetland Inventory maps of the U.S. Fish and Wildlife Service (USFWS, 2023), the USDA NRCS Web Soil Survey (USDA, 2023), and aerial photos were used to determine the presence of wetlands or streams.

The presence or non-presence of wetlands were determined by using the Routine Determination Methodology of the Corps of Engineers Wetland Delineation Manual: Western Mountains, Valleys, and Coast Region (USACE, 2010). Observed dominant vegetation on the site is listed in Appendix C Table 1.

The NRCS Web Soil Survey indicates the following soil types on the property:

During the site visit, no areas that meet the three criteria (hydrophytic vegetation, hydric soils, and hydrology) required to make a wetland determination were observed.

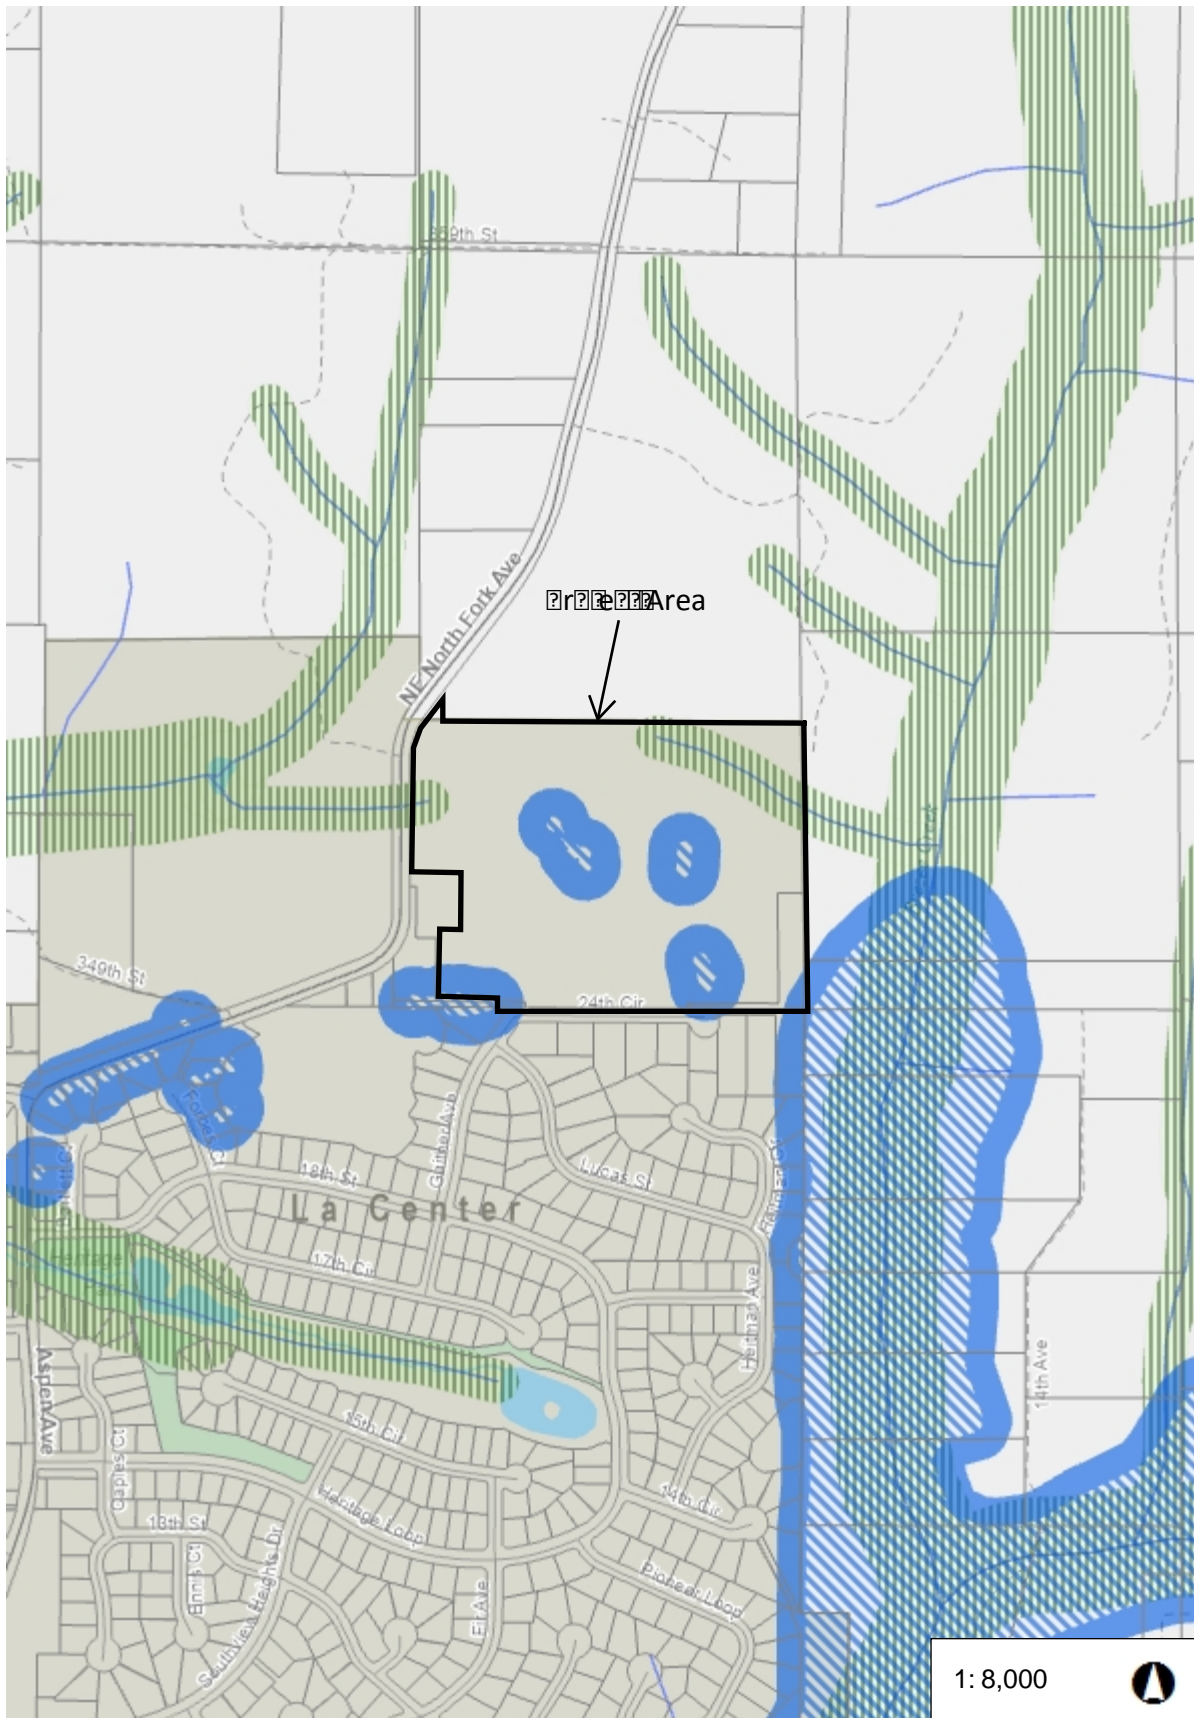
Figure 3 of 5. Priority Habitat and Species Group/Water Features
 Critical Areas Report & Mitigation Plan
 Project: Vineyard Vista Subdivision

The Clark County GIS shows two mapped DNR water features on the project area as shown on Figure 3. The west feature was not found to exist on site and is likely a mapping error based on

mapped site topographic contours. The DNR Type Ns mapped stream in the northeast quadrant of the site was observed to be accurate. This stream is within a forested ravine in the northeast part of the study area. During the 2018 site visit, the streambed consisted of dry rock cobble. The width of the stream channel is between one and two feet on average. The stream is a tributary to Breeze Creek which is off-site to the east. Because this stream is seasonal, it would require a 75-foot riparian ecosystem area buffer (Type Ns, high mass wasting potential - seasonal stream with a defined channel) per LCMC Table 18.300.090(2)(f). This buffer will also be referenced as “stream buffer” throughout the remainder of this report.

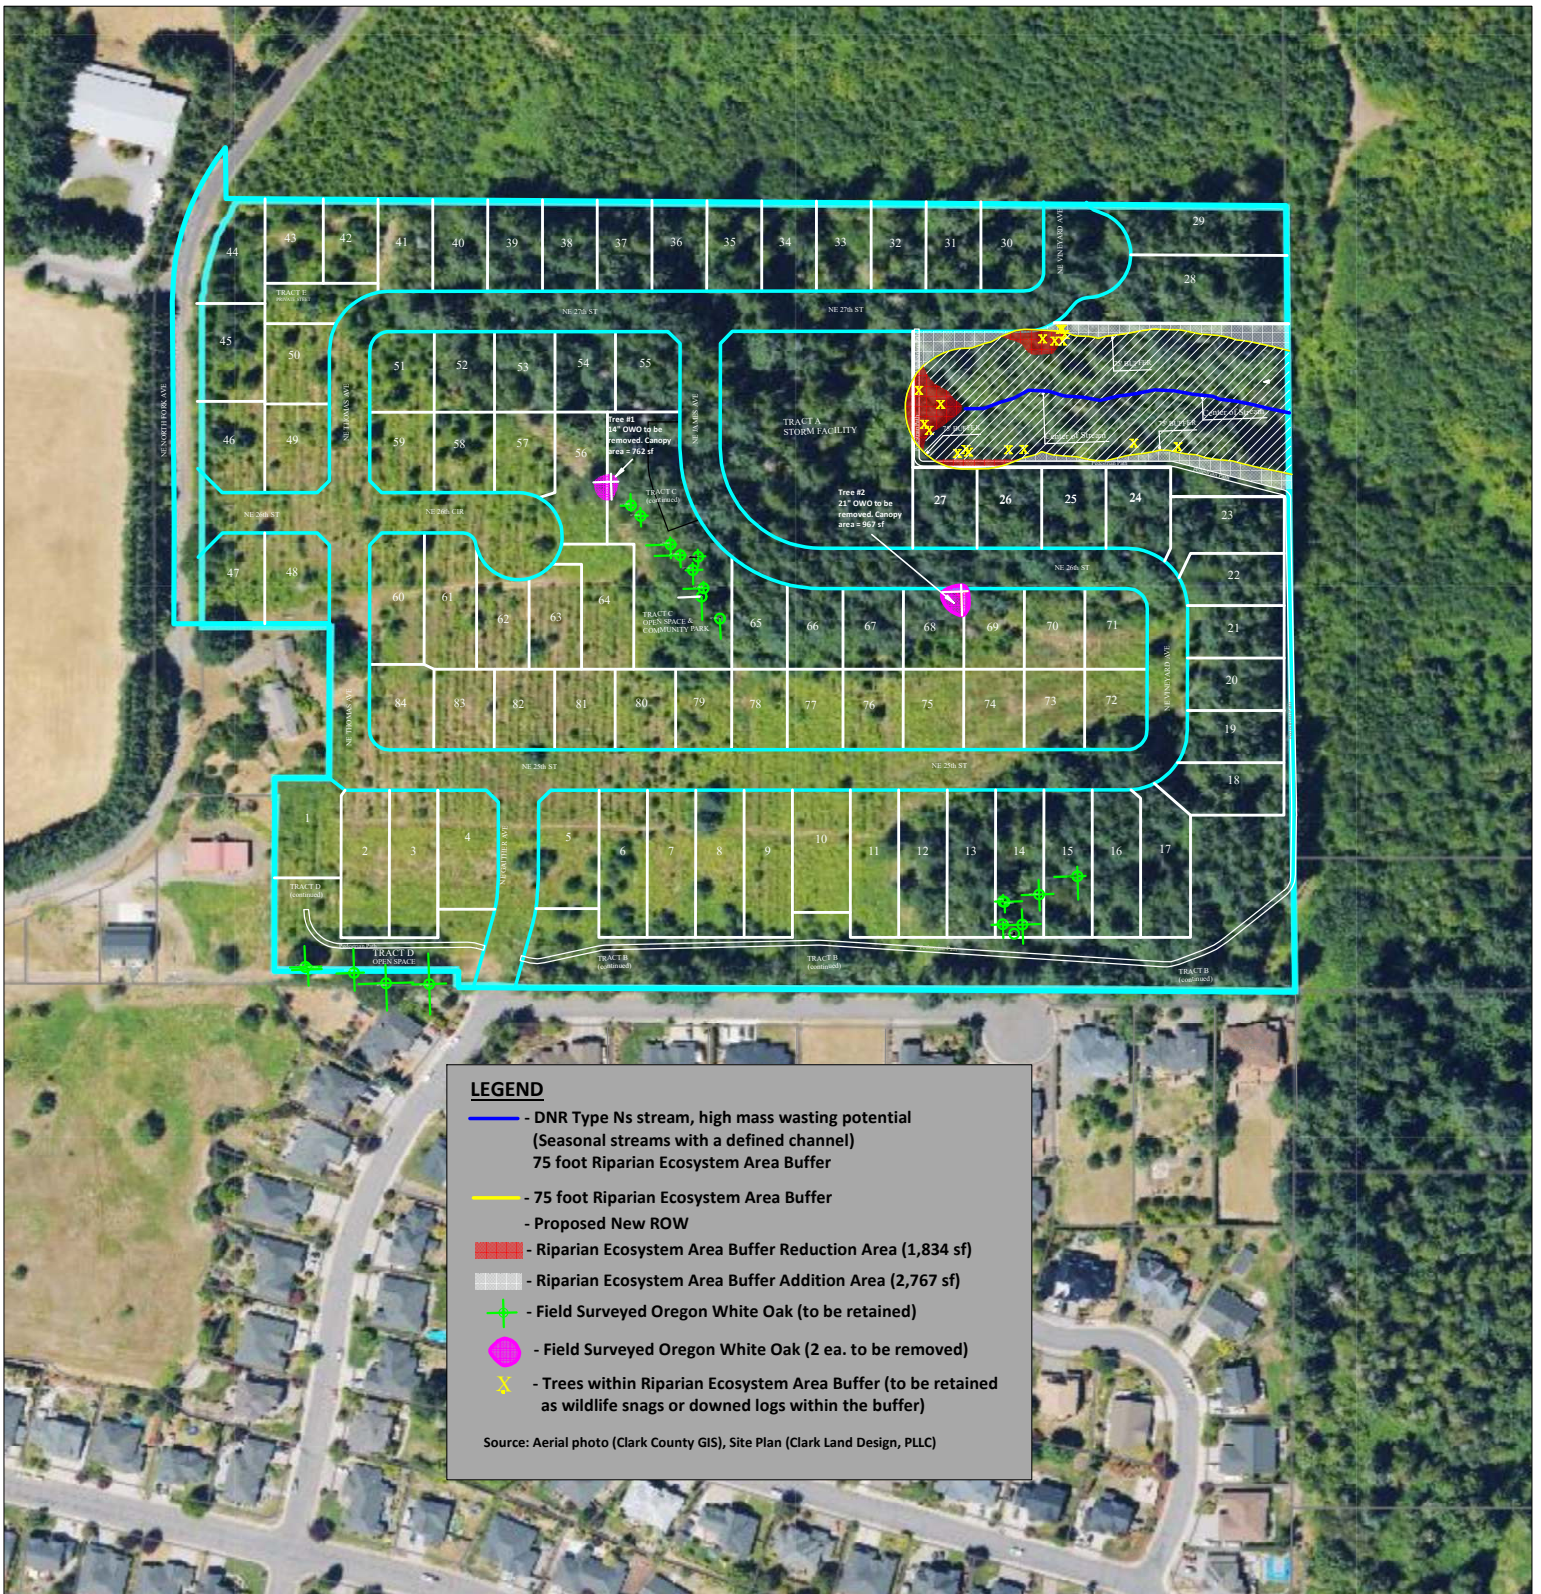
Figure 4 of 5 - Critical Area Impacts
Critical Areas Report & Mitigation Plan

The property contains numerous oak trees of various sizes which have been surveyed and are shown on Figure 4. WDFW defines oak woodlands as follows: In non-urbanized areas west of the Cascades, priority oak habitat is stands 0.4 ha (1 acre) in size; in urban or urbanizing areas, single oaks, or stands of oaks <0.4 ha (1 ac), may also be considered priority habitat n found to be particularly valuable to fish and wildlife (e.g. they contain many cavities, have a large diameter at breast height (dbh), are used by priority species, or have a large canopy). Two oaks identified as trees #1 and #2 and are to be removed adjacent to lots 56, 68, and 69. The oaks cannot be avoided due to grading that is required in order to make these lots level for development.

The project will require minor reductions to the outer portions of the Type Ns stream buffer in the area shown as “Tract B – Open Space” on Figure 4. These buffer reductions are required for a wood chip pedestrian path along the west and south side of Tract B. The reduction in buffer area of 1,834 ft² will be compensated by adding 2,767 ft² onto the existing buffer in Tract B. The areas of buffer reductions and addition are functionally equivalent as both consist of mature upland forest.

The project's critical areas plan developed by Wolfe Project Management (Sheet CA-1, Figures) shows a total of ten trees will need to be removed within the areas which must be graded to construct the stormwater facility and fill slopes along the interior road network adjacent to the buffer. These trees include red alder (*Alnus rubra*), big-leaf maple (*Acer macrophyllum*), Western hemlock (*Tsuga heterophylla*), and Western red cedar (*Thuja plicata*). These trees will be felled in place and left on the ground surface as downed wildlife logs.

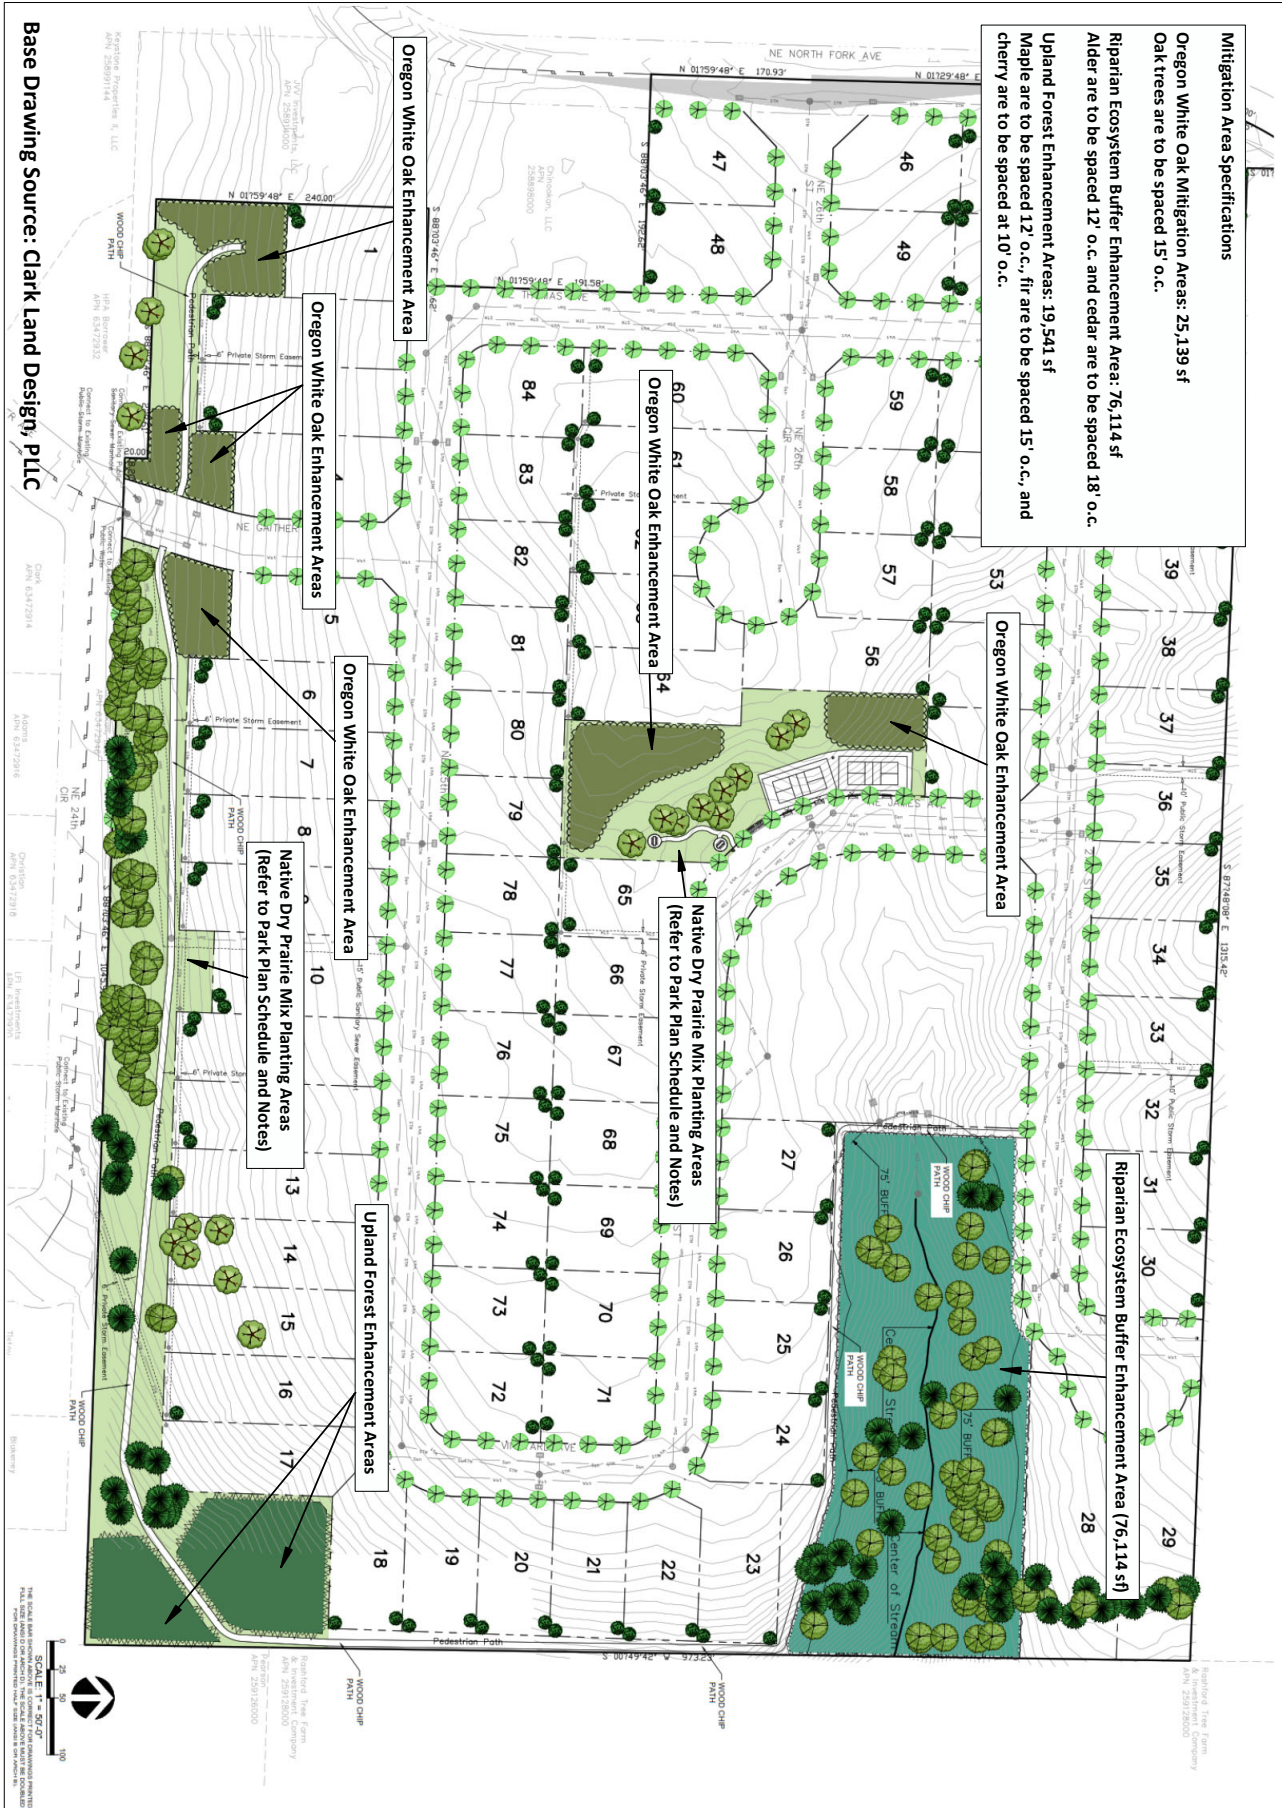
Figure 5 of 5 - Mitigation Planting Plan
Critical Areas Report & Mitigation Plan

The applicant proposes replacing the 1,729 ft² of impacted Oregon white oak canopy with 25,139 ft² (0.56 acres) of oak enhancement within the confines of the B, C, and D open space tracts as shown on Figure 5.

Riparian Ecosystem Buffer Enhancement Area: 76,114 sf
Alder are to be spaced 12' o.c. and cedar are to be spaced 18' o.c.

Upland Forest Enhancement Areas: 19,541 sf
Maple are to be spaced 12' o.c., fir are to be spaced 15' o.c., and cherry are to be spaced at 10' o.c.

The riparian ecosystem buffer will be planted with the native tree species listed in Table 2 to enhance wildlife habitat functions.

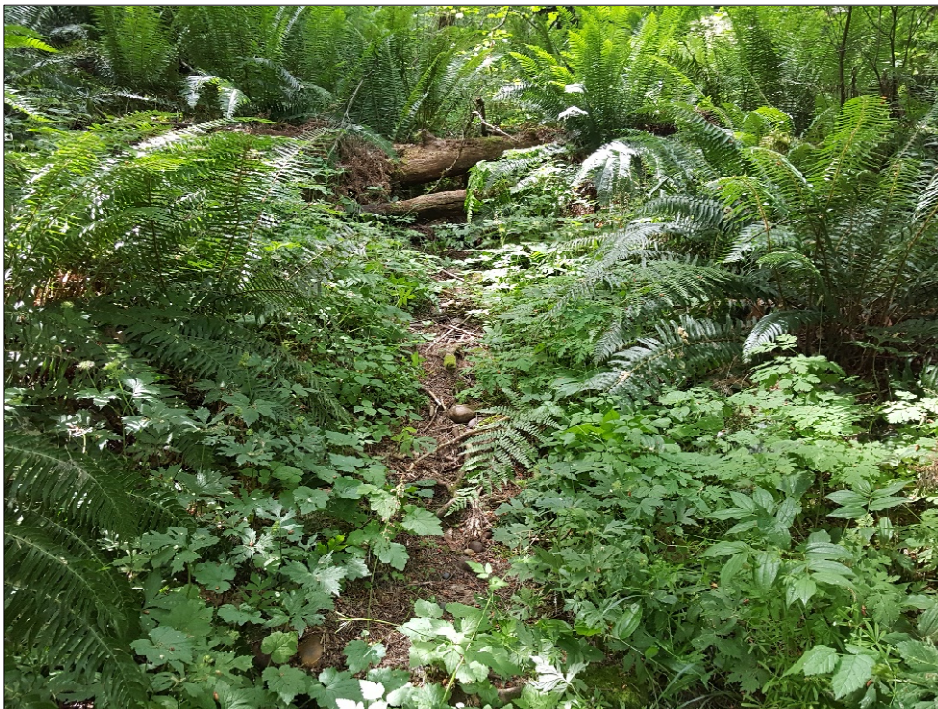
Photo 4. Seasonal stream in northeast portion of the property.

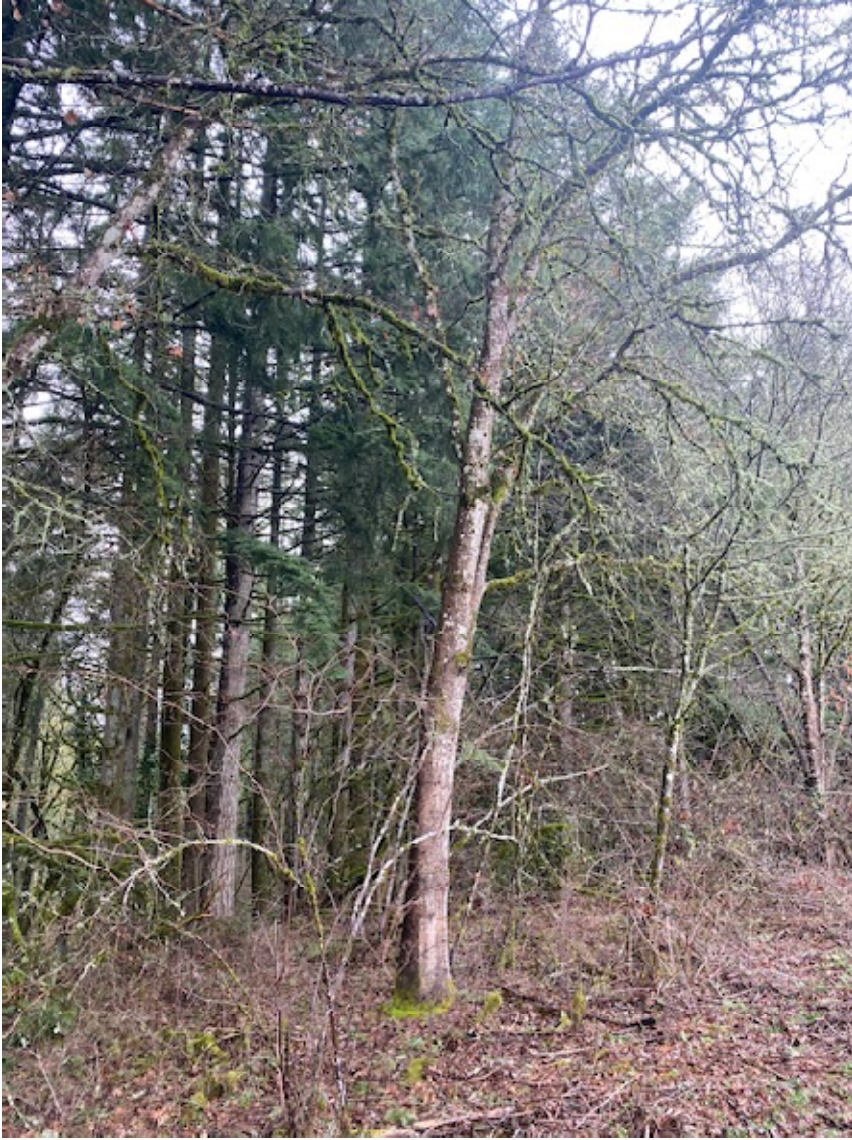
Tree #2: 21"DBH

This Oregon white oak is in poor health.

There is significant die back and deadwood throughout the canopy. The tree also has multiple co-dominant stems that are prone to failure due to weaker attachments to the main trunk.

This tree is a good candidate for removal and replacement.
