KDEV, LLC Geotechnical Engineering Evaluation

Valley View Subdivision 2219 NE 339th St La Center, Washington

True North Project No. 22-0216-1 August 2022 August 8, 2022

Subject: Geotechnical Engineering Evaluation

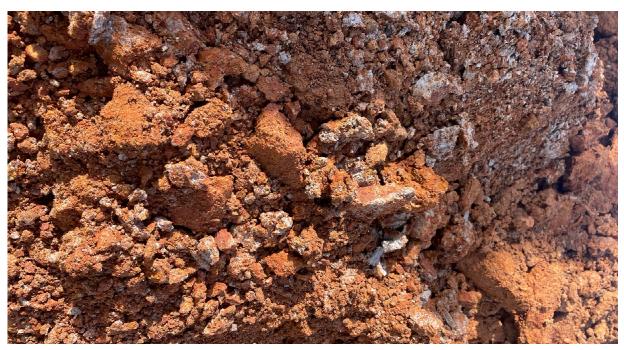
Photo 1. Excavation at TP-3; colorful silty clay observed in every test pit at varying depths.

The ground surface at the site is generally level across the site. The elevation at the site ranges from approximately 286 to 306 feet above mean sea level (AMSL). Photographs of some of our explorations are included in Figure 3.

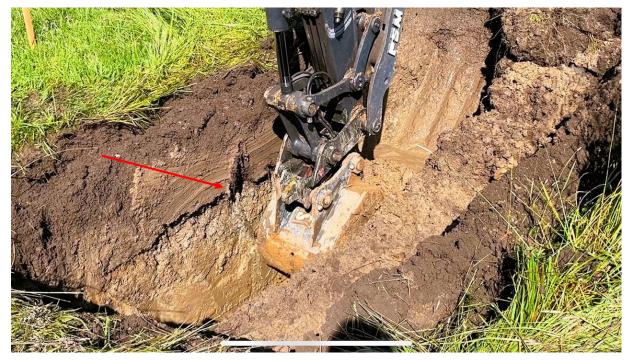
Photo 2. Excavation at TP-5, arrow pointing toward damaged clay drainage pipe; no groundwater observed.
