FINAL TECHNICAL INFORMATION REPORT

Riverside Neighborhood Park La Center, Washington

***Riverside Neighborhood Park
Drainage Report***

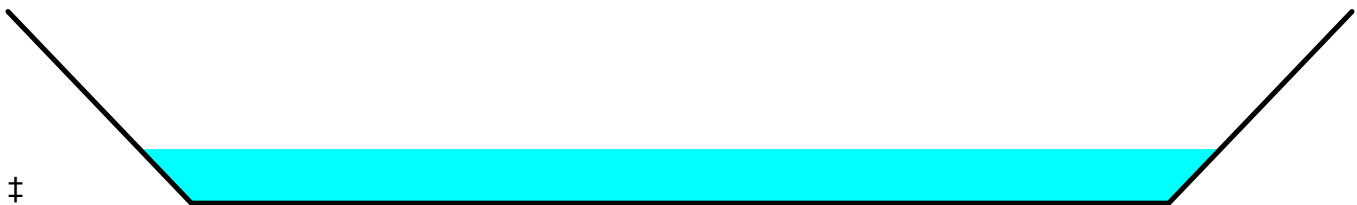
8.00' x 0.50' deep channel, n= 0.200
 Side Slope Z-value= 3.0 '/' Top Width= 11.00'
 Length= 110.0' Slope= 0.0160 '/'
 Inlet Invert= 192.00', Outlet Invert= 190.24'

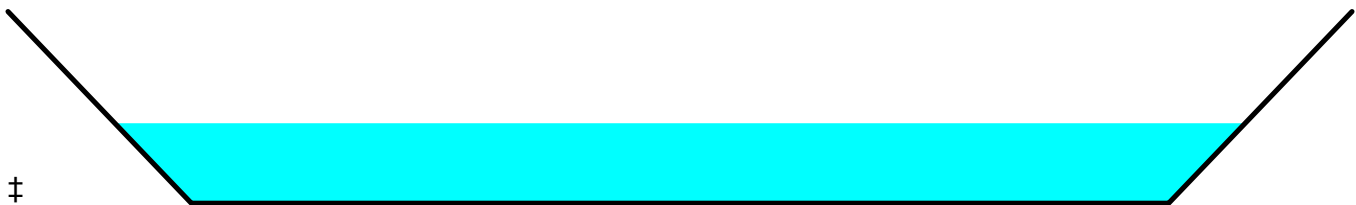
8.00' x 0.50' deep channel, n= 0.200
Side Slope Z-value= 3.0 '/' Top Width= 11.00'
Length= 110.0' Slope= 0.0160 '/'
Inlet Invert= 192.00', Outlet Invert= 190.24'

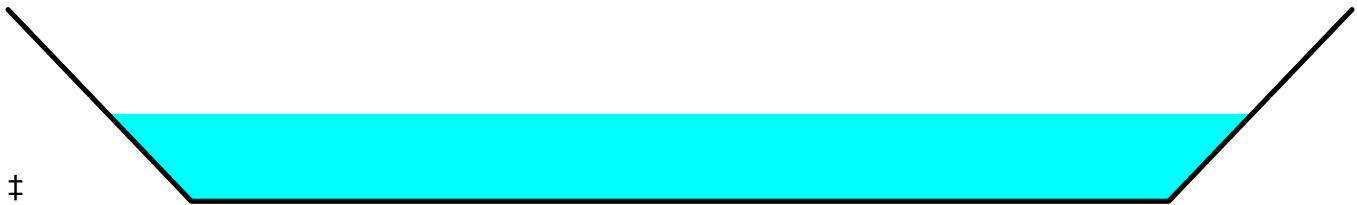
8.00' x 0.50' deep channel, n= 0.200
Side Slope Z-value= 3.0 '/' Top Width= 11.00'
Length= 110.0' Slope= 0.0160 '/'
Inlet Invert= 192.00', Outlet Invert= 190.24'

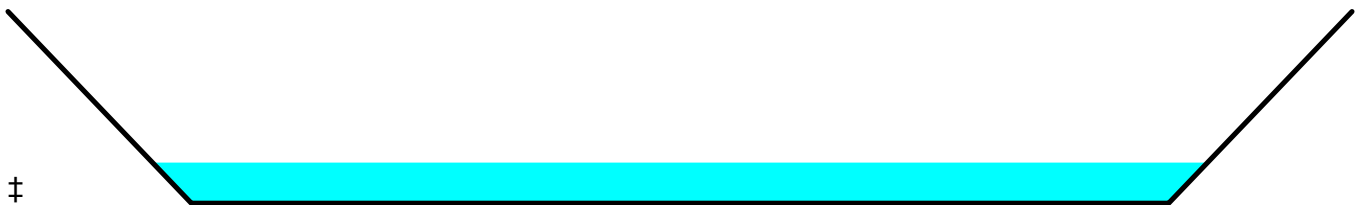
Summary for Reach R1: Swale

Inflow Area = 31,399 sf, 54.19% Impervious, Inflow Depth = 1.03" for WQ event
 Inflow = 0.19 cfs @ 7.94 hrs, Volume= 2,682 cf
 Outflow = 0.18 cfs @ 8.17 hrs, Volume= 2,682 cf, Atten= 3%, Lag= 13.3 min

Peak Storage= 97 cf @ 8.02 hrs
 Average Depth at Peak Storage= 0.11'
 Bank-Full Depth= 0.50' Flow Area= 4.8 sf, Capacity= 2.53 cfs

8.00' x 0.50' deep channel, n= 0.200
 Side Slope Z-value= 3.0 ' / ' Top Width= 11.00'
 Length= 110.0' Slope= 0.0160 ' / '
 Inlet Invert= 192.00', Outlet Invert= 190.24'

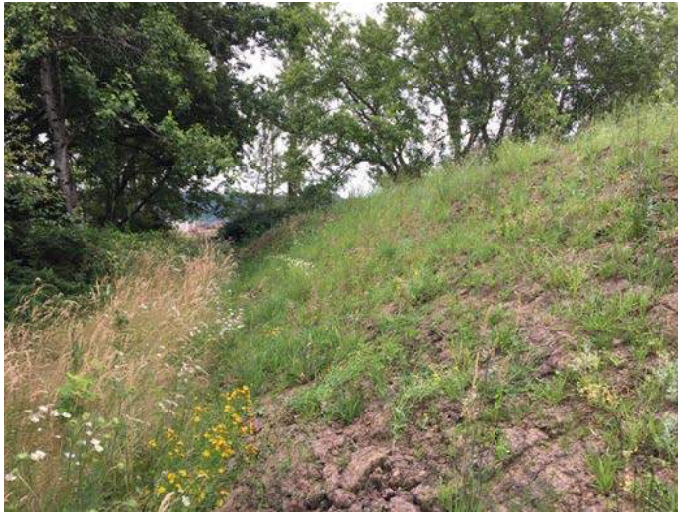
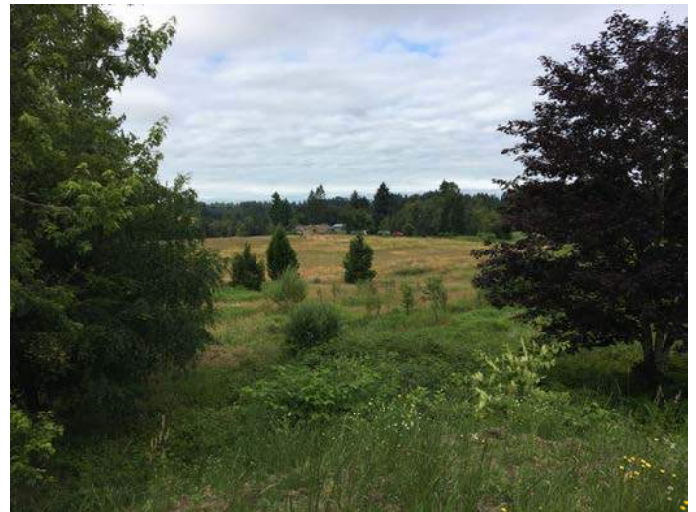
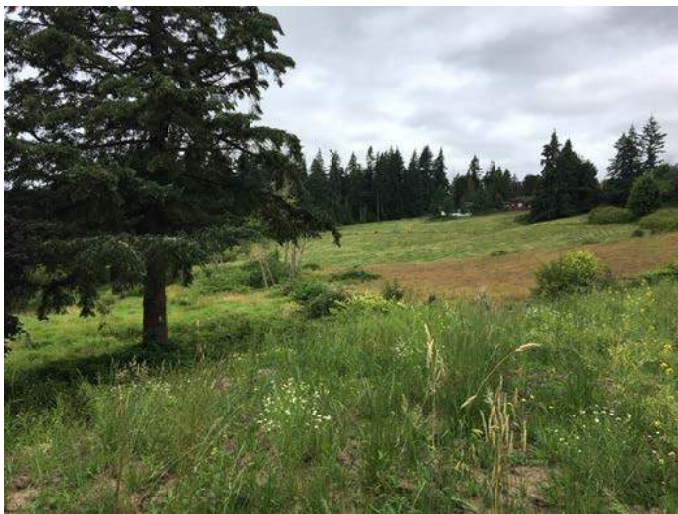
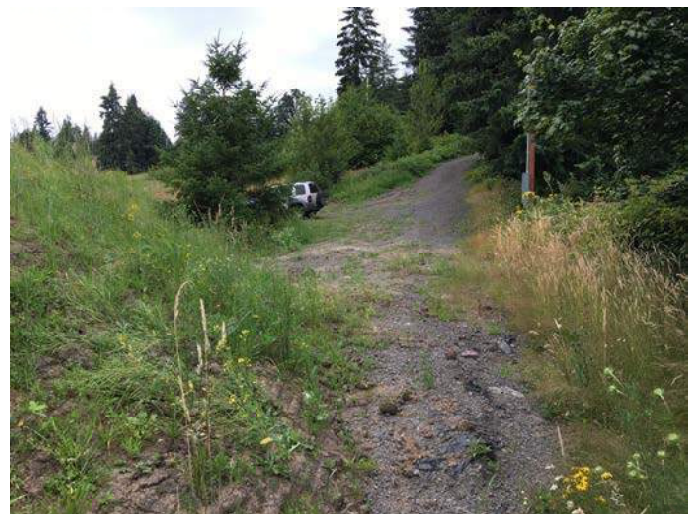
See Figure 8 for approximate photograph locations and directions. Photographs were taken at the time of our fieldwork.

The proposed site layout and site conditions during our reconnaissance are shown on the attached Site Plan (Figure 8) and Site Photographs (Figure 9). The existing topography shown on the Site Plan is consistent with that observed during the reconnaissance.

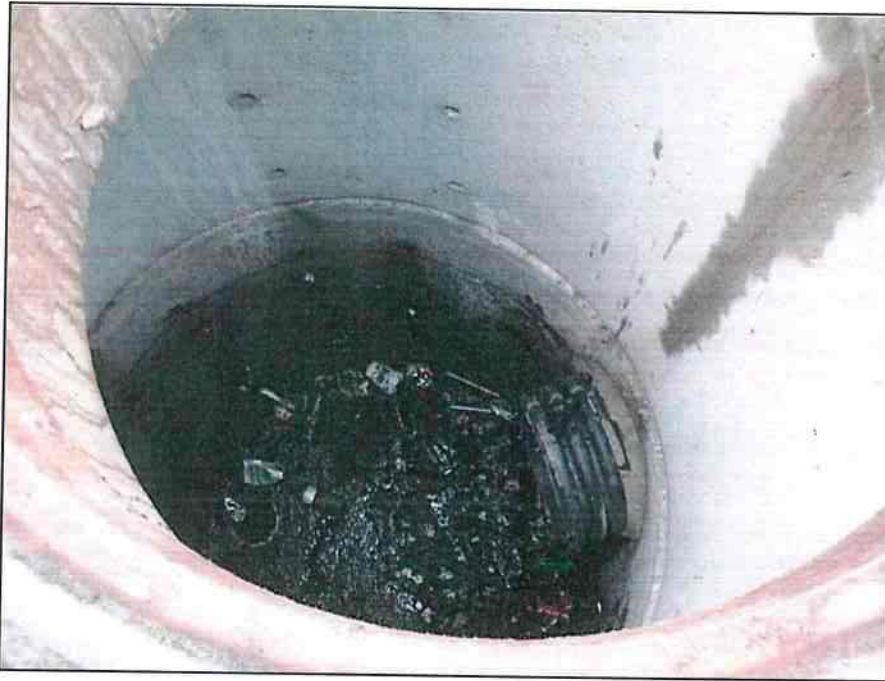
Drywell with Accumulated Trash

A drywell is a perforated, open-bottomed manhole used to infiltrate stormwater into the ground. Drywells temporarily store stormwater runoff during rain events. Drywells do not discharge to a downstream conveyance system or nearby surface water. Instead, drywells rely on the ability of the site's soils to infiltrate the stormwater into the ground.

While not the intended use, drywells trap sediment and some of the oily pollutants in runoff. They are more likely to fill with oily sediment in areas that lack swales or other treatment facilities. Fine soil sediment can clog drywells and lead to localized street flooding. Also, pollutants discharged into drywells can migrate into groundwater. Drywells were often installed in closed topographic depressions, areas with well-drained soils, or areas having inadequate storm sewers. Because drywells can be easily clogged and tend to concentrate pollutants in one place; pollution and sediment control practices should be used to protect them.

Drywell			
Drainage System Feature	Potential Defect	Conditions When Maintenance Is Needed	Minimum Performance Standard
General	Does Not Dissipate Stormwater	Does not dissipate stormwater.	Replace or repair.
	Opening Clogged	Openings are clogged, reducing capacity.	Openings have been cleared (e.g. by water-jetting); or Convert existing, clogged drywell to a sediment trap and install a new drywell or drainage trench. To convert to a sediment trap, required are grouting holes, covering the base with concrete, and adding piping.
	Standing Water	Standing water indicates the drywell is into the water table.	Rebuild drywell to prevent stormwater from going directly into groundwater.
	Trash and Debris	Trash, debris, or floatables that may exit through pipes.	No trash or debris in drywell.
		Trash or debris in any inlet or outlet pipe.	Inlet and outlet pipes free of trash or debris.
	Sediment	Sediment in drywell exceeds 60 percent of the depth below the inlet pipe.	No sediment in drywell.
