# PRELIMINARY TECHNICAL INFORMATION REPORT

## Riverside Neighborhood Park La Center, Washington

PLS Engineering  
Consulting Engineers and Planners  
604 W. Evergreen Blvd  
Vancouver, WA 98660  
PH: (360) 944-6519  
[PM@plsengineering.com](mailto:PM@plsengineering.com)

Submitted: October, 2020

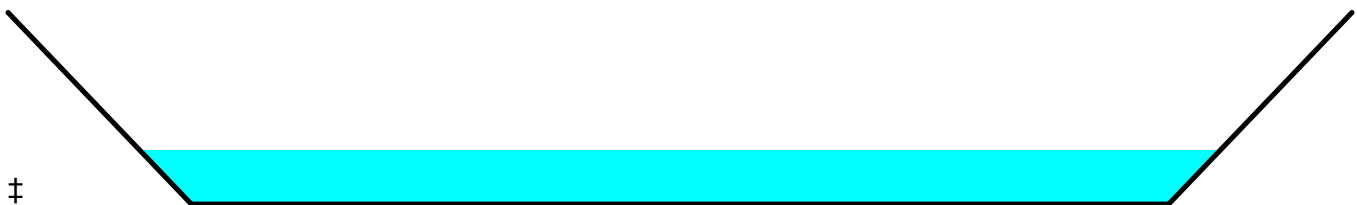
8.00' x 0.50' deep channel, n= 0.200  
 Side Slope Z-value= 3.0 ' / ' Top Width= 11.00'  
 Length= 110.0' Slope= 0.0160 ' / '  
 Inlet Invert= 192.00', Outlet Invert= 190.24'

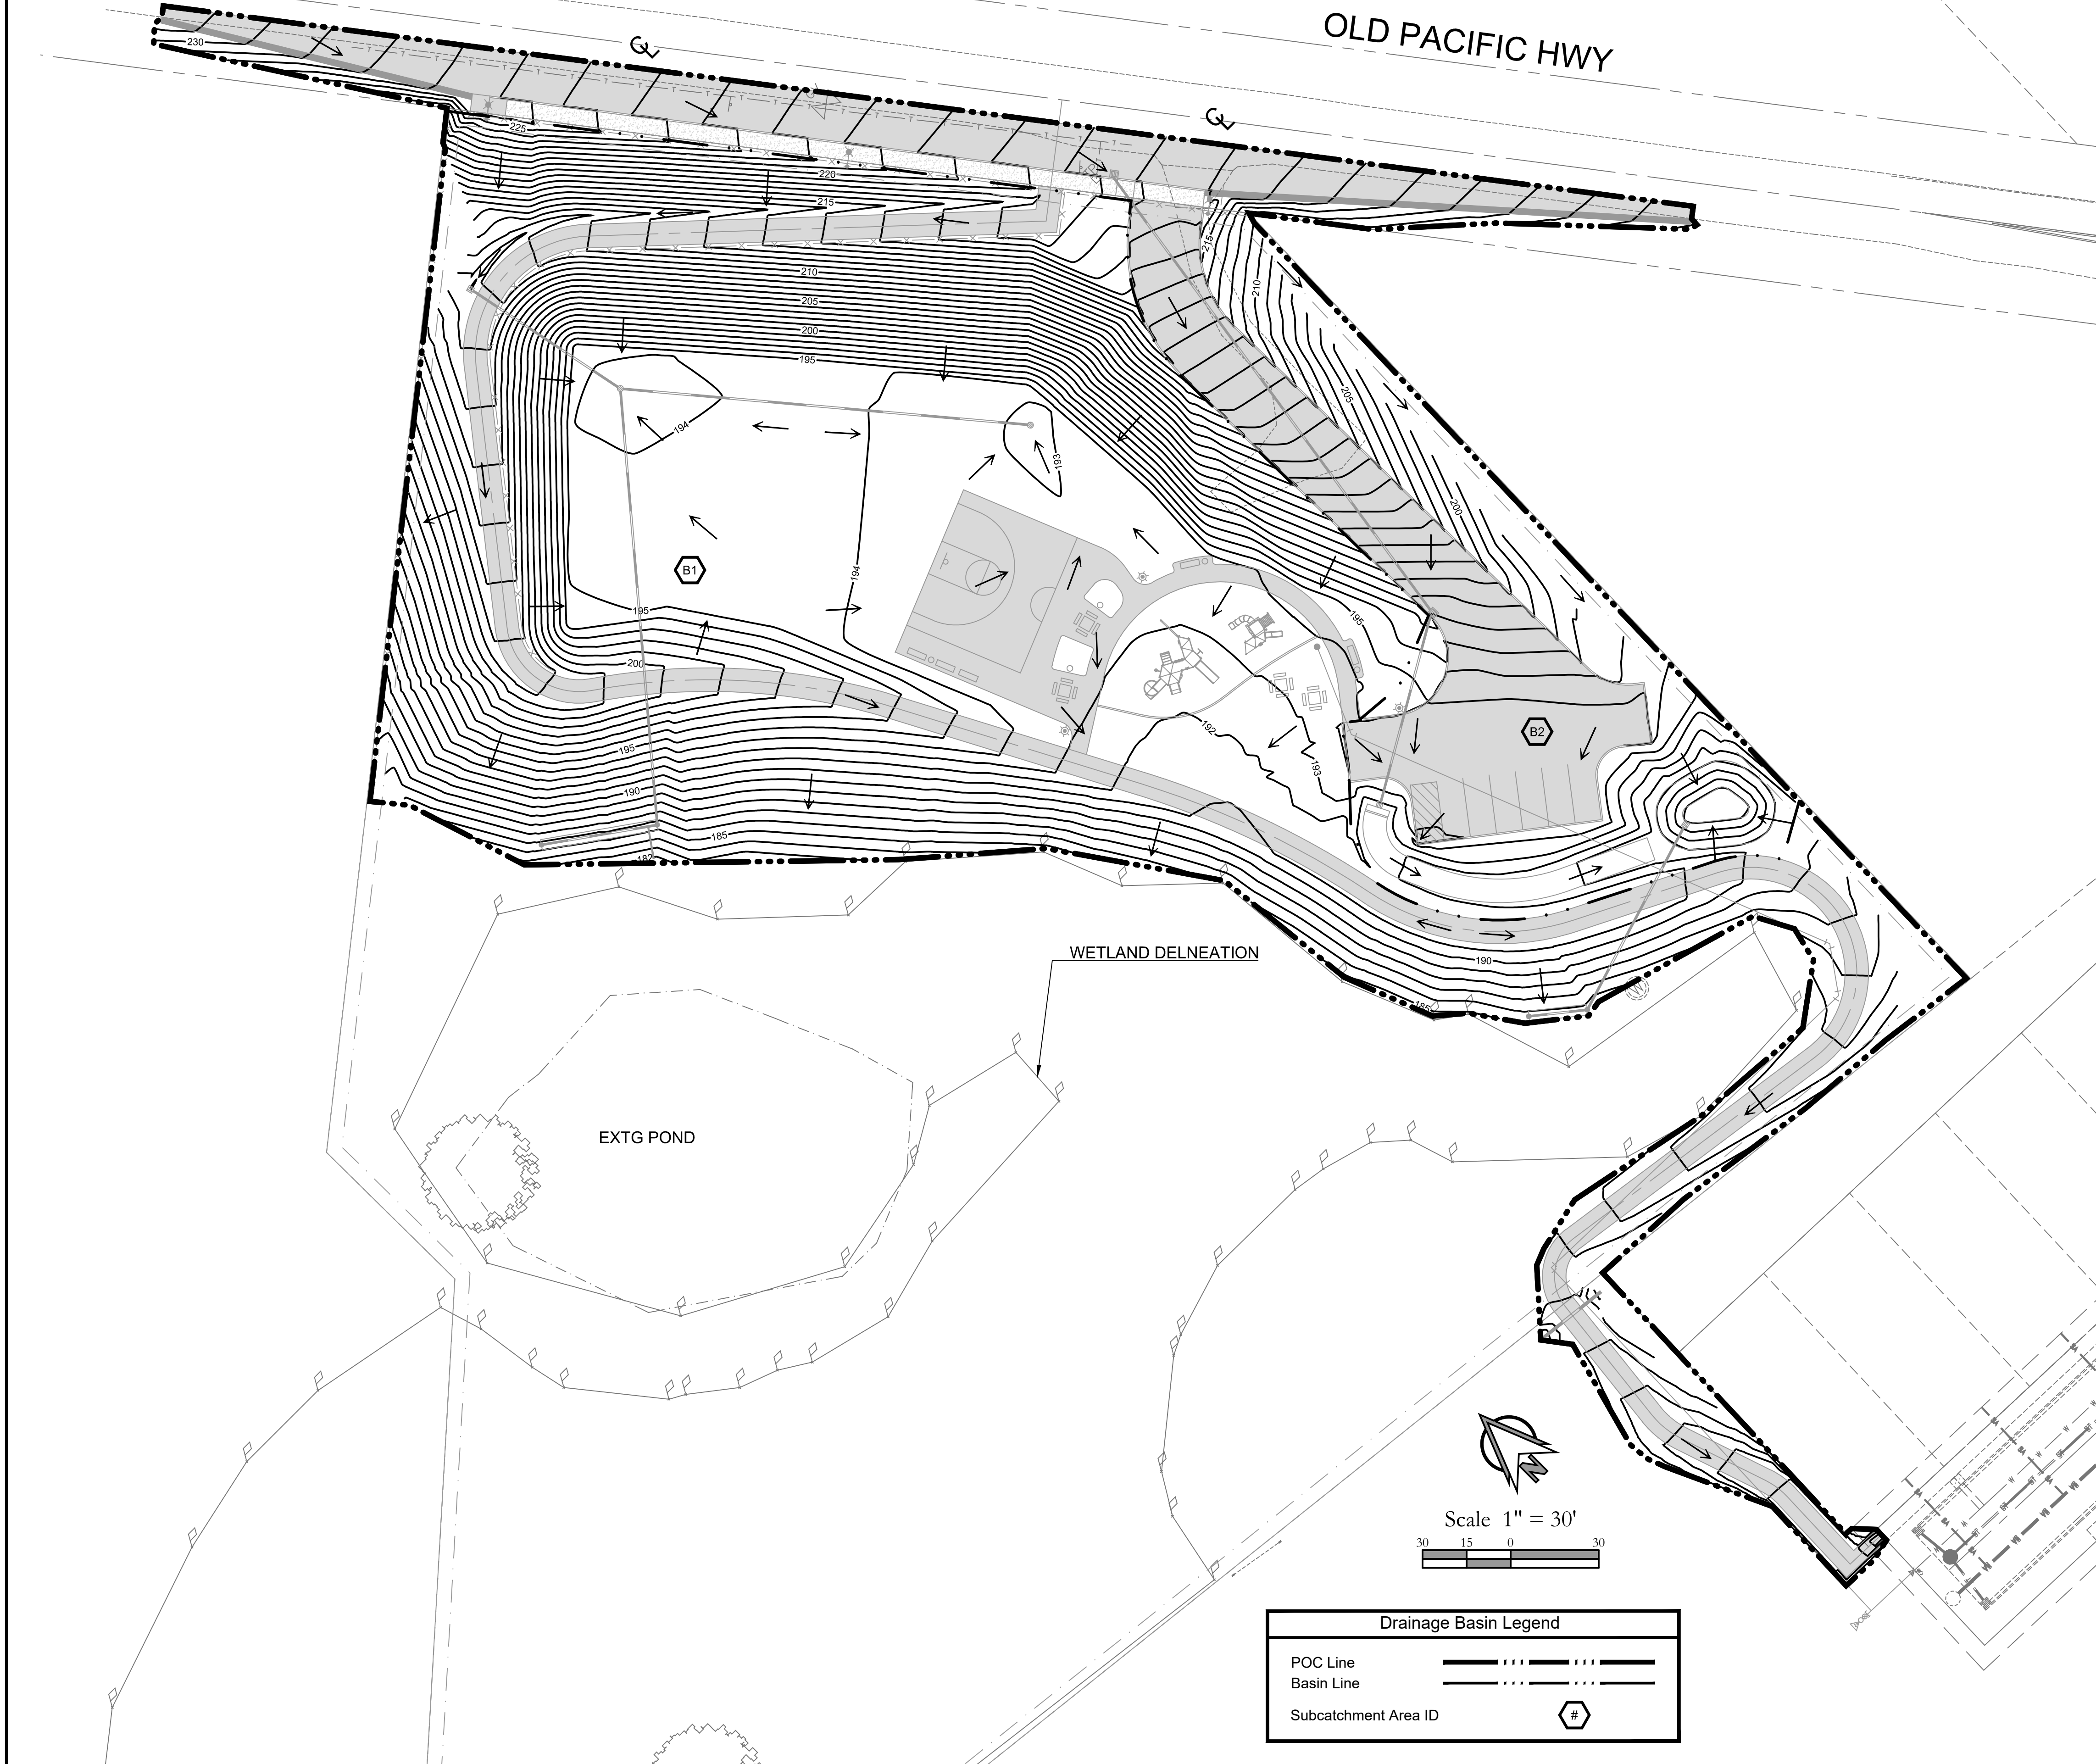
**PROPOSED STORM DRAINAGE:**  
Basin 1 is comprised on non-pollution generating surfaces. It is collected in area drains and a ditch inlet, and routed to a flow spreader designed to detain the WQ event. Basin 2 collects the pollution generating surfaces and routes them to a biofiltration swale for treatment, and then a detention pond, where the runoff is released at rates that allow the total site to be equal to or slightly less than the existing site discharge.

Point of Compliance 1: Pre-Development Basin Area	
<b>B1 Basin 1 Areas:</b>	
Landscaped Area:	70,000 SF
Sidewalk Area:	15,263 SF
<b>Total B1 Area:</b>	<b>85,263 SF</b>
<b>B2 Basin 2 Areas:</b>	
Landscaped Area:	14,383 SF
Road Area:	7,331 SF
Driveway Area:	9,685 SF
<b>Total B2 Area:</b>	<b>31,339 SF</b>
<b>Total Point of Compliance Area:</b>	<b>116,662 SF (2.68 AC)</b>

Scale 1" = 30'
