Geotechnical Site Investigation

North Fork Urban Holdings

La Center, Washington

January 20, 2021

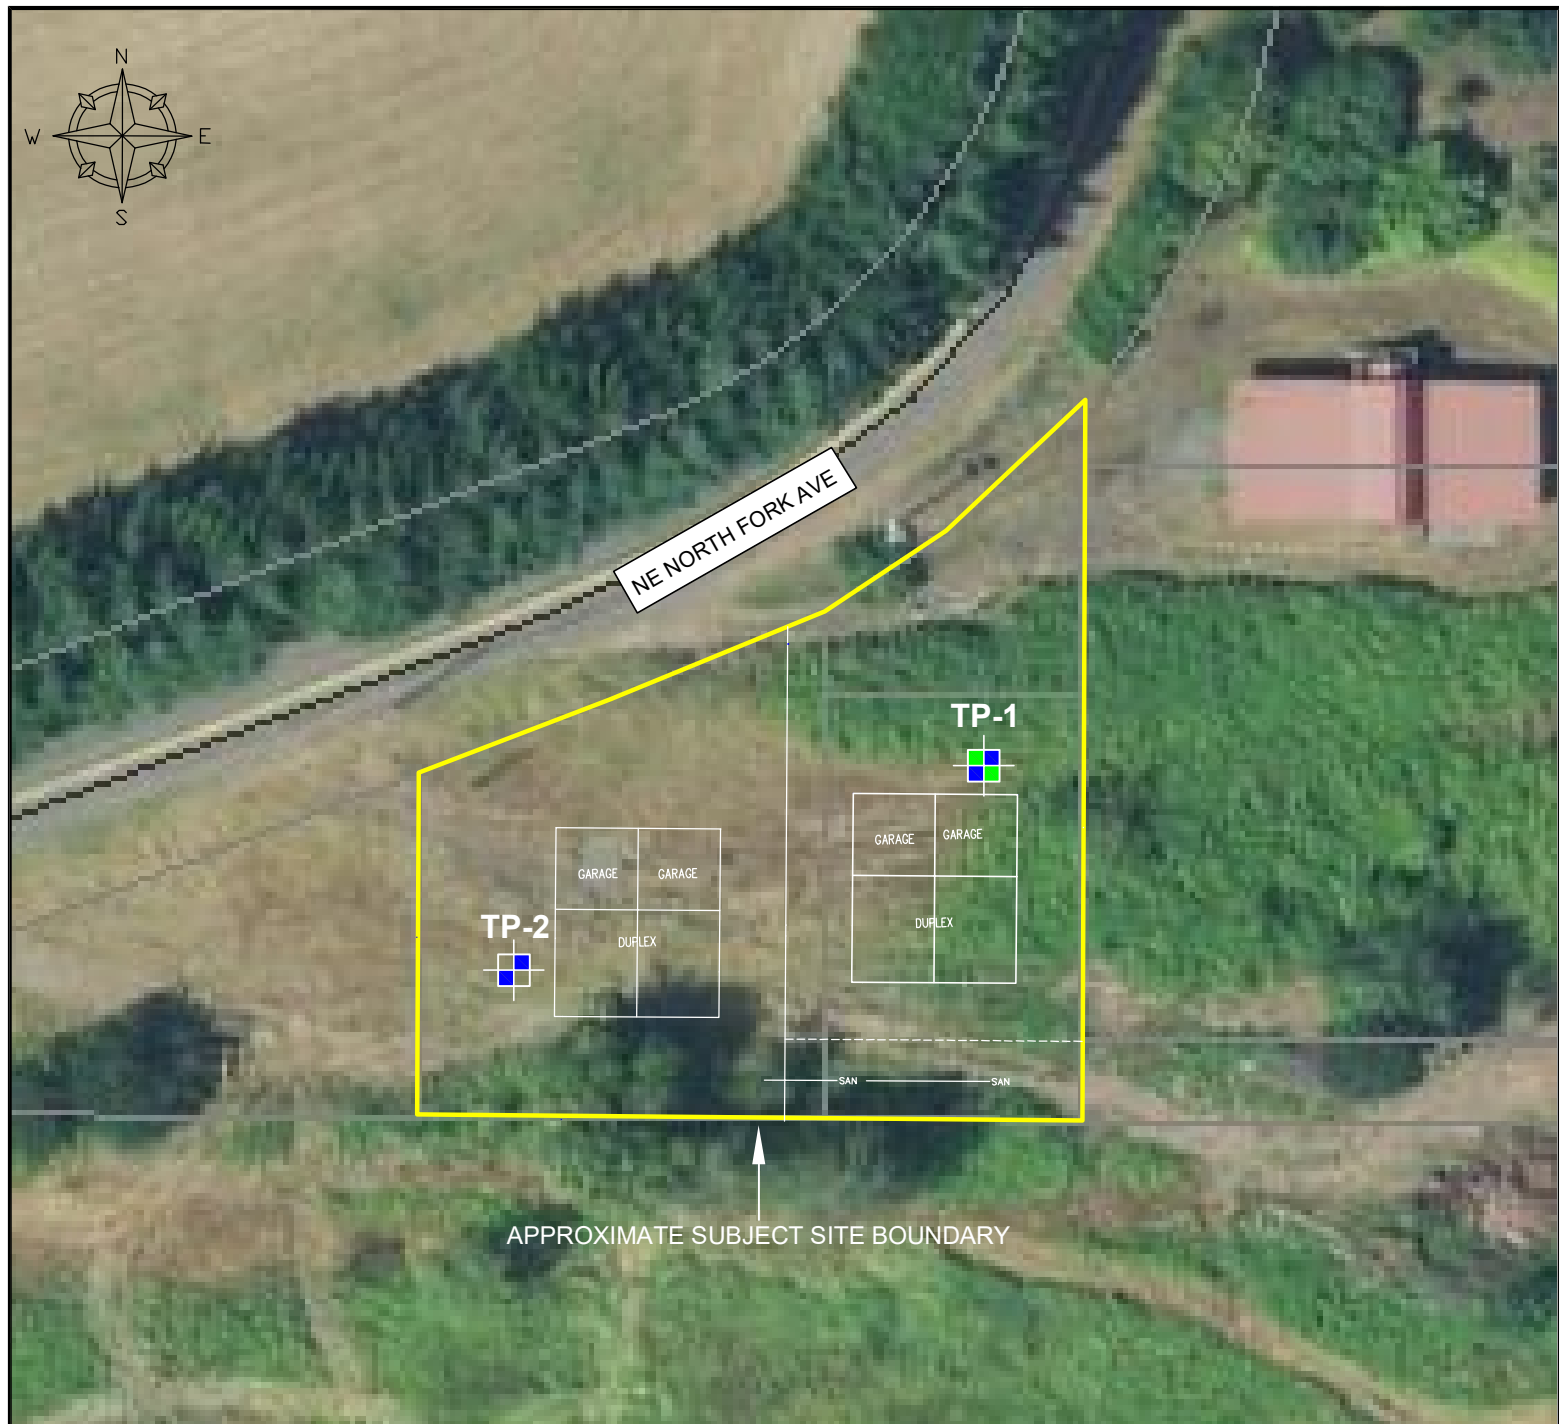
APPROXIMATE SUBJECT SITE BOUNDARY

Infiltration Test Results

TEST PIT LOCATION

Review of site topographic mapping indicates the proposed development area is moderately sloping with elevations ranging from approximately 394 feet above mean sea level (amsl) in the southern area to 418 feet amsl in the northern area of the site. Observed existing improvements consisted of an approximately 20-foot-wide sanitary sewer easement bordering the southern property lines as shown on Figure 2. The property is primarily vacant with no observed structures.

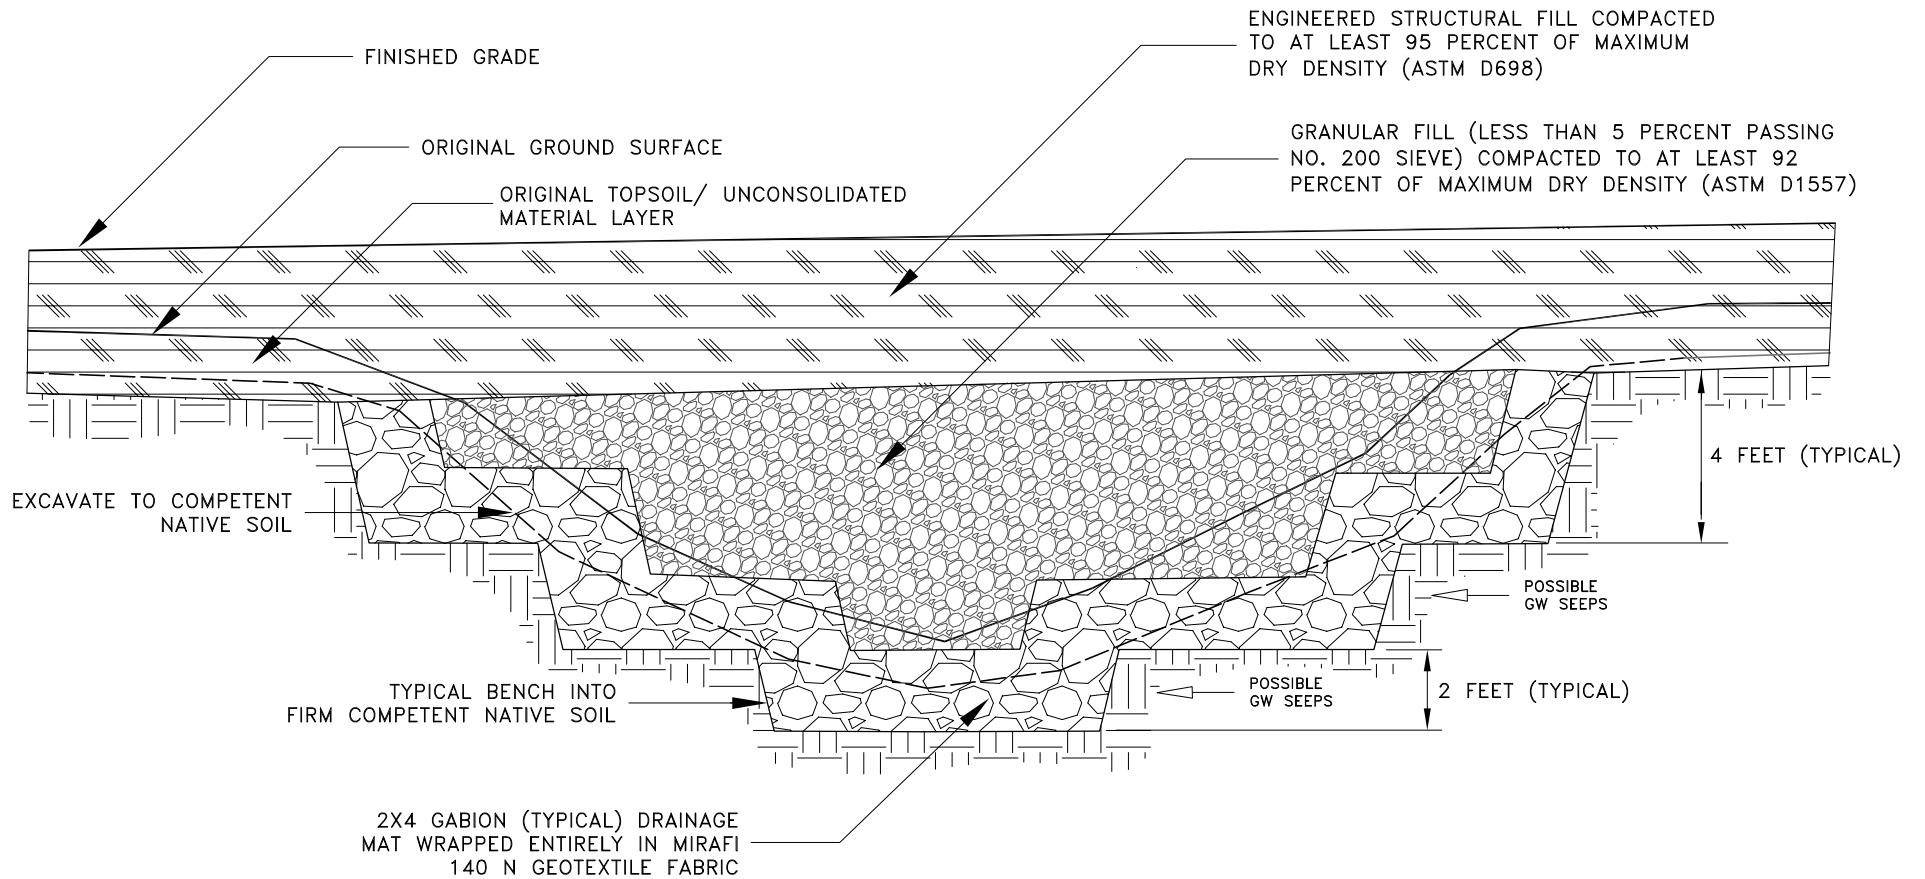
TYPICAL DRAINAGE MAT CROSS-SECTION

NOTE: LOCATION, INVERT ELEVATION, DEPTH OF TRENCH, AND EXTENT OF PERFORATED PIPE REQUIRED MAY BE MODIFIED BY THE GEOTECHNICAL ENGINEER DURING CONSTRUCTION BASED UPON FIELD OBSERVATION AND SITE-SPECIFIC SOIL CONDITIONS.

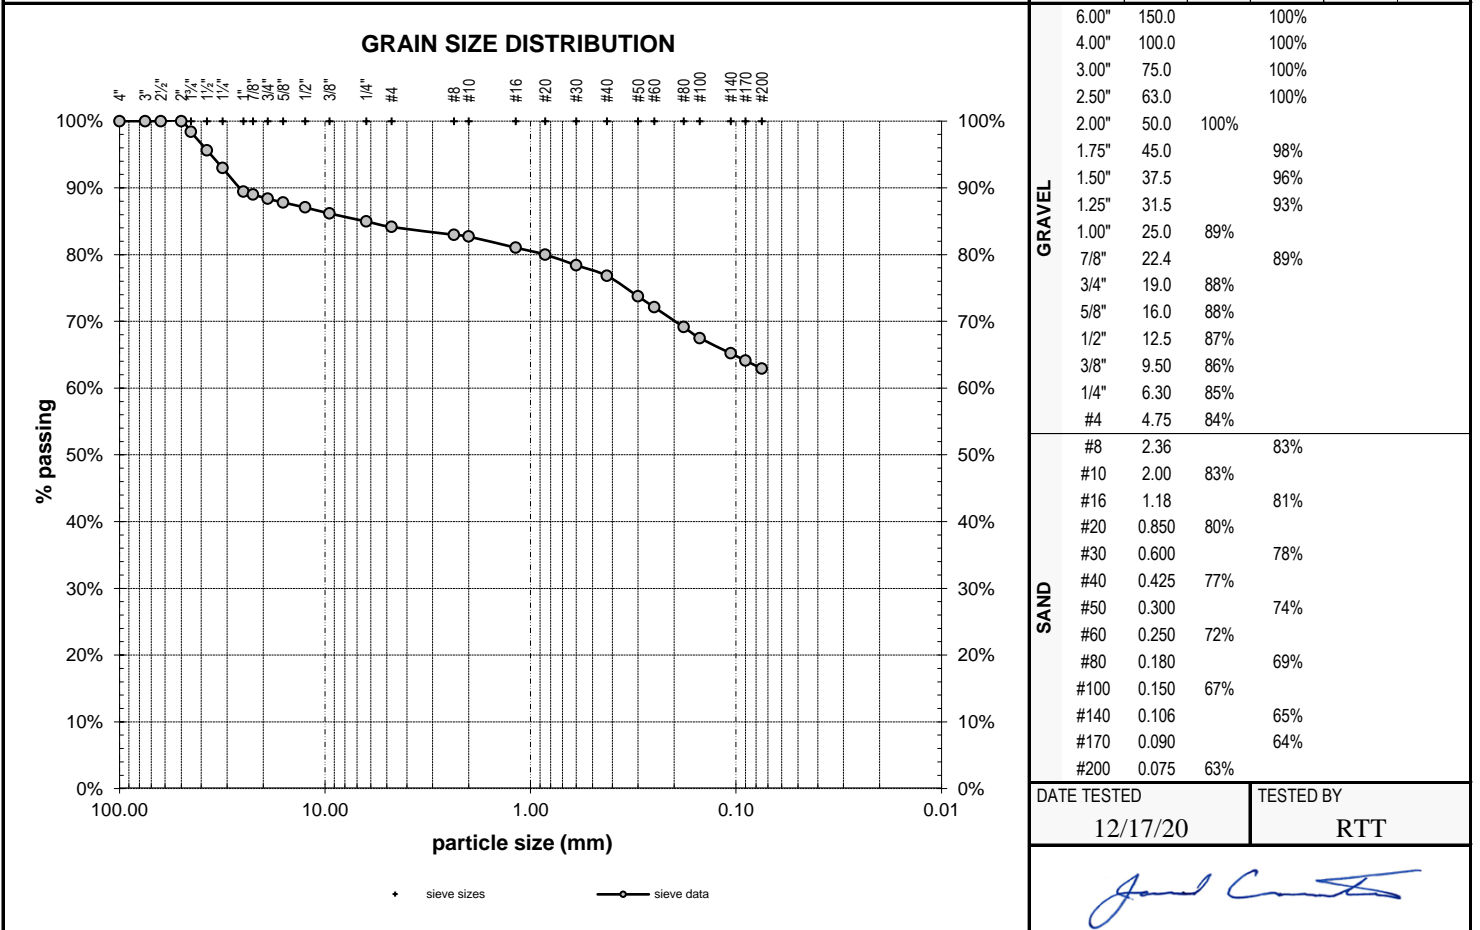
PARTICLE-SIZE ANALYSIS REPORT

LABORATORY TEST DATA	
LABORATORY EQUIPMENT	TEST PROCEDURE
Rainhart "Mary Ann" Sifter, air-dried prep, hand washed, composite sieve - #4 split	ASTM D6913, Method A

ADDITIONAL DATA initial dry mass (g) = 2144.2 as-received moisture content = 19.5% liquid limit = 39 plastic limit = 18 plasticity index = 21 fineness modulus = n/a coefficient of curvature, C_c = n/a coefficient of uniformity, C_u = n/a effective size, $D_{(10)}$ = n/a $D_{(30)}$ = n/a $D_{(60)}$ = n/a NOTE: Entire sample used for analysis; did not meet minimum size required.	SIEVE DATA % gravel = 15.9% % sand = 21.2% % silt and clay = 62.9%
--	--

Soil Type 1 was observed in both test pits to primarily consist of brown/red oxide, moist, medium stiff sandy lean CLAY with gravel. Analytical laboratory testing conducted upon a representative soil sample obtained from test pit TP-1 indicated approximately 63 percent by weight passing the No. 200 sieve and an in situ moisture content of 20 percent. Atterberg limits analysis indicated a liquid limit of 39 percent and a plasticity index of 21 percent. The laboratory tested sample of Soil Type 1 is classified CL according to USCS specifications and A-6(11) according to AASHTO specifications.

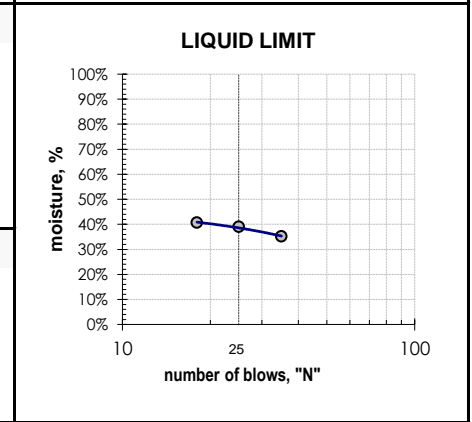
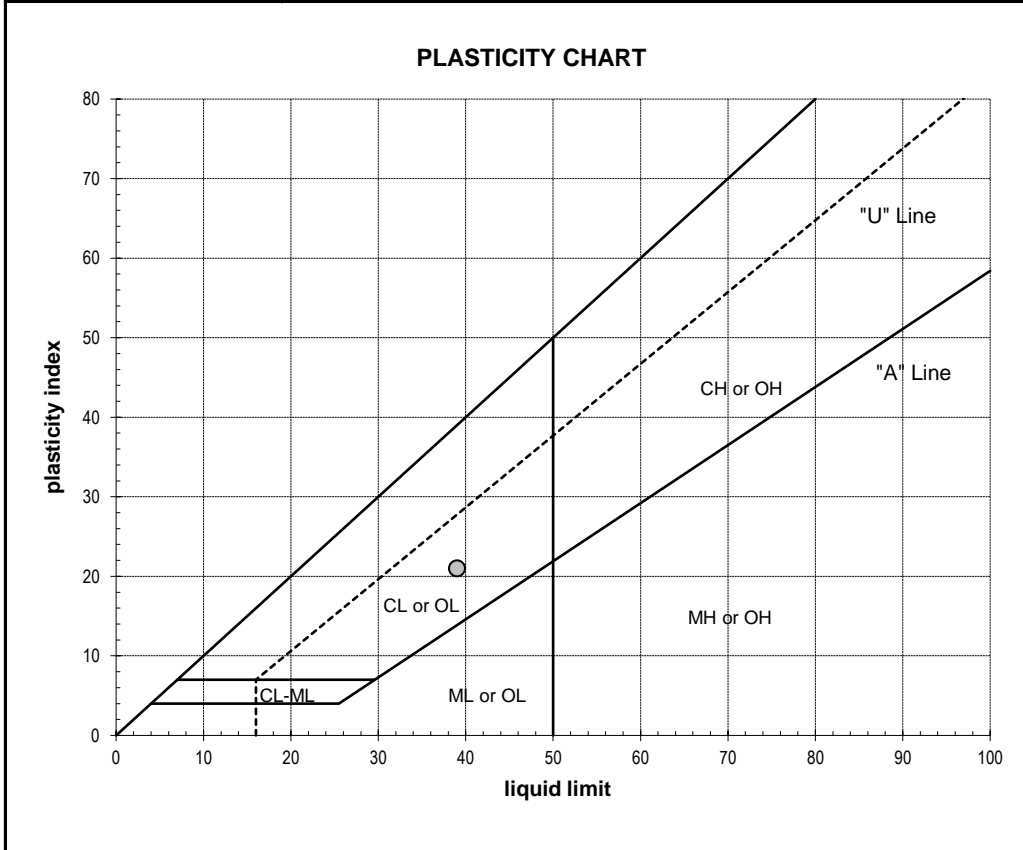
ATTERBERG LIMITS REPORT

ATTERBERG LIMITS liquid limit = 39 plastic limit = 18 plasticity index = 21	LIQUID LIMIT DETERMINATION				
		1	2	3	4
	wet soil + pan weight, g =	30.82	35.01	33.39	
	dry soil + pan weight, g =	28.24	31.05	29.77	
	pan weight, g =	20.90	20.89	20.86	
	N (blows) =	35	25	18	
moisture, % =	35.2 %	39.0 %	40.6 %

SHRINKAGE shrinkage limit = n/a shrinkage ratio = n/a	PLASTIC LIMIT DETERMINATION				
		1	2	3	4
	wet soil + pan weight, g =	27.08	27.32		
	dry soil + pan weight, g =	26.15	26.33		
	pan weight, g =	20.93	20.75		
	moisture, % =	17.8 %	17.7 %

ADDITIONAL DATA	
% gravel =	15.9%
% sand =	21.2%
% silt and clay =	62.9%
% silt =	n/a
% clay =	n/a
moisture content =	19.5%

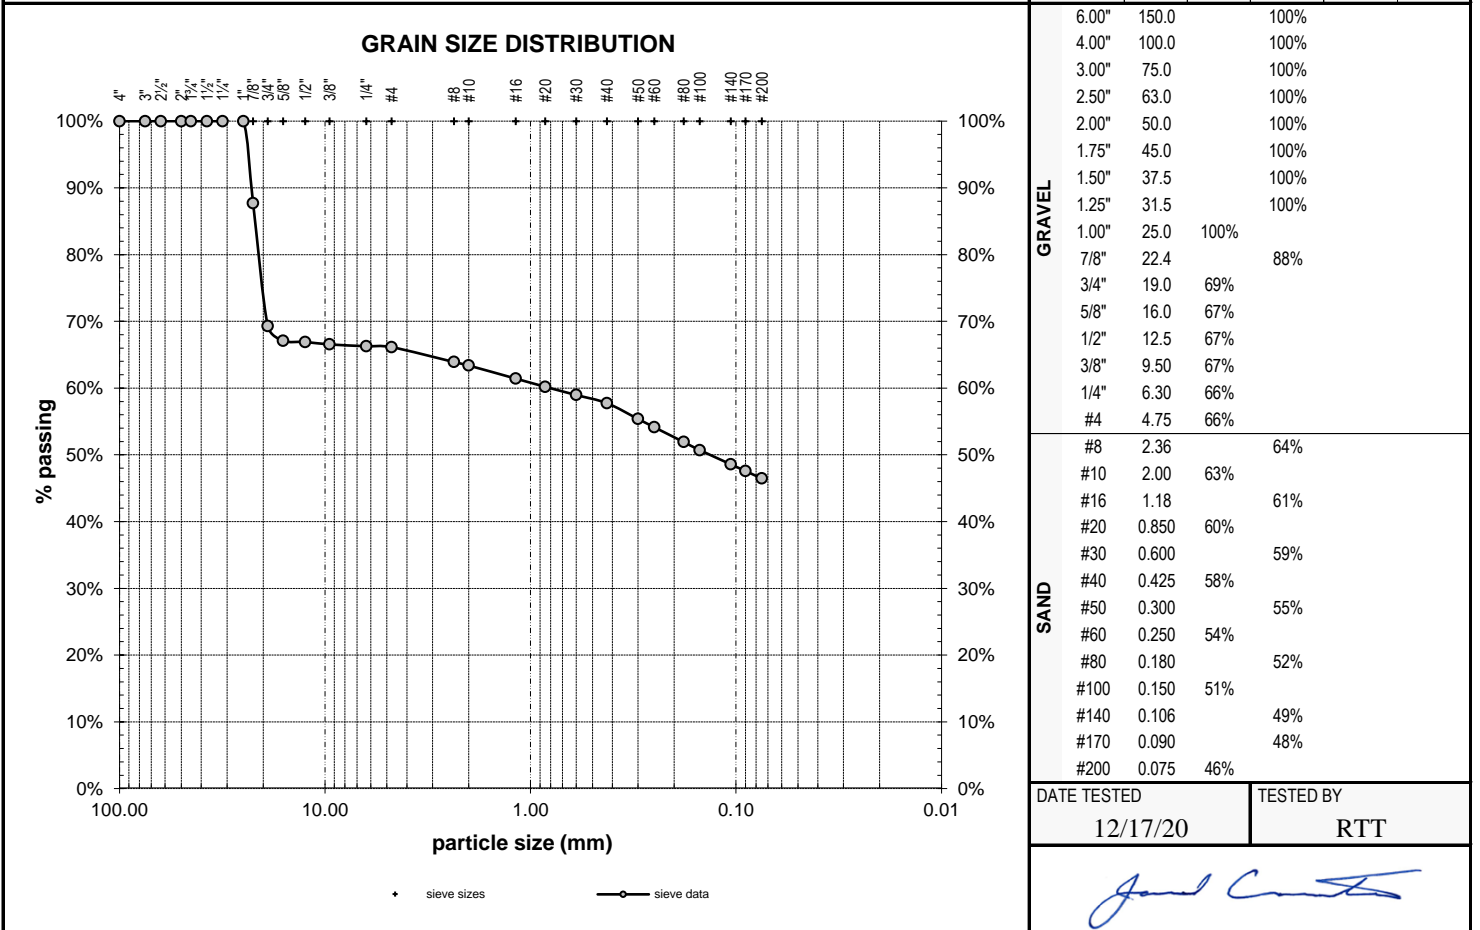
LABORATORY TEST DATA	
LABORATORY EQUIPMENT Rainhart "Mary Ann" Sifter, air-dried prep, hand washed, composite sieve - #4 split	TEST PROCEDURE ASTM D6913, Method A

ADDITIONAL DATA initial dry mass (g) = 3052.8 as-received moisture content = 20.8% liquid limit = 51 plastic limit = 28 plasticity index = 23 fineness modulus = n/a coefficient of curvature, C_c = n/a coefficient of uniformity, C_u = n/a effective size, $D_{(10)}$ = n/a $D_{(30)}$ = n/a $D_{(60)}$ = 0.803 mm NOTE: Entire sample used for analysis; did not meet minimum size required.	SIEVE DATA % gravel = 33.9% % sand = 19.7% % silt and clay = 46.5%
---	--

Soil Type 2 was observed in both test pits underlying Soil Type 1 and primarily consisted of light brown, moist, medium dense, minorly weathered clayey GRAVEL with sand. Analytical laboratory testing conducted upon a representative soil sample obtained from test pit TP-1 indicated approximately 47 percent by weight passing the No. 200 sieve and an in situ moisture content of 21 percent. Atterberg limits analysis indicated a liquid limit of 51 percent and a plasticity index of 23 percent. The laboratory tested sample of Soil Type 2 is classified GC according to USCS specifications and A-7-6(7) according to AASHTO specifications.

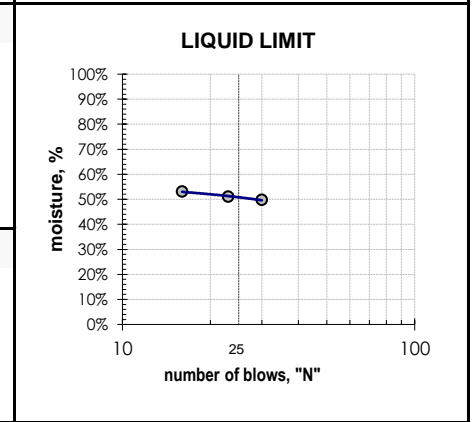
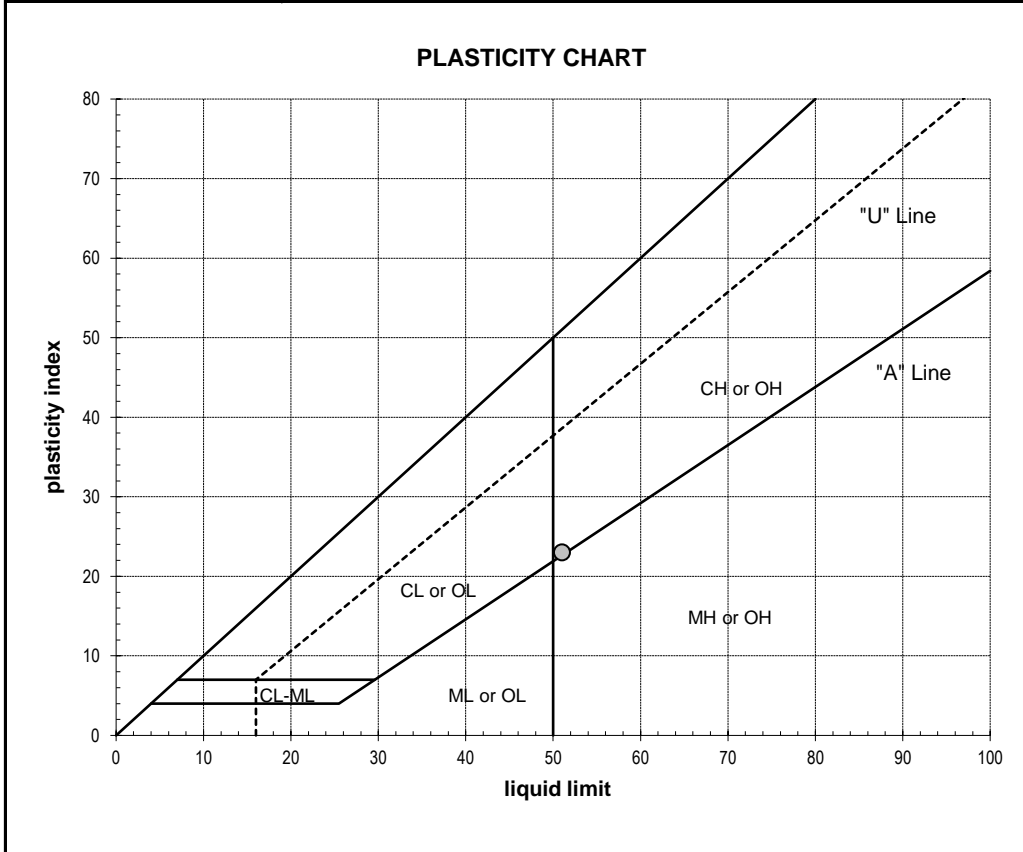
ATTERBERG LIMITS REPORT

ATTERBERG LIMITS liquid limit = 51 plastic limit = 28 plasticity index = 23	LIQUID LIMIT DETERMINATION				
		①	②	③	④
	wet soil + pan weight, g =	32.13	30.64	32.31	
	dry soil + pan weight, g =	28.46	27.31	28.25	
	pan weight, g =	21.08	20.79	20.60	
N (blows) =	30	23	16		
moisture, % =	49.7 %	51.1 %	53.1 %

SHRINKAGE shrinkage limit = n/a shrinkage ratio = n/a	PLASTIC LIMIT DETERMINATION				
		①	②	③	④
	wet soil + pan weight, g =	28.20	27.77		
	dry soil + pan weight, g =	26.55	26.26		
	pan weight, g =	20.79	20.92		
moisture, % =	28.7 %	28.3 %

ADDITIONAL DATA	
% gravel =	33.9%
% sand =	19.7%
% silt and clay =	46.5%
% silt =	n/a
% clay =	n/a
moisture content =	20.8%

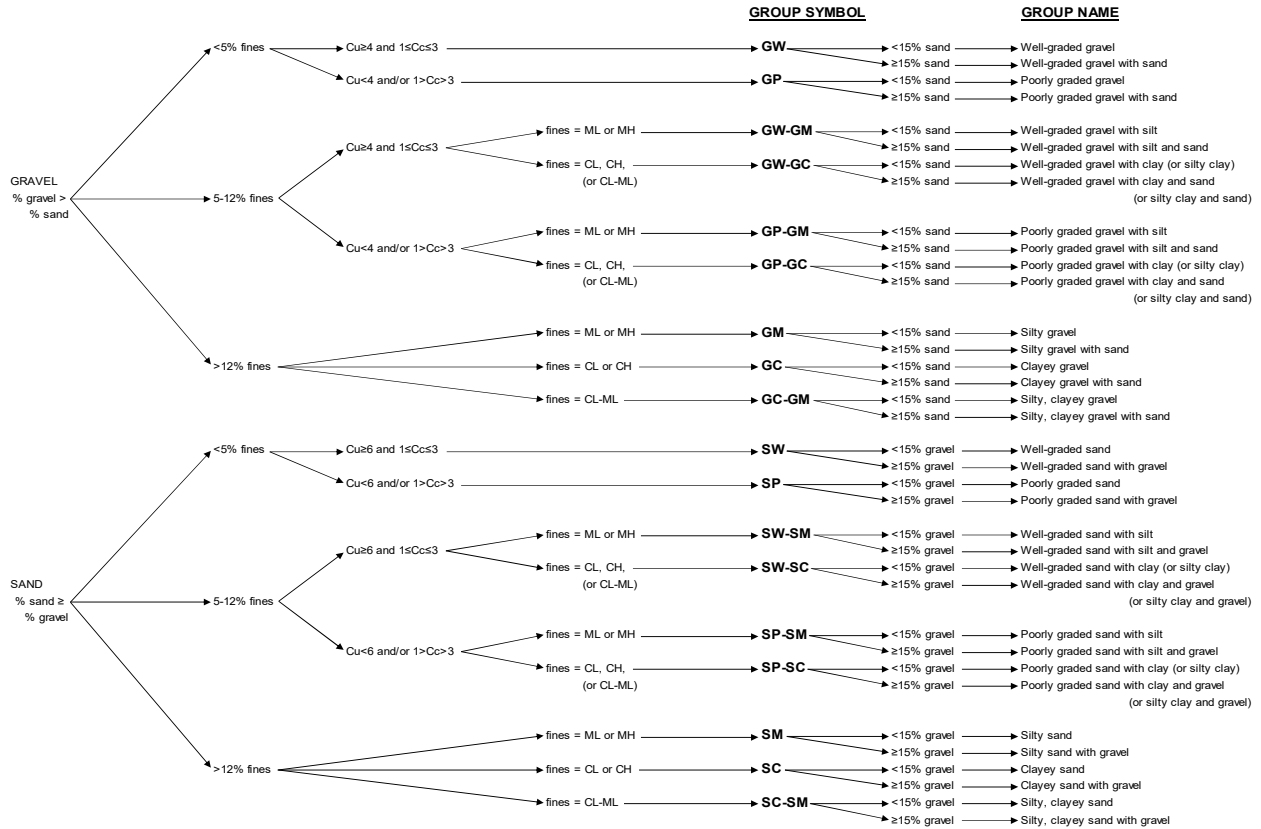
Flow Chart for Classifying Coarse-Grained Soils (More Than 50% Retained on No. 200 Sieve)

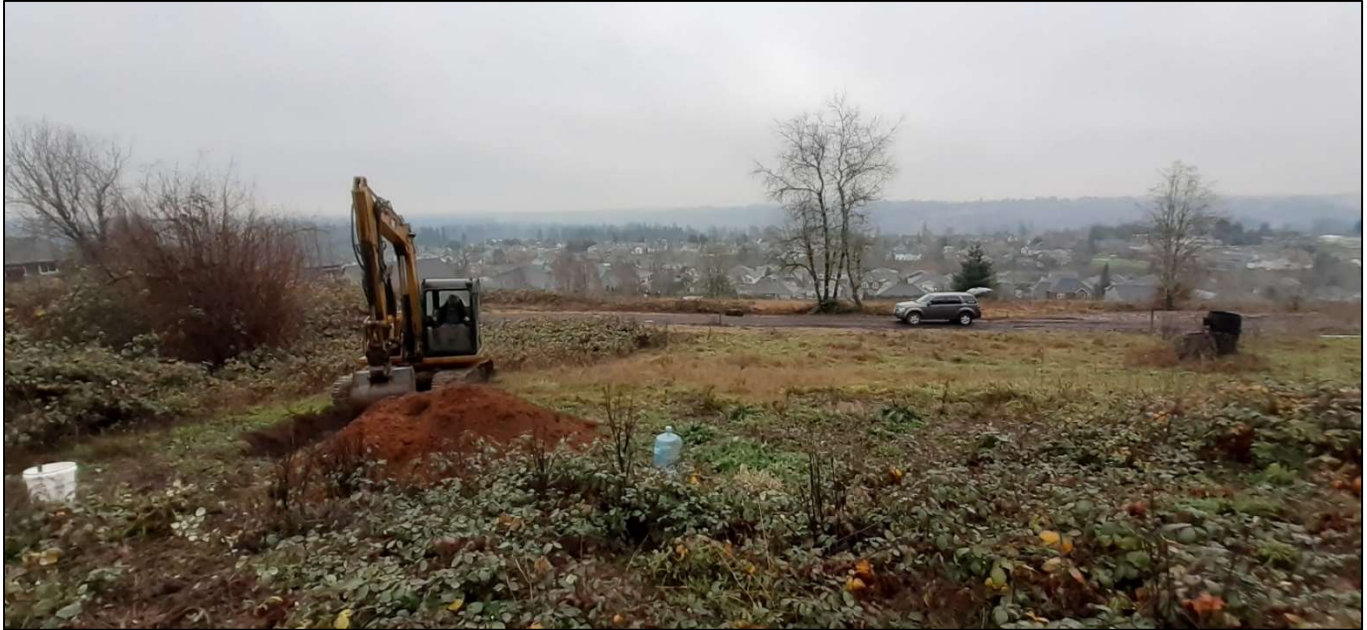
Conducting Test Pits, Looking South towards TP-1

A geotechnical field investigation consisting of visual reconnaissance, two test pits (TP-1 and TP-2), and two infiltration tests was conducted at the site on December 11, 2020. Test pits were explored with a track-mounted excavator. Subsurface soil profiles were logged in accordance with Unified Soil Classification System (USCS) specifications. Disturbed soil samples were collected from relevant soil horizons and submitted for laboratory analysis. Analytical laboratory test results are presented in Appendix A. Exploration locations are indicated on Figure 2. Subsurface exploration logs are presented in Appendix B. Soil descriptions and classification information are provided in Appendix C. A photo log is presented in Appendix D.

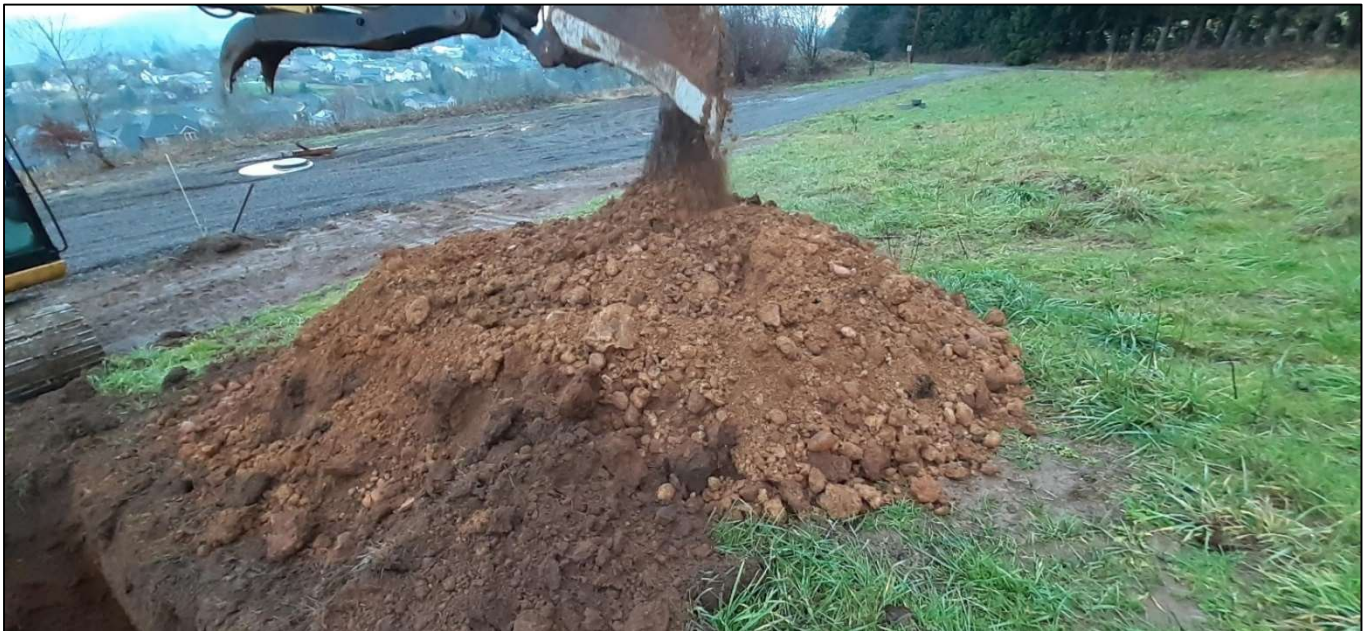
Typical Spoils Observed, TP-2

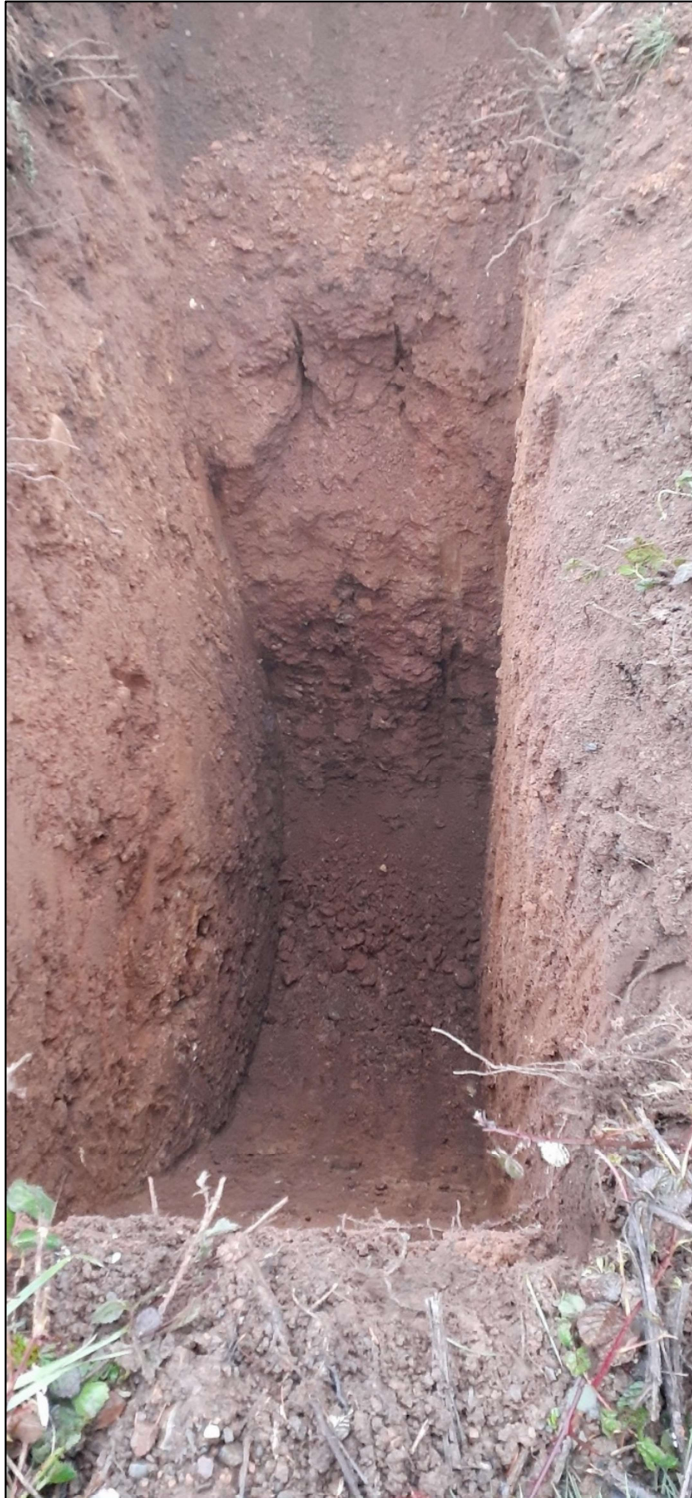
Typical Soil Profile Observed, TP-1

The field investigation indicated the presence of approximately 8 to 10 inches of sod and topsoil in the observed locations. Underlying the topsoil layer, subsurface soils resembling native USDA Hesson gravelly clay loam soil series descriptions were encountered.
