# REVISED BANK USE PLAN

## Highland Terrace *La Center, Washington*

*Prepared by*  
**Ecological Land Services**  
1157 3rd Avenue, Suite 220A • Longview, WA 98632  
(360) 578-1371 • Project Number 2378.01  
Corps Reference Number : NWS-2016-540

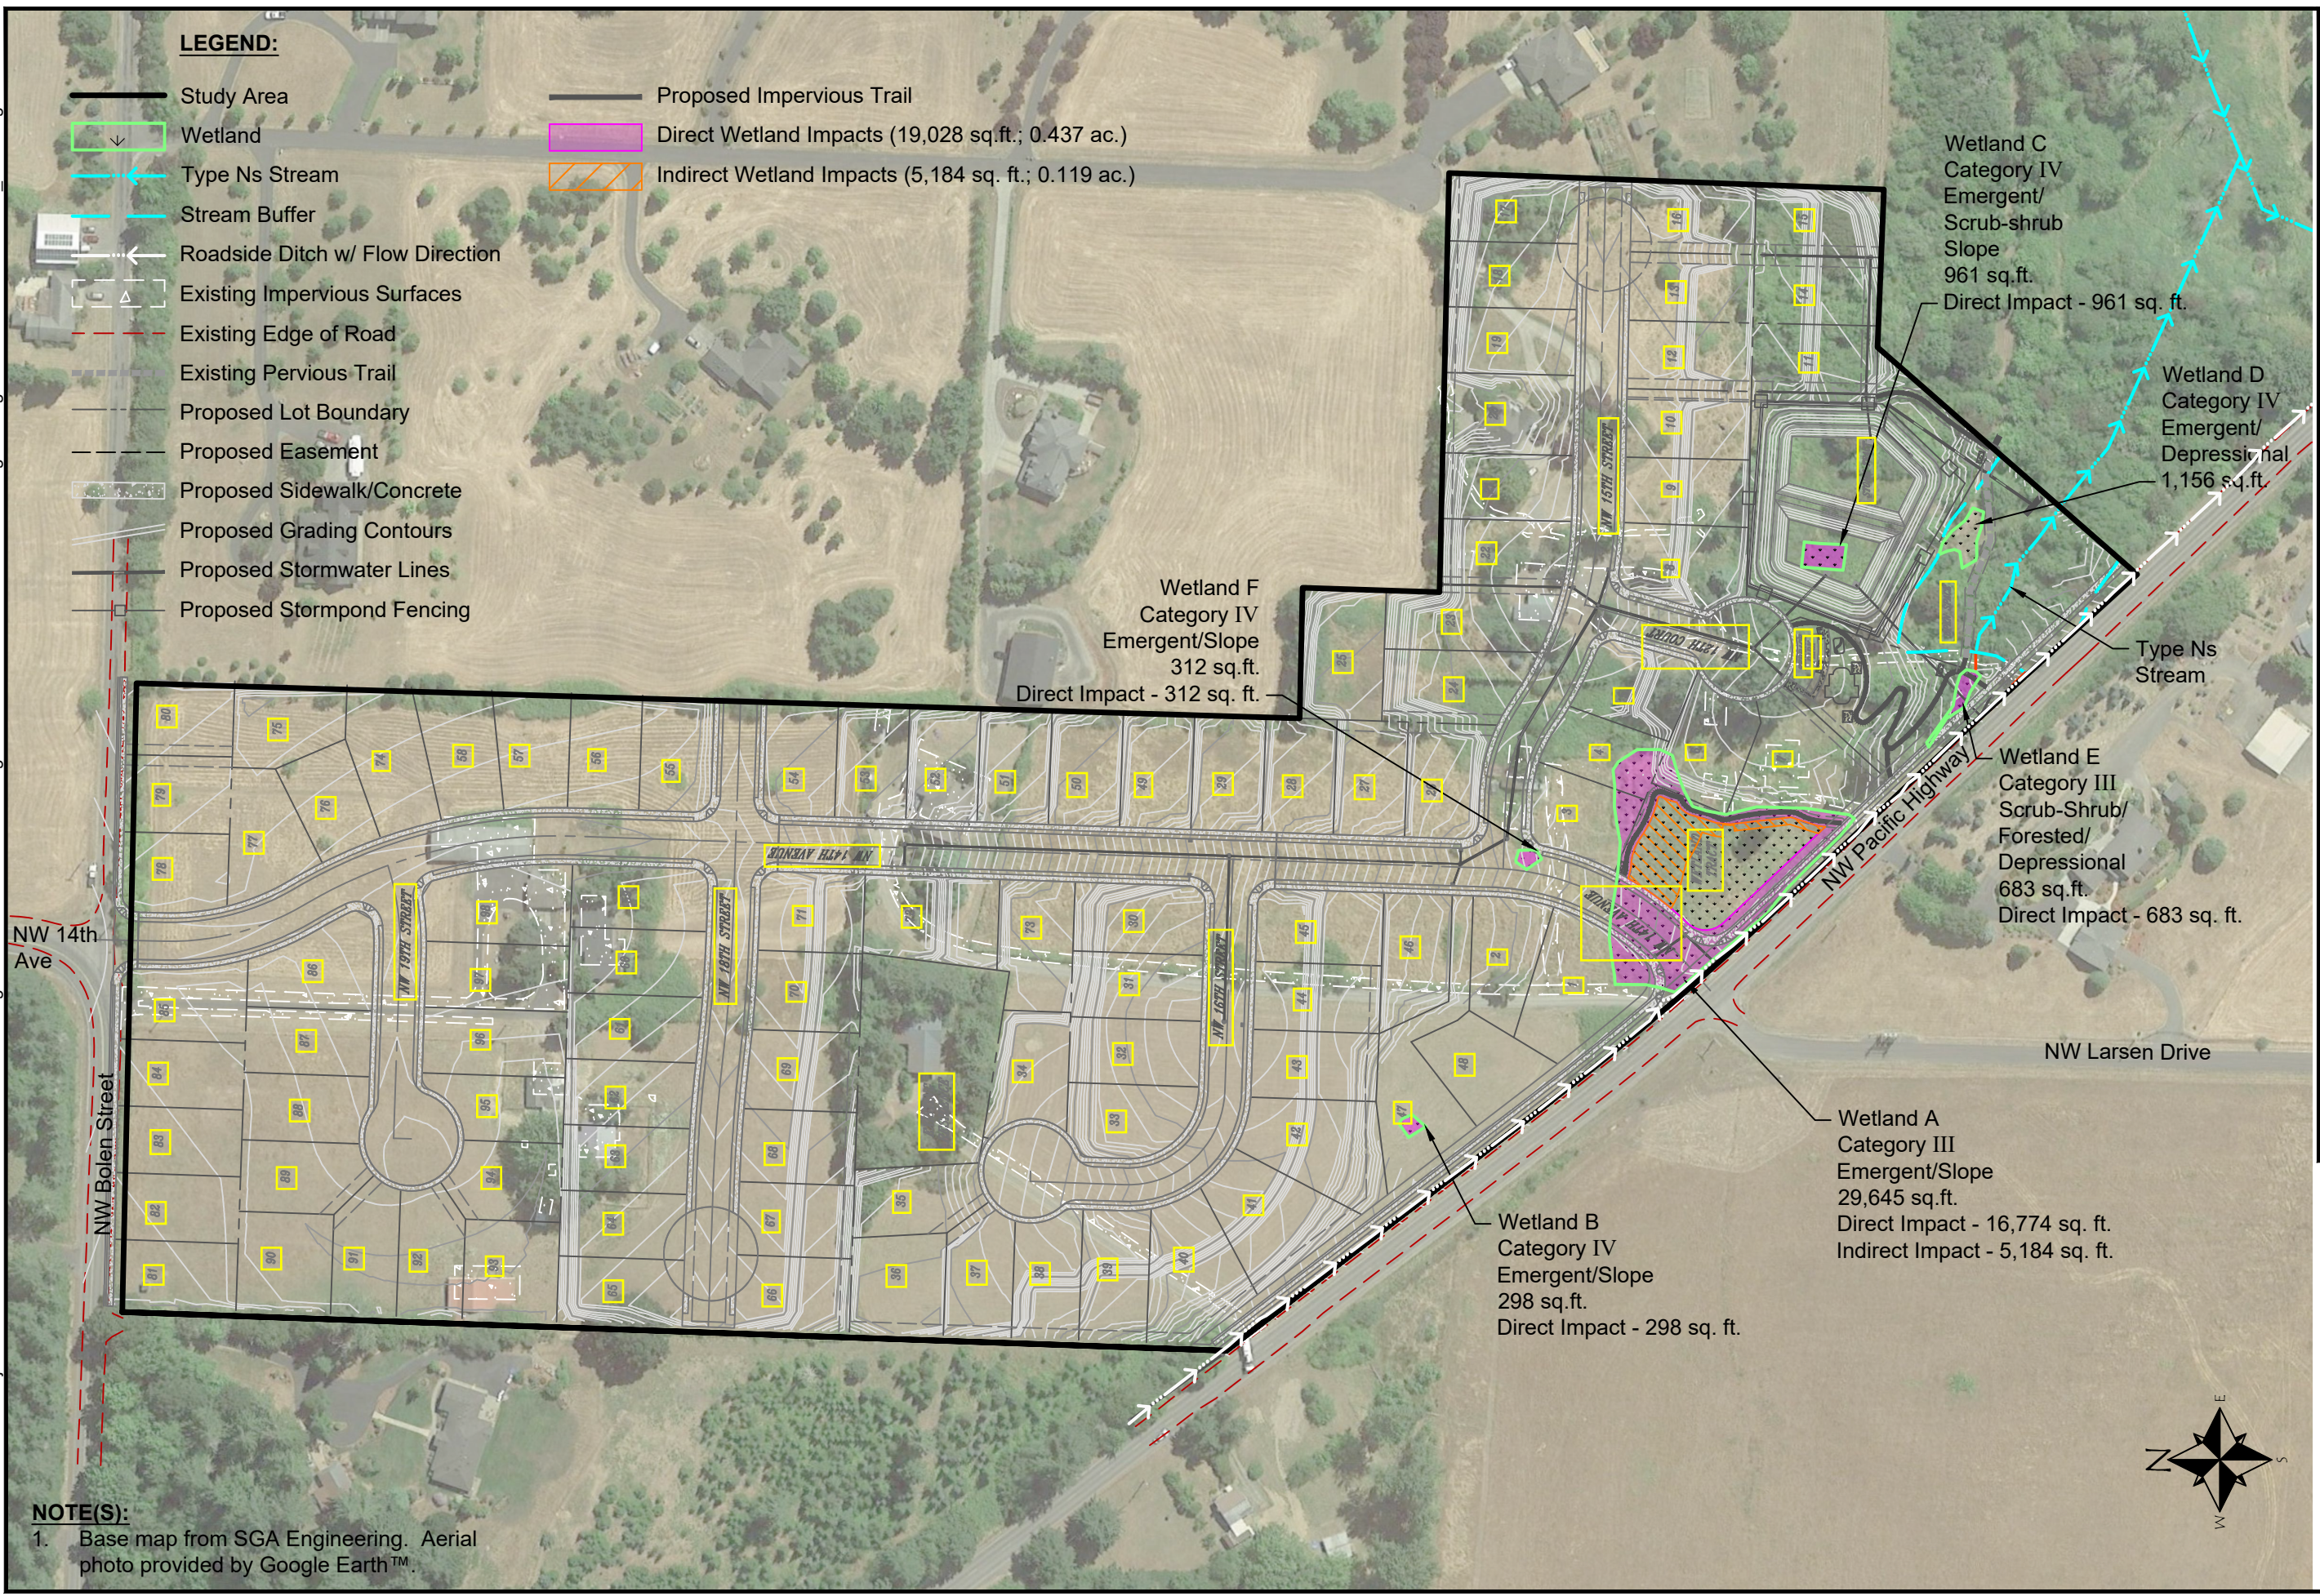
**PROPOSED CONDITIONS**

Construction activities will involve directly impacting 0.437 acres (19,028 sq. ft.) of wetland by grading for lot development as well as indirectly impacting 0.119 acres (5,184 sq. ft.) of wetland due to insufficient buffer. Approximately 0.385 acres (16,774 sq. ft.) of Wetland A will be filled for the City-required road alignment and frontage improvements and to accommodate lot development. Wetland B (0.007 acres, 298 sq. ft.) will be filled completely for lot development while Wetlands E (0.016 acres, 683 sq. ft.) and F (0.007 acres, 312 sq. ft.) will be filled completely for City required road alignment and frontage improvements. Wetland C is in the area most practicable for the stormwater tract and therefore will be impacted due to conversion for the stormwater facility. Table 2 below summarizes the impacts to critical areas.

- Study Area
- Wetland
- Type Ns Stream
- Stream Buffer
- Roadside Ditch w/ Flow Direction
- Existing Impervious Surfaces
- Existing Edge of Road
- Existing Pervious Trail
- Proposed Lot Boundary
- Proposed Easement
- Proposed Sidewalk/Concrete
- Proposed Grading Contours
- Proposed Stormwater Lines
- Proposed Stormpond Fencing
- Proposed Impervious Trail
- Direct Wetland Impacts (19,028 sq.ft.; 0.437 ac.)
- Indirect Wetland Impacts (5,184 sq. ft.; 0.119 ac.)

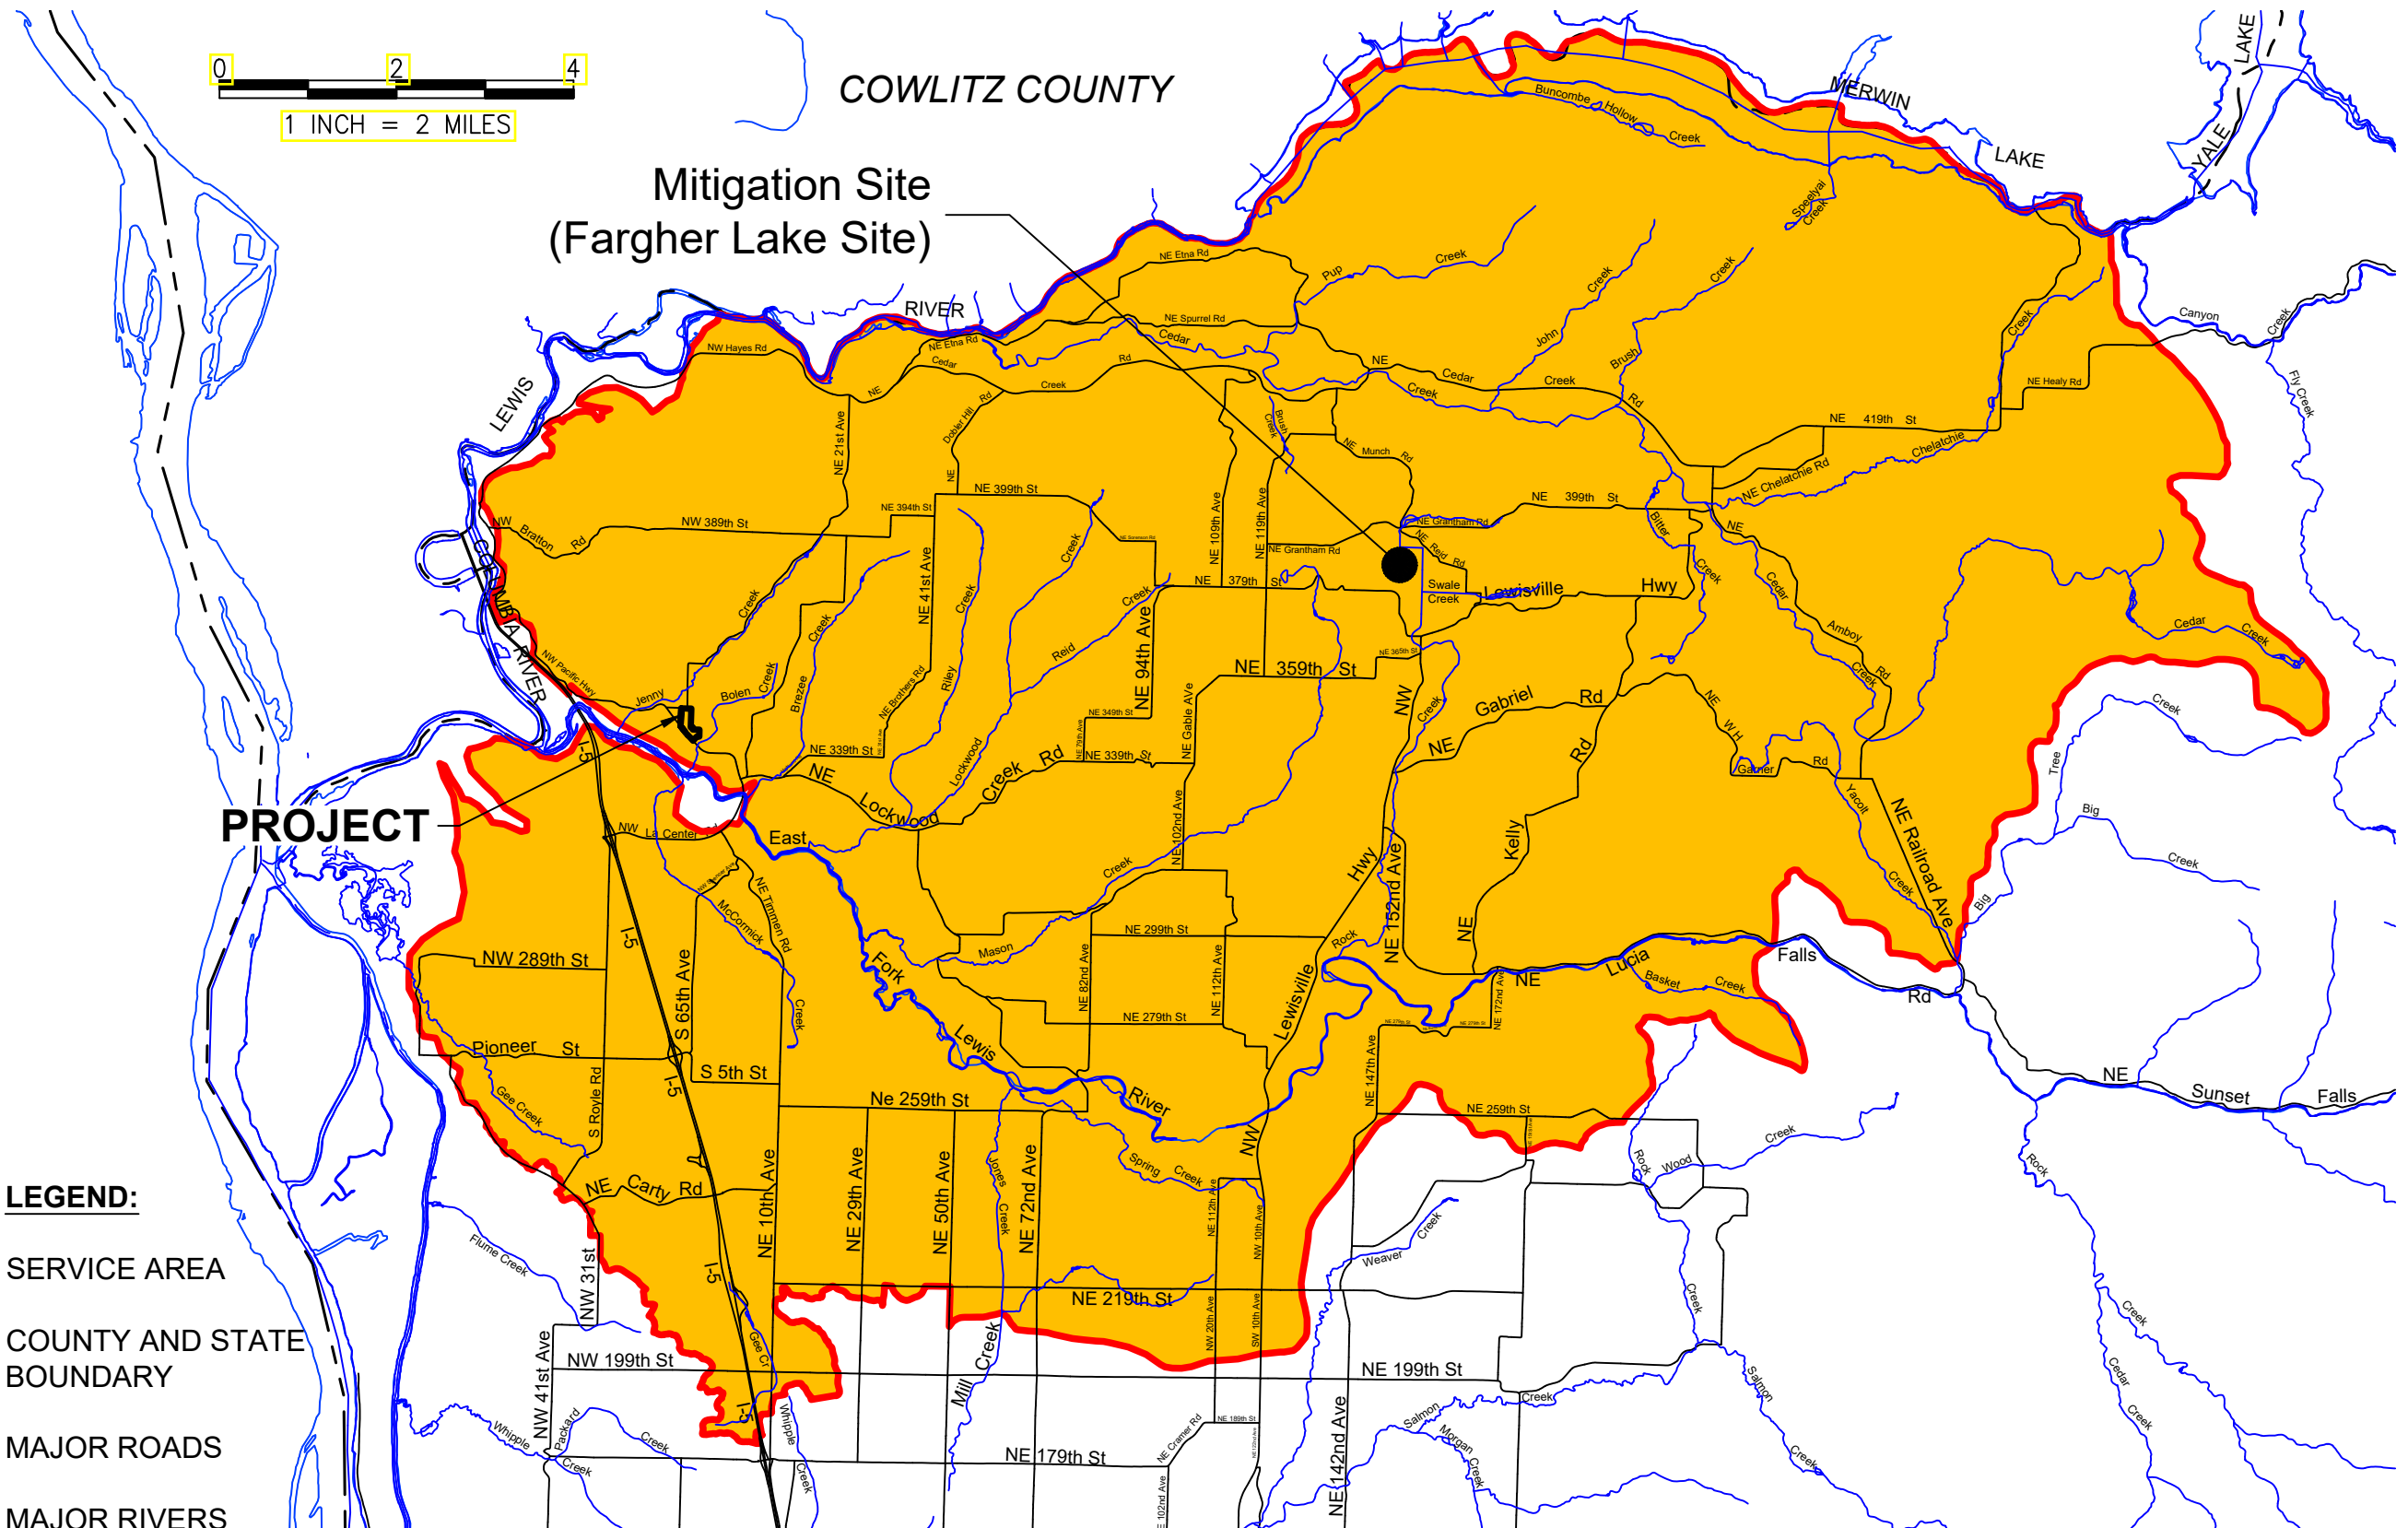
**EFLRMB SERVICE AREA**  
APPLICANT: Evergreen Homes NW  
PROJECT NAME: Highland Terrace Subdivision  
REFERENCE #: NWS-2016-540

The wetlands proposed for impact are located within the service area for the EFLMB (Bank; Figure 5). The project site is located approximately 8 miles west of the Bank within the western portion of the service area. Recent wetland science from Ecology, the Corps, and the U.S. Environmental Protection Agency states that they promote mitigation that is:

1. STATE, COUNTY, ROADS, RIVERS AND STREAM BOUNDARIES FROM ECOLOGY WEBSITE:  
<http://www.wsdot.wa.gov/mapsdata/geodatacatalog/default.htm>
2. SERVICE AREA BOUNDARY BASED ON MAP PREPARED BY STEPHEN STANLEY WETLAND RESTORATION BIOLOGIST WASHINGTON DEPARTMENT OF ECOLOGY SEA PROGRAM.
3. MAP PREPARED BY ECOLOGICAL LAND SERVICES, INC., DECEMBER, 2007 AND JANUARY, 2010.
