CRITICAL AREAS MITIGATION PLAN

Stephens Hillside Farm

Date: May 2, 2018

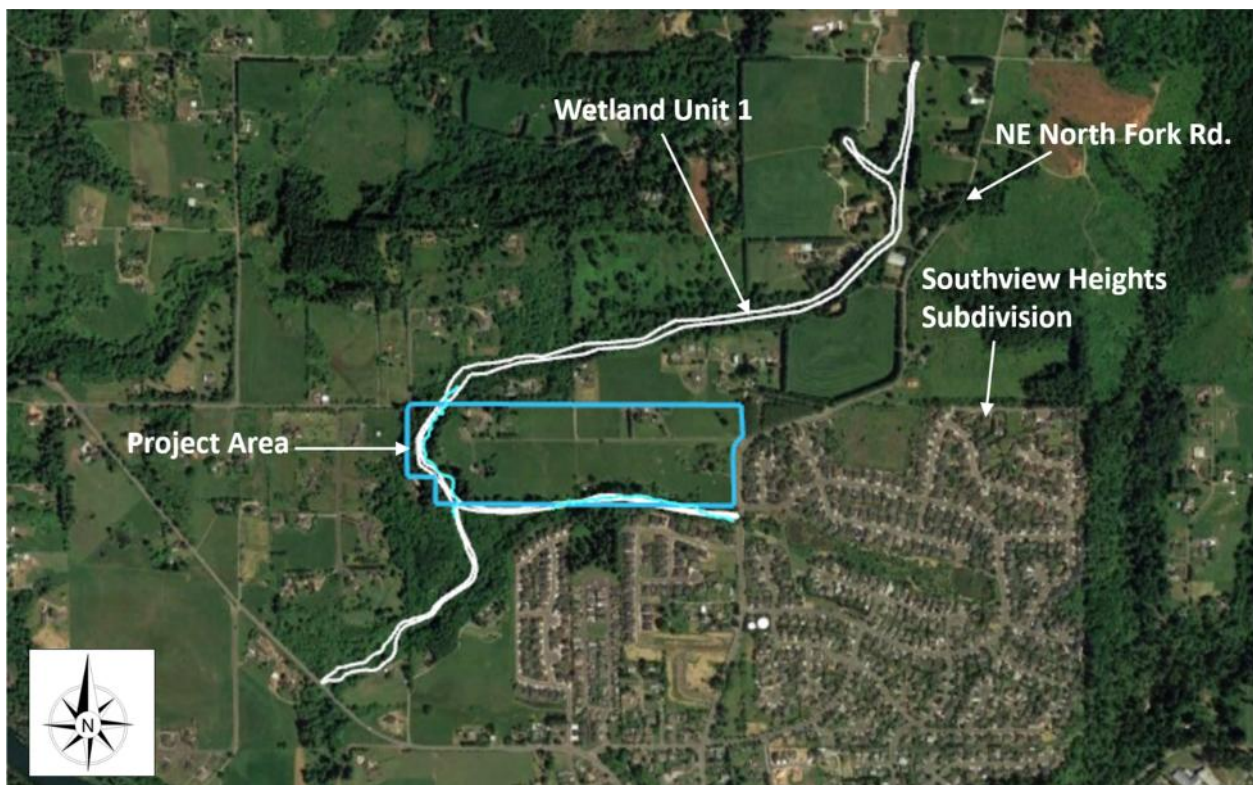
Figure 2. Aerial photo of the project area and surrounding land uses.

The project area is located along the northeast side of the City of La Center. Land uses to the east and south are in residential subdivisions. Open space, forestland, and farmland are the dominant land uses to the north and west. Interstate 5 is 2.7 miles to the southwest.

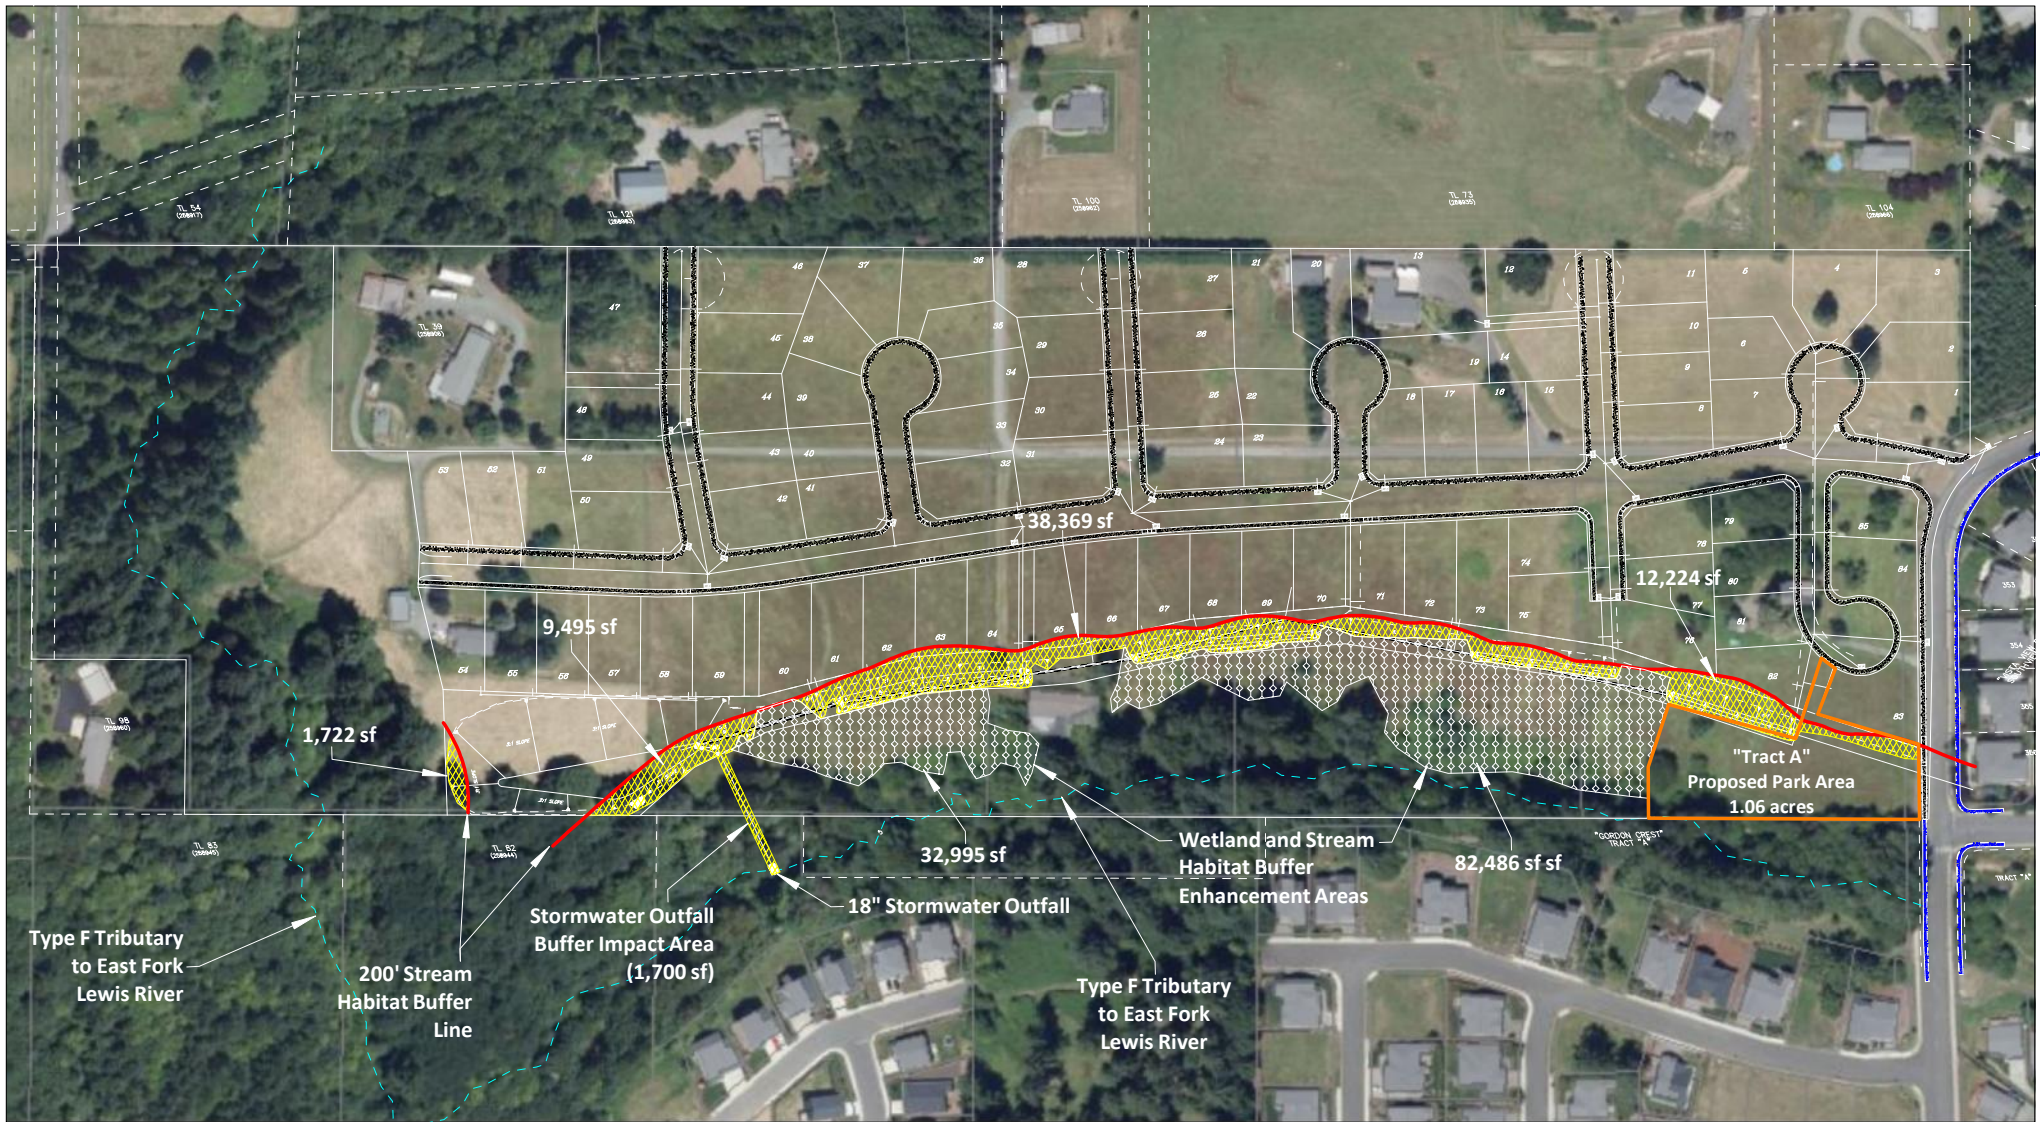
Figure 5 of 5
Critical Areas Buffer Impacts and Mitigation
Critical Areas Mitigation Plan

Note: Site plan provided by The Wolfe Group, LLC.

The site plan developed by The Wolfe Group, LLC (Figure 5 of 5) avoids direct impacts to any of the regulated Category 2 wetlands on the project site.

The applicant proposes to treat stormwater from pollution generating surfaces (impervious) with bioswales and detain in a detention pond. The bioswales are in the buffer of the Type F streams. Per the comments in the November 2, 2017 Pre-Application Conference notes for the Hillside Farm Subdivision (now known as the Stephens Hillside Farm), the city stated that stormwater treatment in the outer 25 percent of the stream buffer could be allowed. This allowance was also verbally given by city staff Jeff Sarvis and Tony Cooper to the project engineer Jeff Whitten. The stormwater facilities will all be located within the outer 25% of the 200-ft. stream buffer, or outer 50 feet. The total area of buffer encroachment by the stormwater facilities is 1.45 acres. Included in this area is a stormwater outfall corridor that will require removal of vegetation within a 10-foot-wide swath of approximately 1,700 square feet in area extending downslope from the stormwater facility south of Lot 59 to the edge of the stream. The stormwater pipe will be buried underground within this corridor. Rock rip rap

A proposed park is to be located in the southeast portion of the project area to the south of lots 76, 82, and 83. The park will be located within the 120-ft. wetland buffer in an area of grassland pasture. Some trees are located in the west portion of the park which will be retained. The landscape architect for the project has completed a proposed park plan which includes a landscaping planting plan (see Appendix C). No other encroachments are proposed within the 120-ft. wetland buffers on the project area.

Wetland and Stream Habitat Buffer Mitigation Area: 2.65 acres (See Figure 5 of 4 for planting area locations)

1. Wetland and Stream Habitat Buffer Mitigation Area: Plant native shrubs and trees within the 2.65-acre wetland buffer areas as shown on Figure 5 of 5.

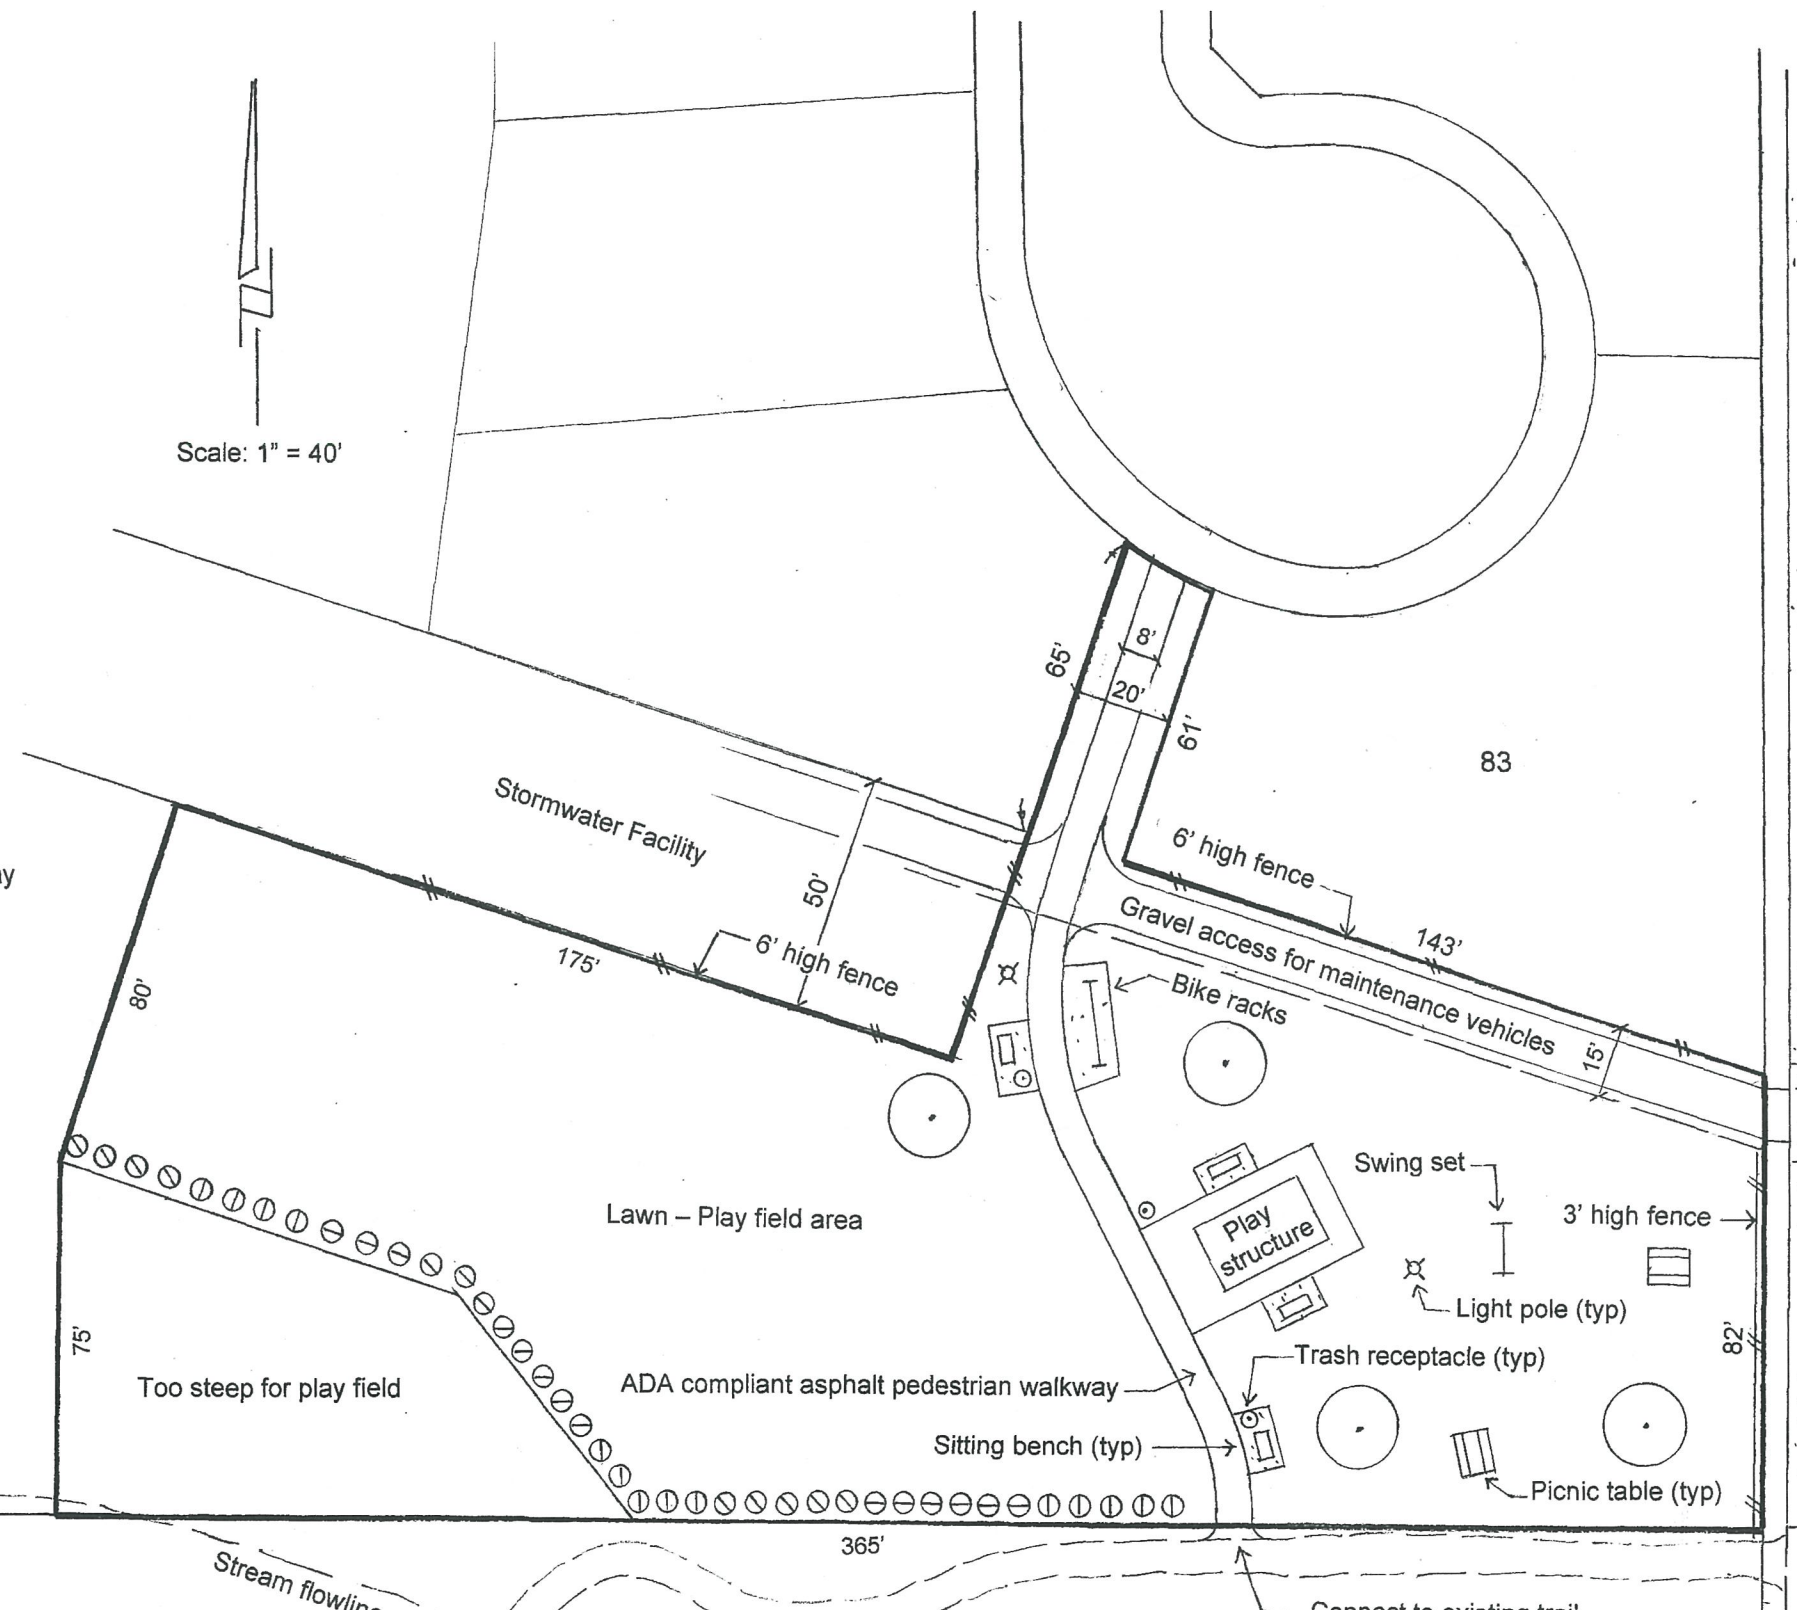
Proposed Park Plan
for Stephens Hillside Farm

Planting Plan

Symbol	Common Name	Botanical Name	Planting Size	Mature Size	Quantity
•	Trident Maple	Acer buergeranum	2" cal	25' high	4
⊖	Gulf Stream Nandina	Nandina domestica	2 gal	3' - 4' high	11
⓪	Bird Nest Spruce	Picea abies "Nidiformus"	2 gal	3' - 4' high	15
⊙	Otto Luyken Laurel	Prunus laurocerasus	2 gal	4' high	10

The applicant has designed the park to be in the proposed location due to generally steep topographic terrain over the majority of the site. The proposed location is in the only relatively flat part of the site and is also centrally located to the surrounding residential homes. The park will have frontage along Aspen Ave. A 3’ high non-sight-obscuring fence will contain children and play equipment from entering the roadway and allow police to visually monitor the park from Aspen Avenue.
